TECHNICAL BULLETIN

SC1 & SC2 Splice Coupler

July 2024

CABLE SEATING DEPTH

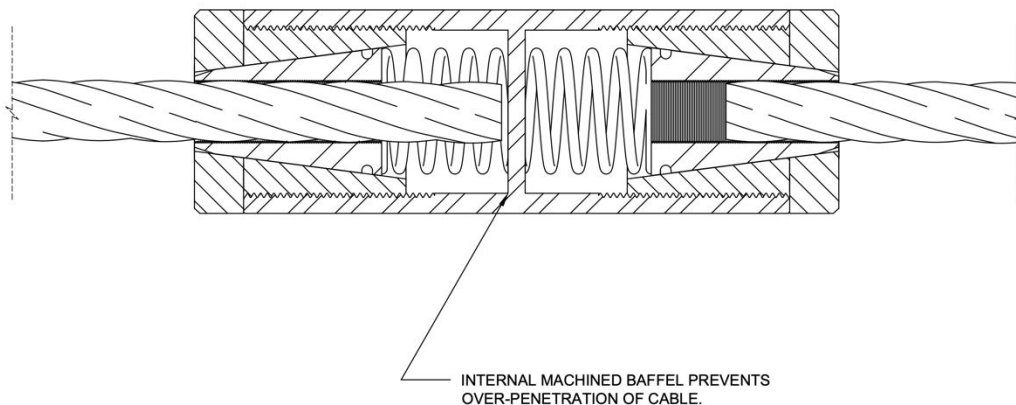
An issue that may arise with inexperienced or inattentive technicians during the installation of the SC1/SC2 Splice Coupler is the failure to fully seat the cable within the wedges. A common mistake is that the installer pushes the cable partially into the wedges, this can give the false impression that the cable is fully seated because the cable “feels tight” when hand pressure is applied. However, the cable will slip from the wedges during tensioning of the tendon.

CORRECT

CABLE IS FULLY INSTALLED, WHICH ALLOWS THE WEDGES TO FULLY ENGAGE. MINIMUM ENGAGEMENT LENGTH IS 2-1/4" FROM SPLICE FACE TO CABLE TIP.

INCORRECT

CABLE IS ONLY PARTIALLY INSTALLED IN THE WEDGES. WILL FEEL HAND TIGHT, BUT SLIPS DURING TENSIONING.

One of the SC1/SC2 Splice Coupler design features is that it is machined with two individual wedge chambers on each side of the splice that are separated by a solid steel internal baffle. That means it’s physically impossible for the technician to over-penetrate the cable into the opposite side wedges and cause them to become displaced. Therefore, it is recommended that the cable be installed a minimum depth of 2.25” as measured from the face of the splice end cap.
