TECHNICAL BULLETIN

SC1 & SC2 Splice Coupler

July 2024

SPLICE COUPLER PLACEMENT DURING INSTALLATION

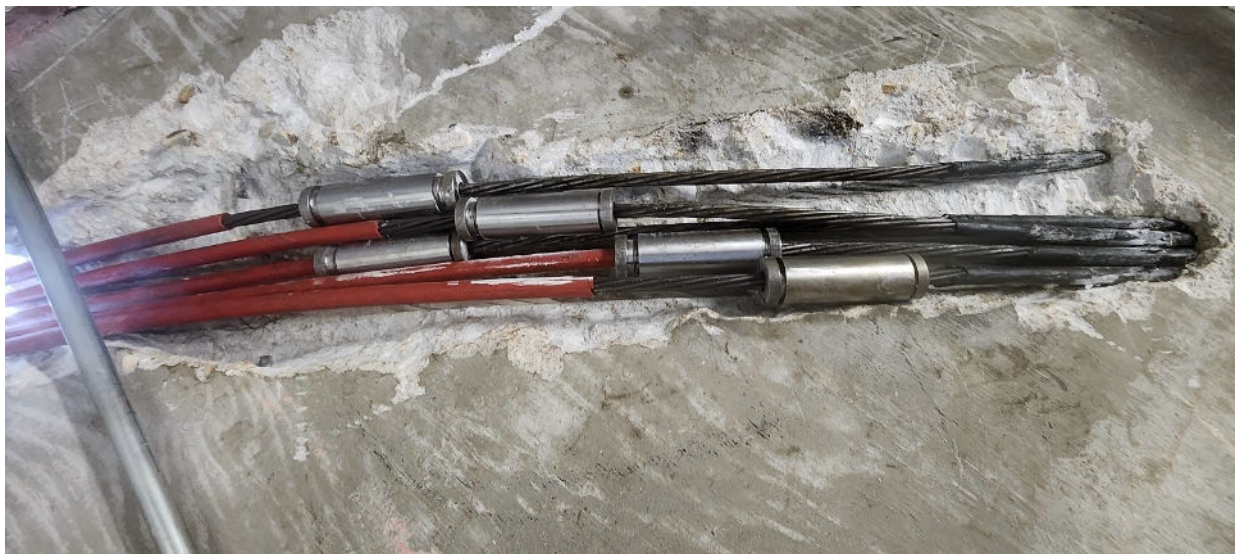
Placement within a lateral tendon sweep

This problem occurs during the repair of tendons that have ruptured from a slab as the result of insufficient hairpin reinforcement. Some installers find it tempting to make the repair within the existing damaged area of the slab, where the tendons are making a lateral directional change. It is strongly recommended to avoid the installation of splices within an area of lateral tendon displacement, instead they should be located in areas where the tendons have returned to a straight configuration.
