# TECHNICAL BULLETIN 2.0

## *SC1 & SC2 Splice Coupler*

### **SPLICE COUPLER PLACEMENT DURING INSTALLATION**

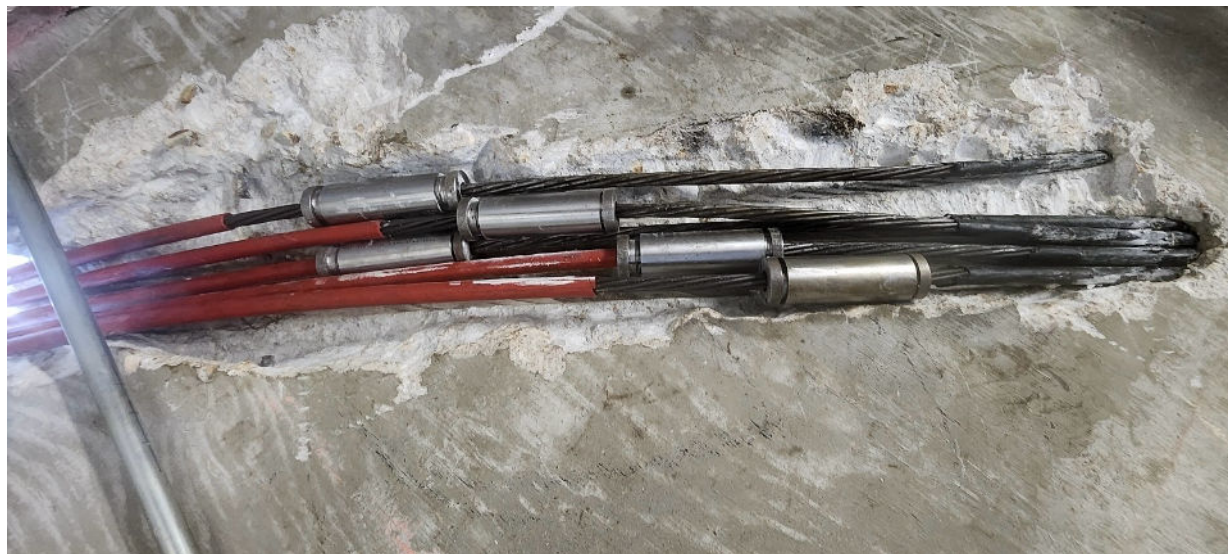
#### **Placement within a lateral tendon sweep**

This problem occurs during the repair of tendons that have ruptured from a slab as the result of insufficient hairpin reinforcement. Some installers find it tempting to make the repair within the existing damaged area of the slab, where the tendons are making a lateral directional change. It is strongly recommended to avoid the installation of splices within an area of lateral tendon displacement, instead they should be located in areas where the tendons have returned to a straight configuration.

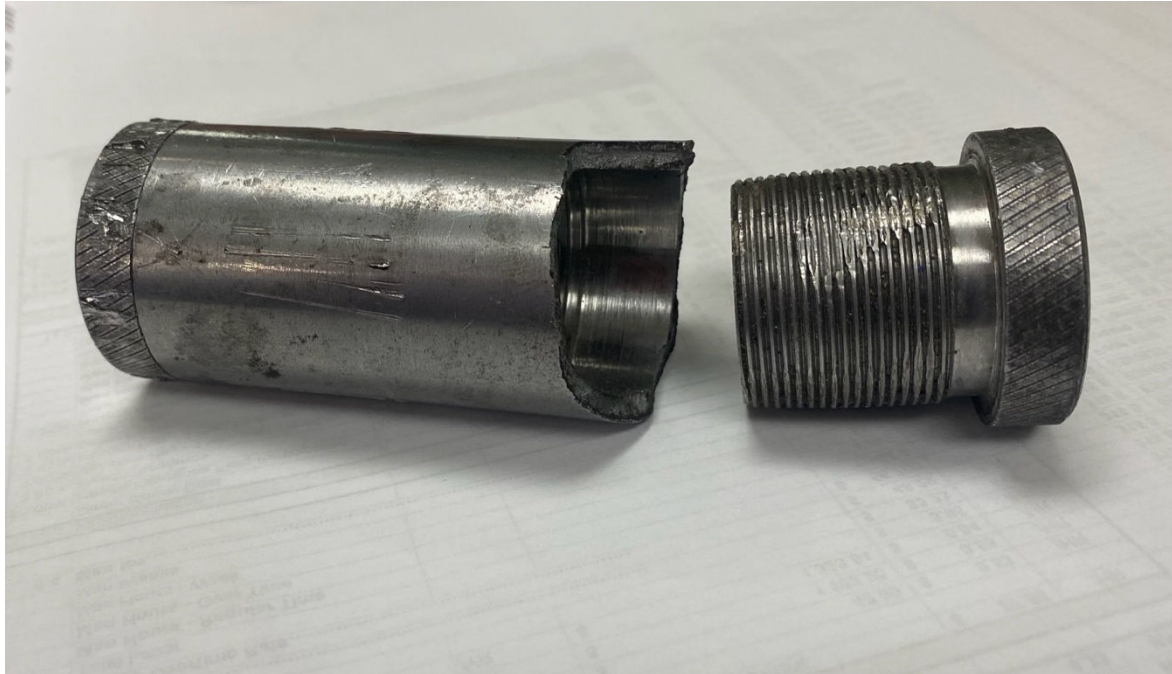
### **Insufficient clearance around the splice coupler**

This issue can develop when splices are installed in a location that causes an out of alignment condition because the splice is prevented from remaining straight due to a hardened obstacle, such as embedded rebar or concrete. During tensioning, the obstacle can cause a high bending stress to develop within the splice coupler, resulting in failure of the hardware. Care should be given to either removing the obstacle or relocating the splice to a location where it can remain in a straight and flat configuration.
