TECHNICAL BULLETIN 1.0

UNBONDED TENDON REPAIR SERIES

REPAIR OF DAMAGE AT LATERALLY DIVERTED TENDONS

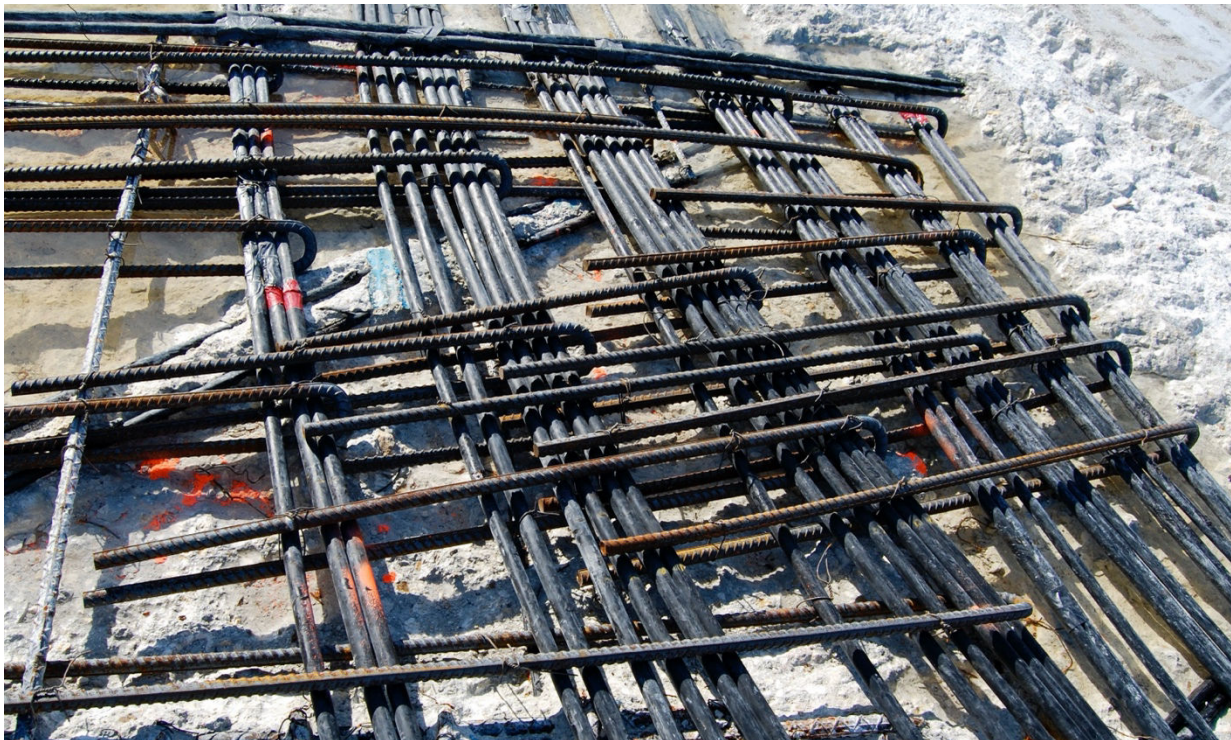
It has been observed that a common cause of tendons rupturing from a slab is due to a lack of adequate mild reinforcement in the form of hairpins that constrain the horizontal shear forces. This is particularly an issue with large groups of bundled cables but can develop with unreinforced single tendon sweeps. If it has been determined that insufficient hairpin reinforcement exists using non-destructive investigative means, such as X-ray or Ground Penetrating Radar, then this needs to be rectified as part of the overall repair strategy. While repair options may be considered, such as the installation of carbon fiber reinforcement to the slab surface, or vertically oriented rebar dowels along the tendon run, they should be thoroughly assessed by the structural engineer. It has been found that these alternatives often prove to be either structurally inadequate, or procedurally unsafe to be used. This often leaves the excavation of concrete from the lateral sweep area and replacement with rebar hairpins as the best alternative. It should be recognized that this repair option can be difficult because it will require the release of tension on all tendons with the repair location, and there may be large sections of concrete that need to be removed. Additionally, the installation of structural shoring in the areas that have temporarily lost post-tensioning support will need to be addressed.

Photo: Supplemental hairpin reinforcement added at banded tendon lateral sweep repair.

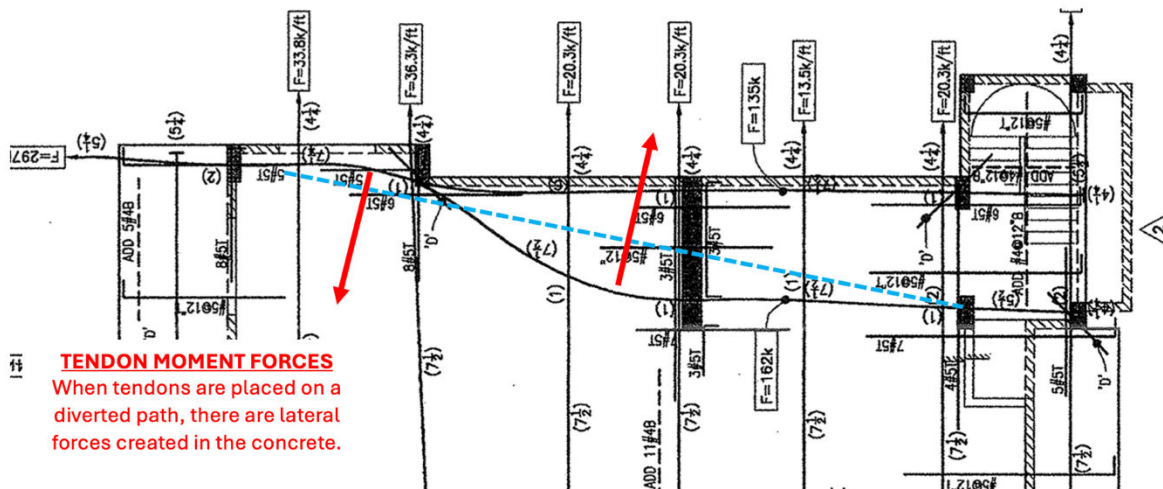
However, a tendons linear profile presents different challenges and is the subject of this discussion. When tendons are placed on a laterally diverted path, there are horizontal forces created in the concrete that must be recognized and accounted for, prior to undertaking any repair of the damaged area.

Image: Plan view sketch showing lateral tendon force in slab structure.

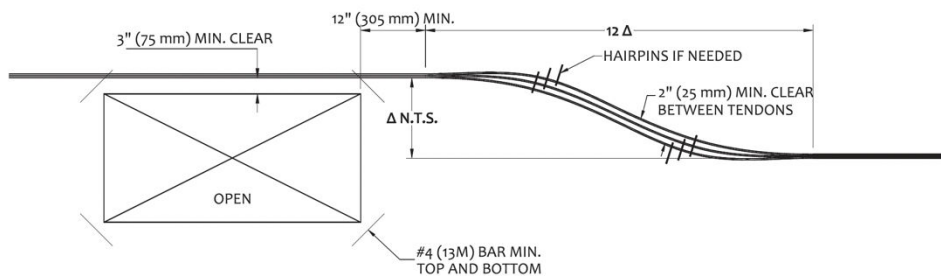
Fig. 4-6 —Typical detail of tendons deviating around an opening and tendon sweeps.

Image: The Post-Tensioning Institute recognizes the need for additional mild reinforcement in lateral sweeps.

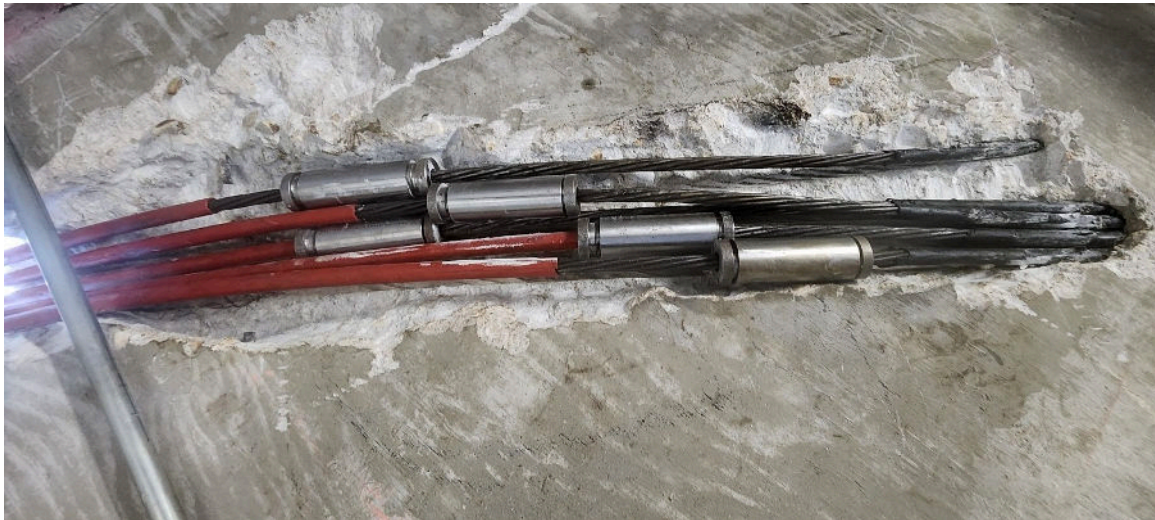
An issue that should be avoided is the installation of splice couplers at a location that places high bending stress on the hardware. These parts are designed to handle high tension loads that run in a straight unidirectional manner through the part. When they are subjected to off-center excentric tension loads, it can overstress the hardware and result in a sudden and catastrophic failure of the splice coupler. It is strongly recommended to avoid the installation of splices within an area of lateral tendon displacement. Instead, they should be located where the tendons have returned to a straight configuration.

Photo: Installation of these splice couplers within the tendon sweep places an excentric load on the hardware.

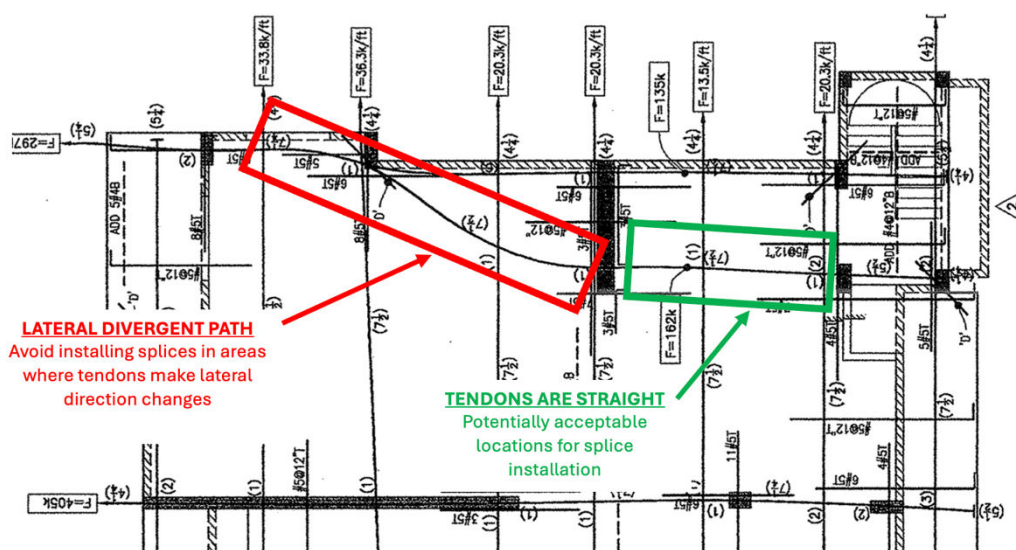
Image: Plan view sketch shows locations to avoid when installing splice couplers.
