TECHNICAL BULLETIN

Post Tensioned Structural Repairs

THE IMPORTANCE OF CONCRETE PREP GEOMETRY FOR POST-TENSION REPAIR

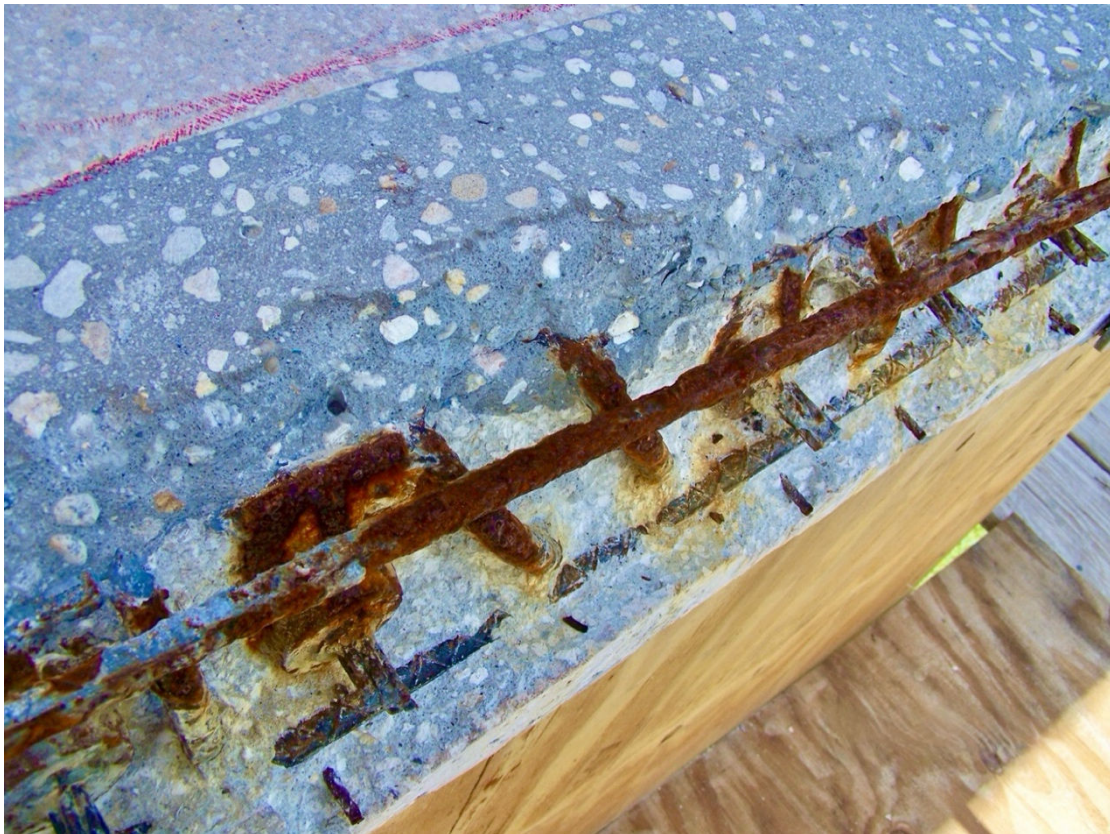
Photo: Old patching material is clearly visible, exposing advanced corrosion of embedded steel.

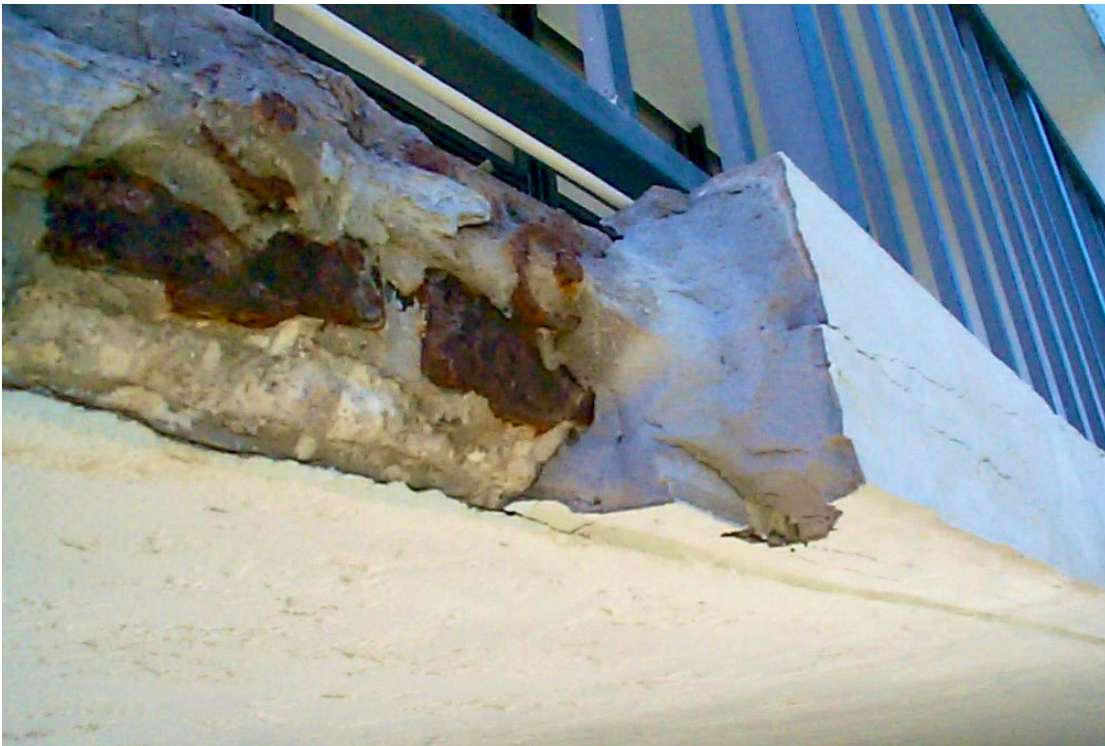
When corrosion damaged concrete is removed only from the face of the anchors and surrounding rebar, this causes the embedded steel elements to become sandwiched between the existing concrete that remains and the new concrete patching mortar. The resulting extreme differential between the properties of the two concrete materials creates a macroscopic corrosion cell with increased corrosion potential that causes the embedded steel to continue to corrode at a rapid rate. The International Concrete Repair Institute (ICRI) describes this phenomenon as the Anodic Ring or Halo Effect. They attribute this accelerated corrosion to the differential in electrical potential that's created "between the chloride contaminated or low pH existing concrete and the chloride-free or high pH repair material".

Photo: This failed slab edge patch was applied to the surface of the anchors without fully excavating the damaged area.

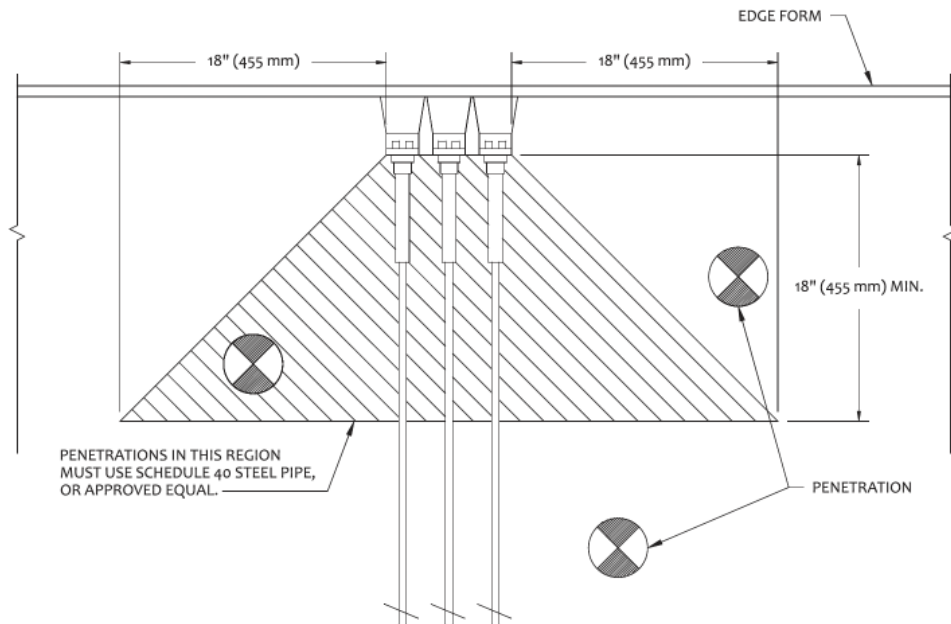
Fig. 4-5—Penetrations near tendon anchorage zone.

Image: The Post-Tensioning Institute recognizes the high-stress zone that exists behind terminal anchors.

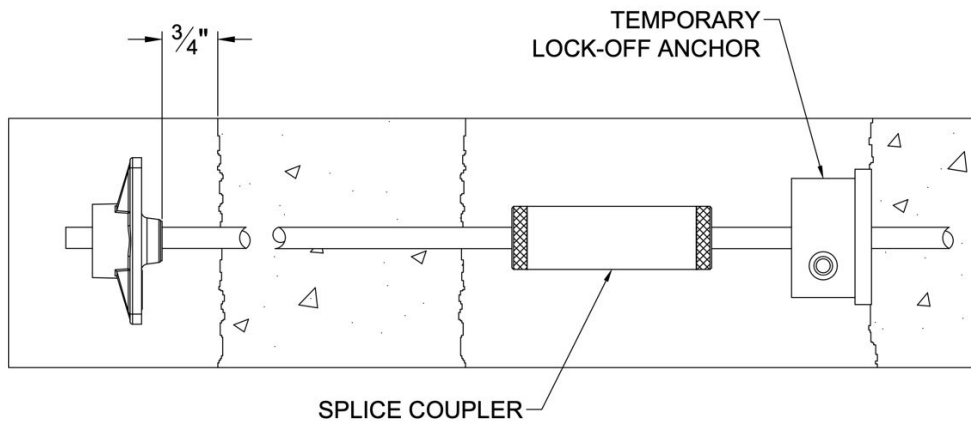
Image: Note that the ICRI required excavation extends into the high-stress zone behind the anchor.

When performing concrete structural repairs, the ICRI *"Guide for Surface Preparation for the Repair of Deteriorated Concrete Resulting from Reinforcing Steel Corrosion"* recommends a "minimum of 0.75 in. (19 mm) clearance between exposed reinforcing steel and surrounding concrete or 0.25 in. (6 mm) larger than the coarse aggregate in the repair material, whichever is greater."

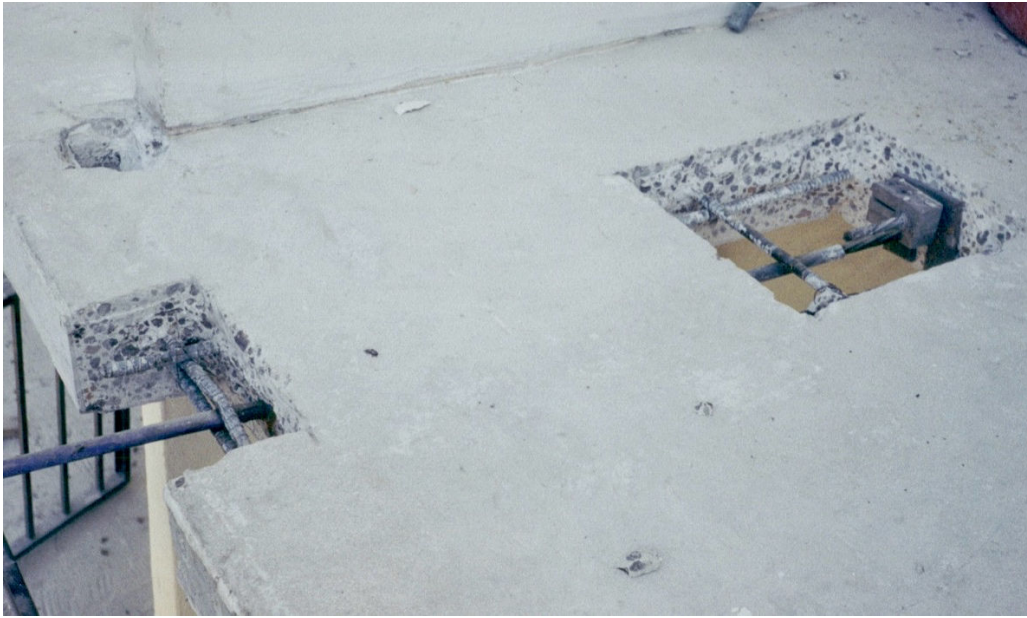
Photo: Shown is a fully excavated slab edge per ICRI requirements with tendon lock-off installed.

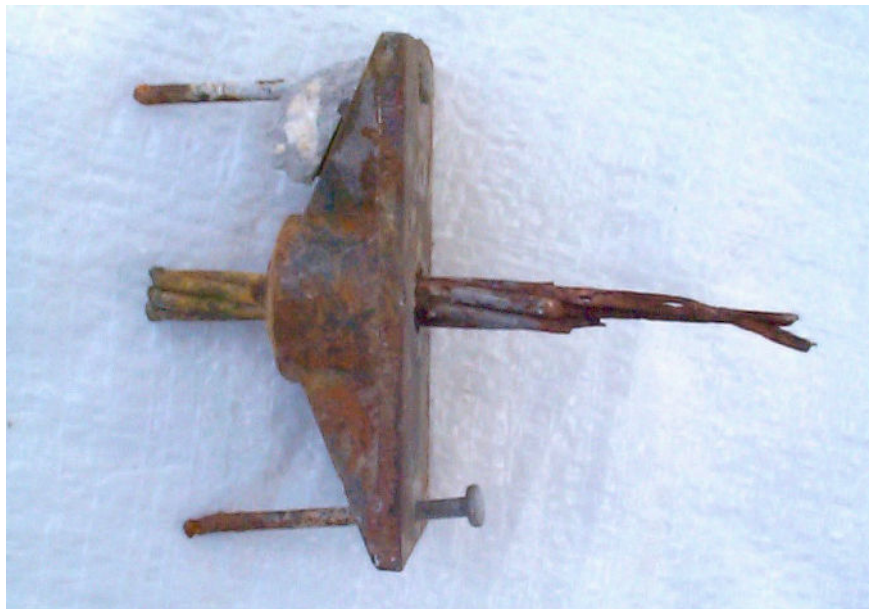
Ongoing corrosion of embedded mild steel around the post-tension anchorages will result in cracking and spalling of the concrete coverage in this critical area. These cracks will permit water to penetrate deeply into the slab and down to the level of the post-tensioning, which can find its way directly into the cables through any disruptions in the tendon sheathing. When this is allowed to happen, it substantially increases the likelihood of corrosion of the steel cable and can ultimately result in a failure of the tendon.

Photo: Tendon end that shows cable corrosion due to water intrusion into the cable sheathing.
