# TECHNICAL BULLETIN

## *Post Tensioned Structural Repairs*

JUNE 2025

### **MONOSTRAND POST-TENSIONED STRESSING ANCHOR POCKET DAMAGE & REPAIR**

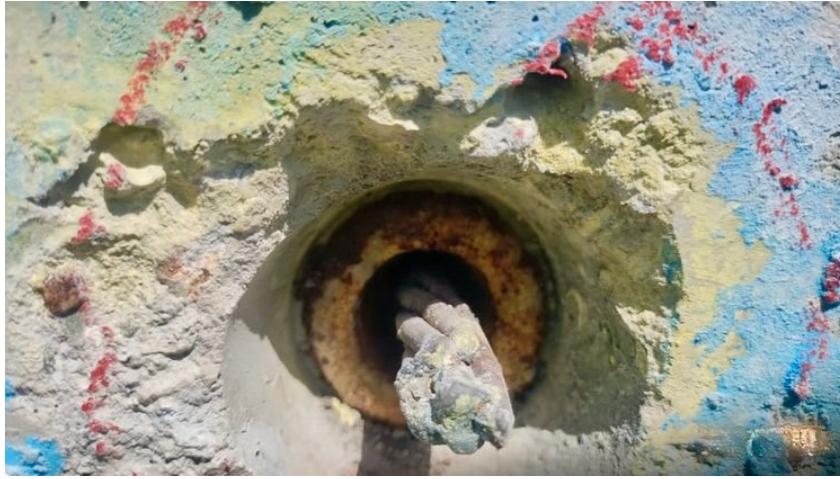
This condition is usually identified after the pocket grout has been removed and the wedges are found to be either loose or missing. While this could be the result of a wedge seating failure at the fixed end anchor during tensioning, that's often not the case, because the cables remain fully engaged with the opposing fixed end terminal anchorage. Were the failure to have occurred at the fixed end, the repair would typically require either the replacement of the entire tendon length, or the installation of a splice coupler in order to add the length of strand needed to stress the tendon. If the cable remains anchored at the fixed end anchor, then there exists the possibility of tensioning at the stressing anchor location, but this requires a specialized repair protocol and equipment. Additionally, the condition of the cable tail is critical in determining if restressing of the existing cable will be possible. If the cable tail is too short, or too badly corroded, there will not be enough usable strand available to permit re-tensioning.

*Image 3: Cable found with missing wedges after the grout was removed.*

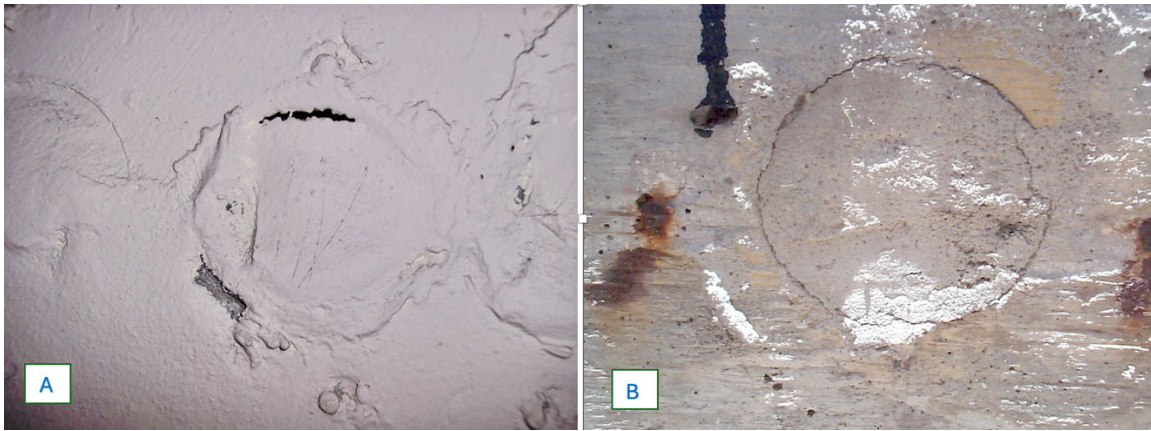
Other common problems that are found during structural remediation are usually the result of improper mixing or placement of the cementitious grout used to fill the anchor pockets. These include excessive cracking at the bond line between the grout and the concrete substrate, and voids in the pocket grout. Shrinkage cracking is often the result of retempering of the grout mixture during installation, which results in excessively high water-cement ratios. Additionally, the surface of the stressing pocket concrete can be contaminated with grease from the strand or other contaminants, which will inhibit proper bonding of the grout to the concrete pocket surface. Problems of this nature can be very detrimental to the useful life of the post-tensioning because it may permit water to ingress directly into the tendon anchor and result in accelerated corrosion of the steel elements. This issue can be particularly detrimental when the stressing anchors are subjected to prolonged direct water exposure. Anchors located below grade level can be exposed to rainwater, landscaping irrigation, or even the water table. Additionally, any anchors located in structures that retain water, such as planters, water tanks, or swimming pools, may be subjected to increased hydrostatic water conditions and pressurized water infiltration. In these situations, the installation of a waterproof membrane at the surface can be critical in protecting the anchor pockets from water infiltration.

*Image 4A: Void located at the top of the stressing anchor pocket. 4B: Drying shrinkage cracks in grout.*

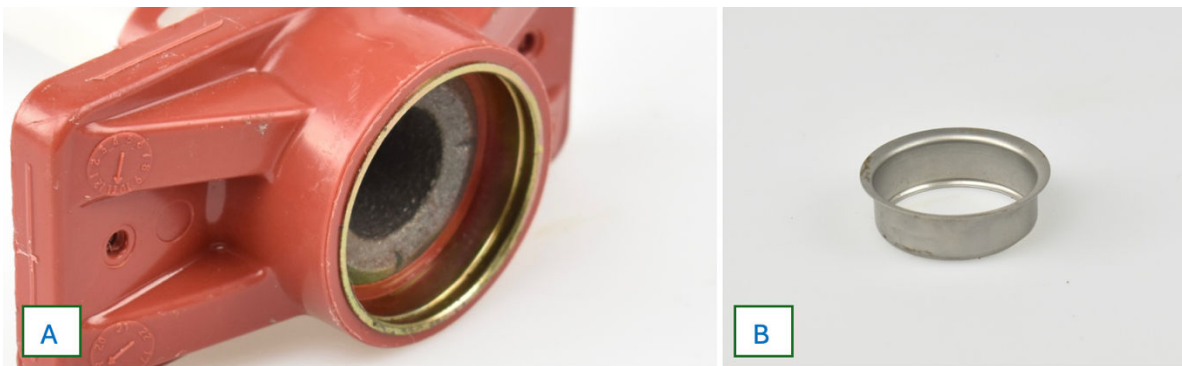
Many encapsulated anchors use a metal burn ring that is incorporated into the anchor. This ring serves two purposes; it protects the anchor encapsulation plastic from the heat of an oxygen acetylene torch used to cut the cable tails to length, and it provides a rigid interface to engage with the grease cap used to seal the anchor encapsulation. When the metal ring has sustained heat damage, it disrupts the integrity of the tendon encapsulation. The repair of this condition has been addressed using replacement metal rings, but this repair is becoming increasingly difficult because of the lack of availability of the metal rings. That's because manufacturers are reluctant to provide only the burn ring due to liability concerns associated with their use retroactively.

*Image 5A: Encapsulated anchor with burn ring installed. 5B: Replacement burn ring.*

As addressed previously, anchor burn rings can be damaged using an oxygen acetylene torch to trim the tensioned strand. Some design professionals call for the replacement of these damaged burn rings. However, not only are the replacement rings increasingly difficult to obtain, but this work can also be misguided. That's because if the torch has burned through the metal ring, it most certainly has also melted some of the plastic anchor encapsulation. Given that the PTI requires an encapsulated anchor assembly to withstand up to 10 psi of hydrostatic pressure for 24 hours, there is no practical mechanism to field test the integrity of the repaired anchor. Therefore, this raises the concern that the replacement of the burn ring is not capable of producing fully functional encapsulation, which also brings into question whether this is an appropriate repair.

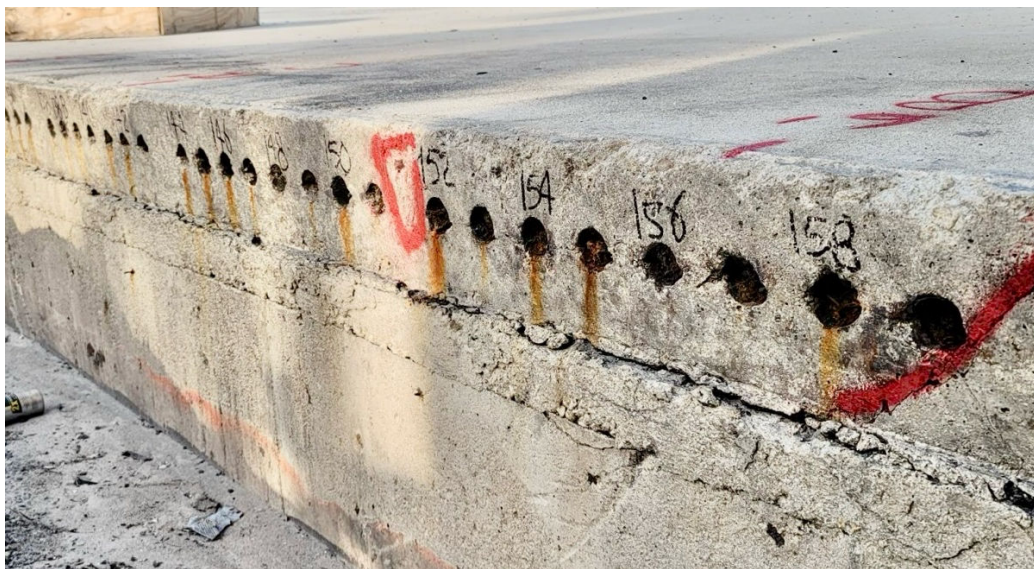
This is more of an issue caused by the location of the stressing anchors relative to the surface of the concrete. Stressing anchor pockets can vary in depth, but their design should provide adequate coverage for the face of the anchor. There are conditions where anchors are placed too close to the concrete surface and coverage is minimal. This condition is primarily observed with non-encapsulated anchors, which increases the corrosion potential of the unprotected anchor, wedges, and strand.

*Image 6: Anchors placed too close to the surface and lacking adequate stressing anchor pocket coverage.*

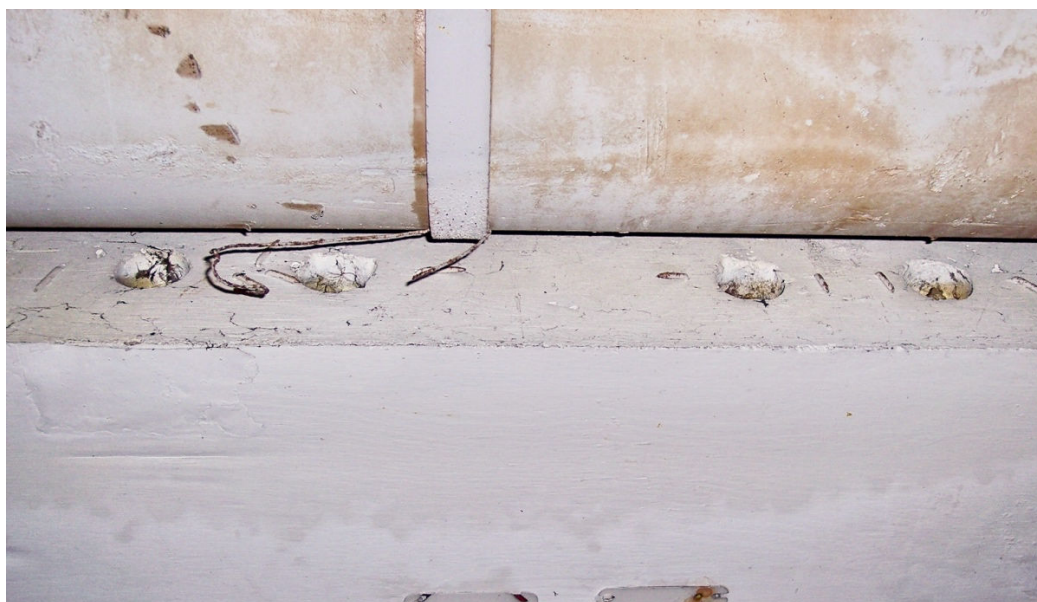
This is a condition that is often found at interior tendon terminations, usually at an expansion joint. It's assumed that the contractor believed that it was unnecessary to fill the anchor pockets with grout because the expansion joint would protect the stressing anchors from water exposure. However, expansion joints are eventually likely to fail, which then places the post-tensioning at an increased risk of damage due to corrosion resulting from exposure to water.

*Image 7: Unfilled anchor pockets located at interior expansion joint.*

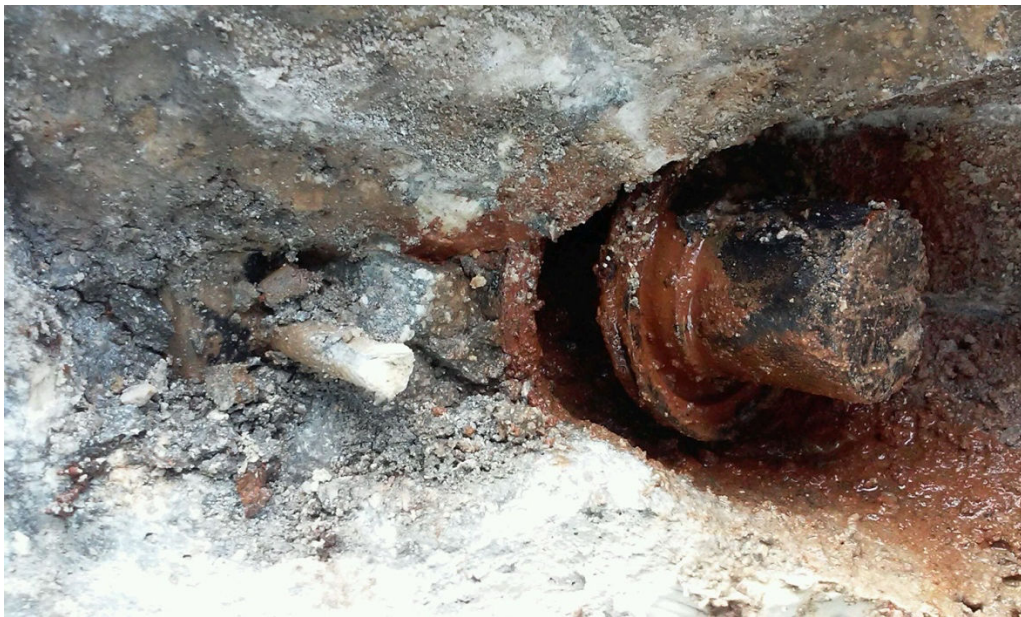
Water infiltration into the tendon strand and sheathing can be the single most significant cause of cable failure that is associated with the stressing anchor pocket condition. While it is possible for water to enter the tendon through cracks in the concrete structure, irregularities in the stressing anchor pocket grout and encapsulation can provide avenues for water to enter directly into the tendon. This is particularly a concern when the anchors are located at or below grade, or at other locations where the anchors can be exposed to prolonged hydrostatic water pressure such as planters, pool walls, and gutters. It should also be recognized that certain types of architectural elements such as stucco and EFIS details, located on top of the anchor pockets, can retain water if delaminated. In these circumstances, there is an increased importance of inspecting the anchor pockets to determine if they were finished correctly. At the very least, the anchor locations should be visually inspected for evidence of drying shrinkage cracks or voids in the pocket grout.

Image 8: Water leaking from anchor after pocket grout removed.

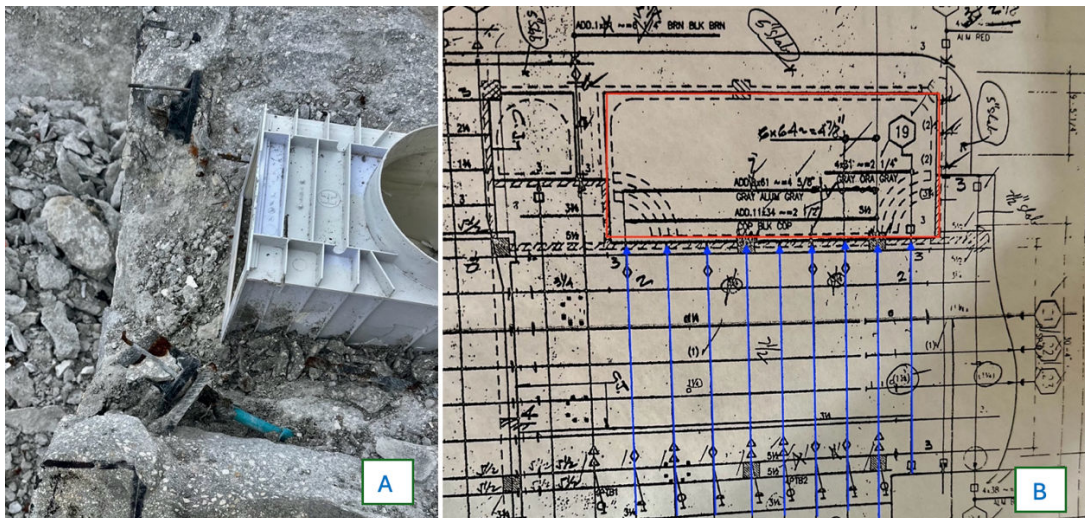
Image 9A: Exposed anchors at pool skimmer. Image 9B: Plan showing stressing anchors located in pool wall.

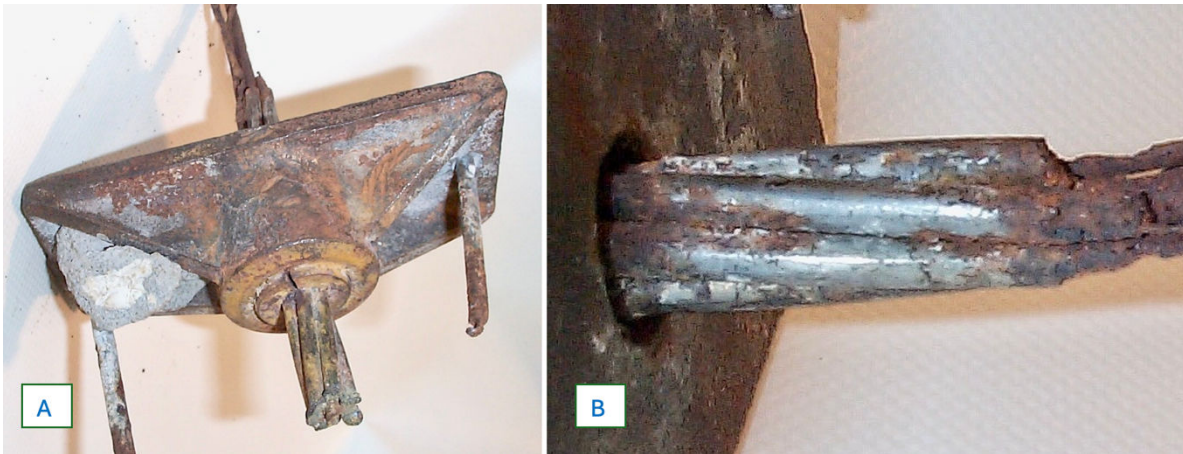
However, it can be more complex and difficult to assess the condition of encapsulated anchor systems. The primary reason is that the tendon components are isolated from direct exposure to the surrounding concrete by means of the plastic strand and anchor encapsulation, which insulates the steel components from electrochemical corrosion potential. This limits the visual condition assessment to obvious signs of damage, such as displaced strand or wedges, or water exfiltrating from the exposed anchor. Finally, a word of caution regarding the broader interpretation of tendon conditions based on an inspection of the anchor pocket. It is recognized that there may be an interest in determining whether a tendon has been compromised by corrosion based exclusively on a visual inspection of the exposed steel anchor face and strand tail. However, experience has demonstrated that it can be difficult to reach a meaningful conclusion unless there are other factors that serve to reinforce this determination. These should include recognized deficiencies in the anchor pocket grout, evidence of water infiltration into the tendon, or damage to the mild steel reinforcement and concrete structure surrounding the terminal anchor, as well as evidence of structural distress (deflection, bending, punching shear, etc.), which would be an indication of the significant loss of post-tensioning in a localized portion of the structure.

*Image 10a: This extracted anchor exhibits minimal corrosion of the strand tail, anchor, & wedges. 10B. Yet the portion of strand under tension had failed due to significant corrosion.*

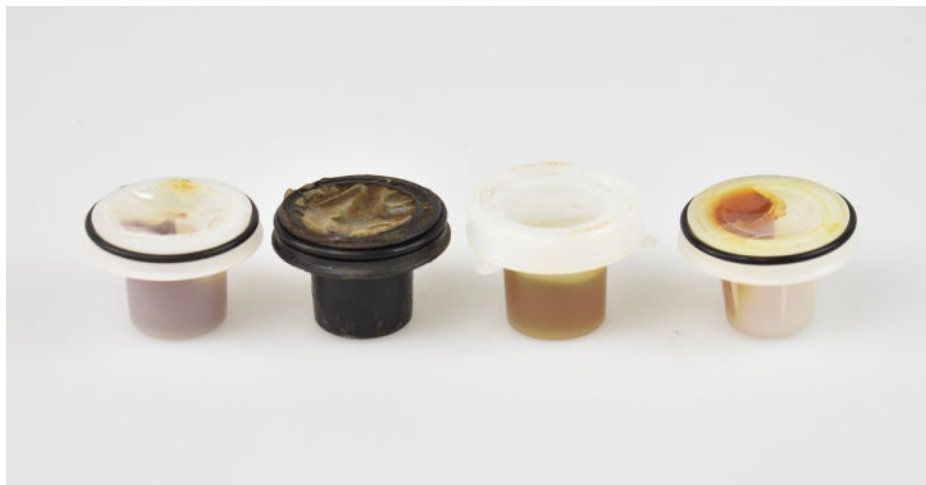
As the remediation of existing stressing anchor pockets is becoming an increasingly common part of many post-tensioned structural restoration projects, there is often little consideration given to whether the new available grease cap is compatible with the existing anchor burn ring. It's worthy to note that while many grease caps may appear identical, there is a high probability that there will be dimensional differences between the existing anchor cap and the available replacement. Experience has shown that while these differences may be slight, the fact remains that it may not fit as well as the original cap. Depending on the significance of these differences, the design professional may consider the replacement of the rubber O-ring with a sealant to help ensure a better seal.

*Image 11: Examples of grease caps from several different encapsulated anchor systems.*

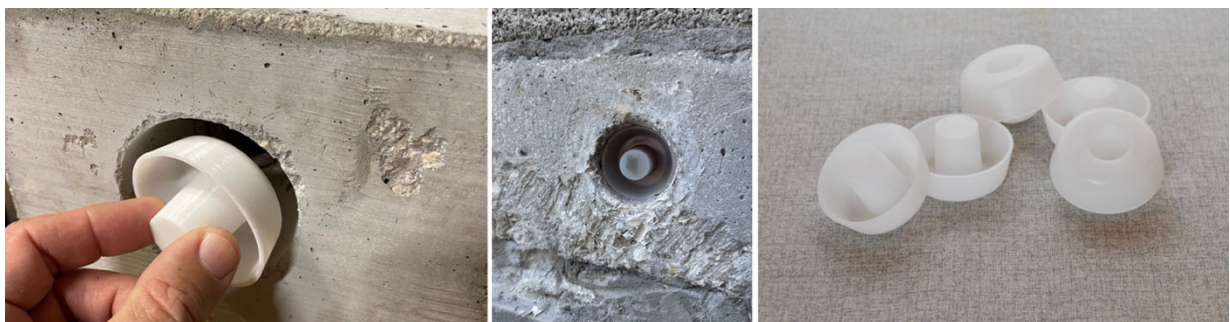
*Image 12: The Anchor Pocket Seal before and after installation. ([www.post-tensionproducts.com](http://www.post-tensionproducts.com))*

The Anchor Pocket Seal is designed to provide an option for the repair of damaged encapsulated anchors, or as a means of protecting non-encapsulated anchors. This polyethylene plastic cap is constructed using the most common stressing anchor pocket dimensions to create a compressive seal within the pocket. Therefore, it is not reliant on engagement with the anchor itself to provide a secure mechanical attachment. When used with an epoxy or caulk sealant to help bridge irregularities and deformations in the surface of the existing anchor pocket, the Anchor Pocket Seal can help prevent water ingress into the tendon.

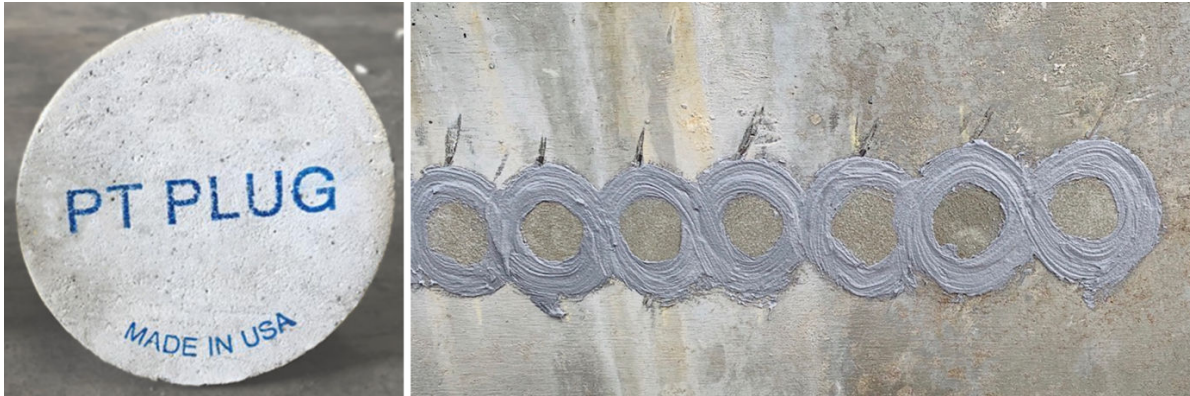
*Image 13: The Precast Post Tension Plug before and after installation. ([www.posttensionplugs.com](http://www.posttensionplugs.com))*

The Post Tension Plug is an anchor pocket filler that is intended to help overcome problems associated with the installation of field mixed grout used to fill stressing anchor pockets. It's a precast plug made of 8,000 psi, non-shrink, non-metallic grout that is bonded to the anchor pocket with an epoxy adhesive. It is designed to fit the stressing pocket after it has been abraded using the Post Tension Plug Reaming Tool and ensures 1" of coverage after the grease cap has been properly seated.
