BARRIER CABLE REPAIR & REPLACEMENT

Barrier Cable Constructors
(800) 330-7883

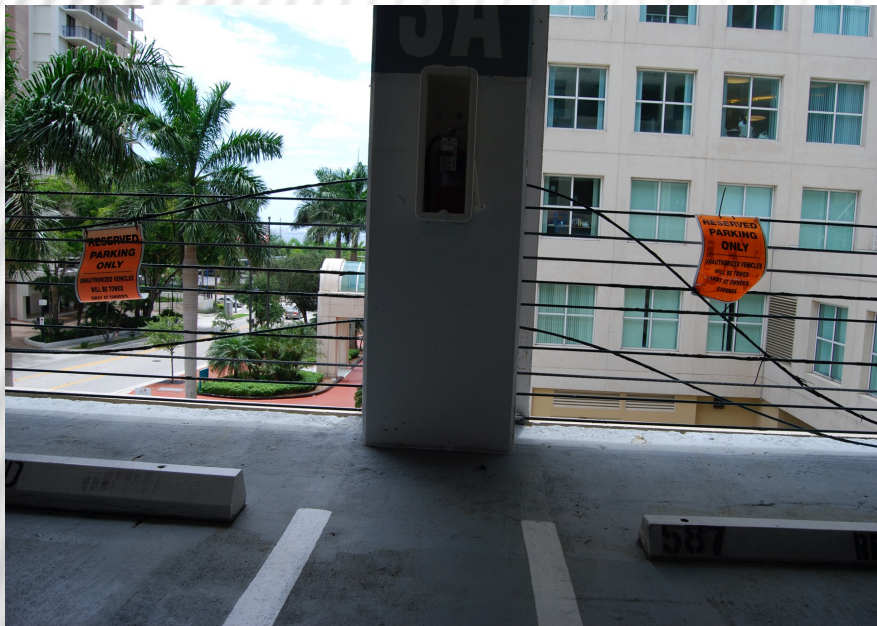
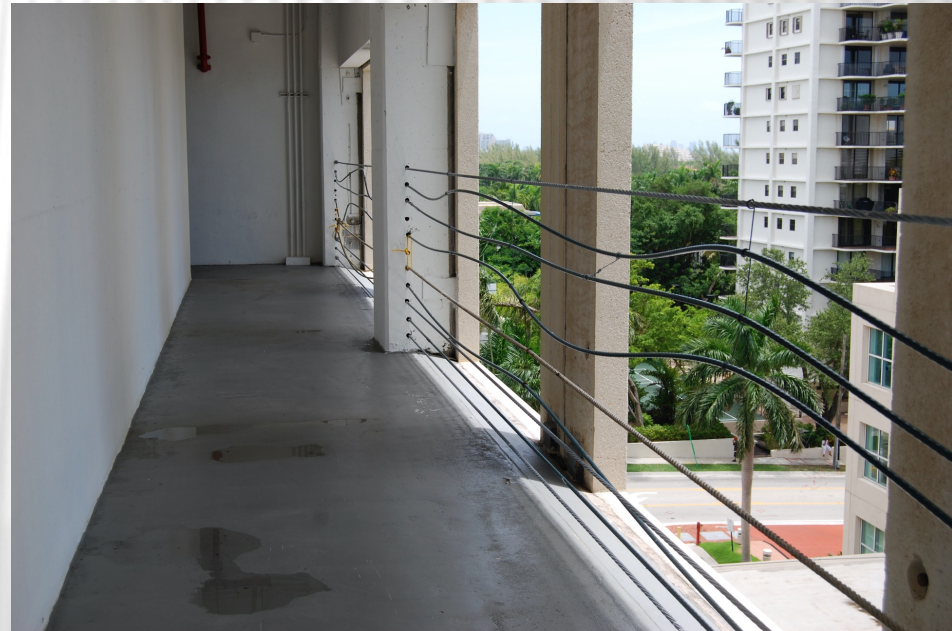
Damage to the barrier system can pose a significant threat to the the safety of vehicles and persons using the garage.

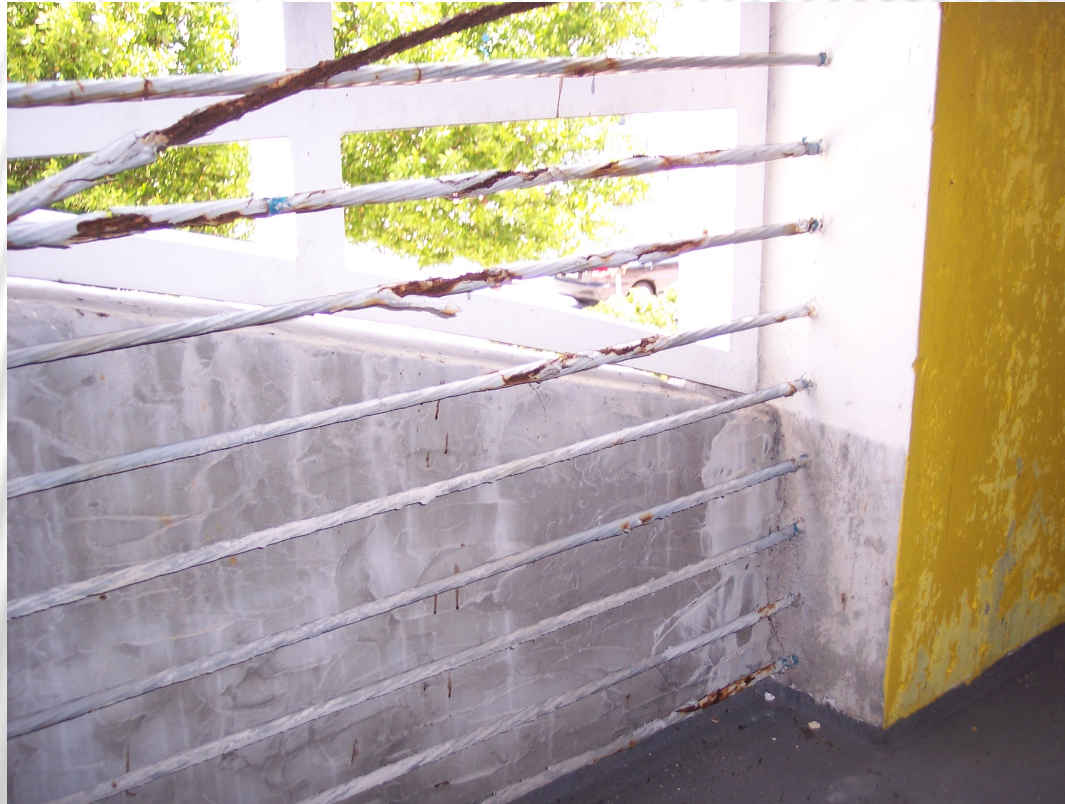
Barrier cable corrosion is usually not a localized problem and is often representative of a systemic breakdown of the barrier installation.

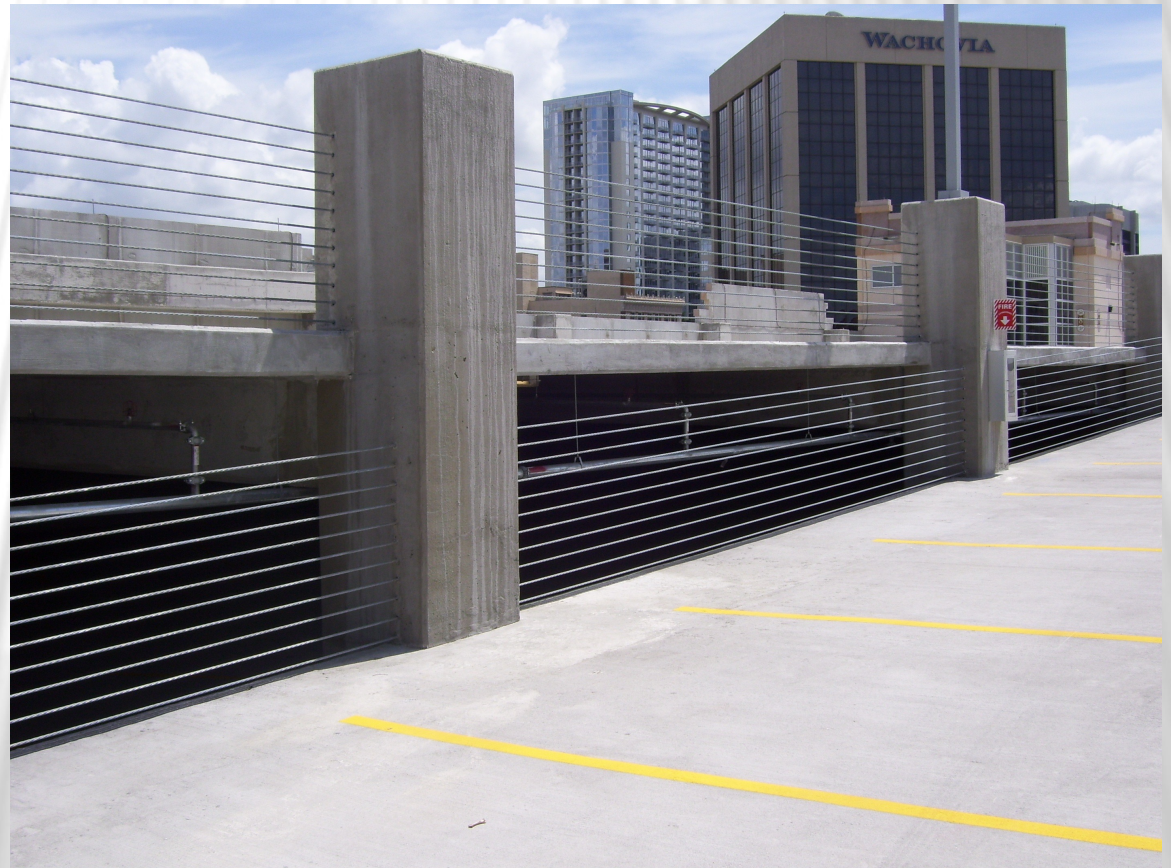
Zinc galvanized coatings have proven to be the most durable means of protecting the barrier cables.

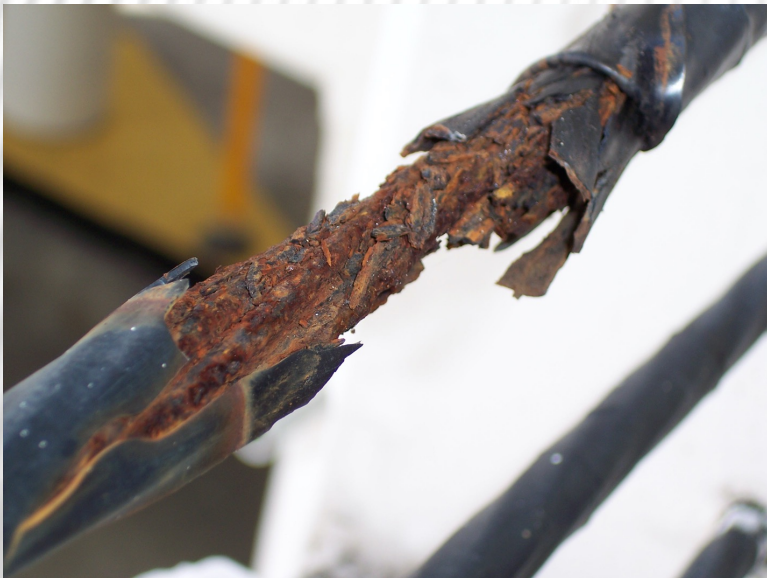
High Density Polyethylene (HDPE) coatings are supposed to provide a continuous seamless extrusion and contain a UV stabilizer in order to withstand prolonged exposure to sunlight. However, these coatings often become brittle and will ultimately lead to cable failure, unless the coating was applied over galvanized strand.

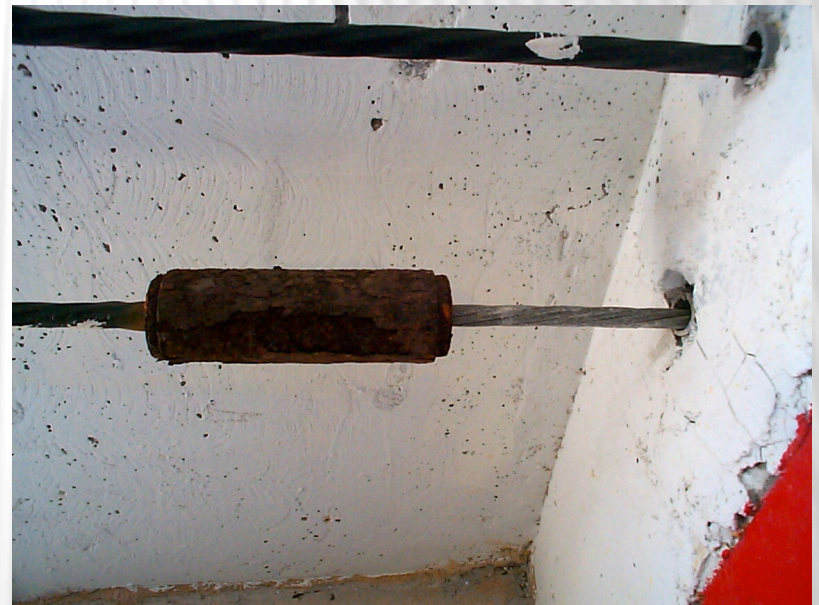
Examples of corroded structural cable splices.

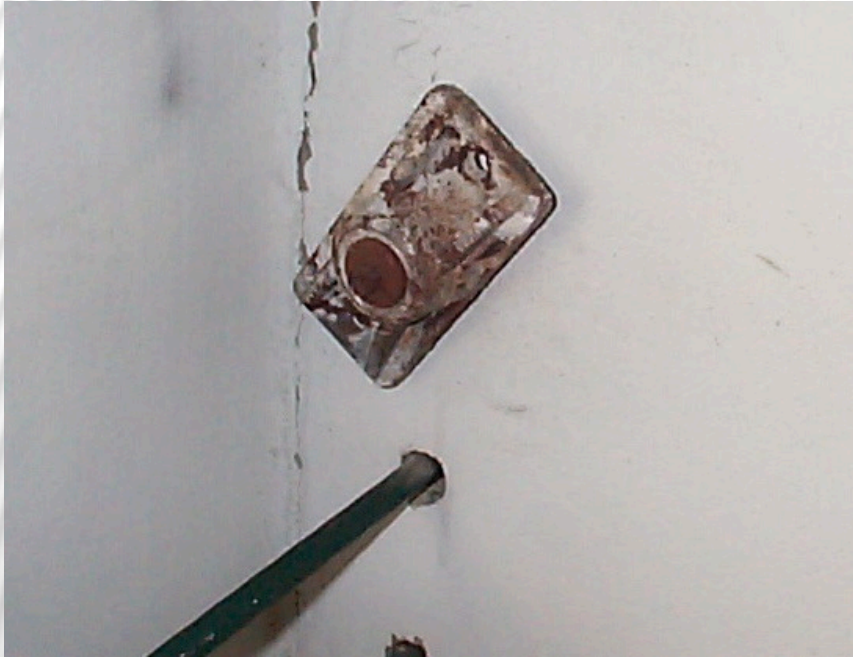
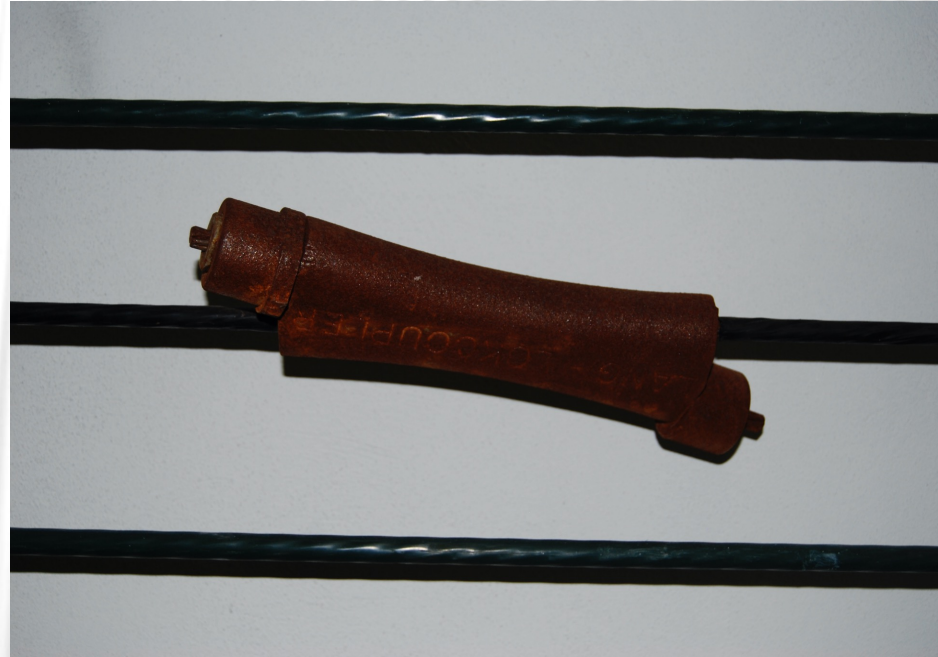
Examples of corroded structural cable anchor and splice.

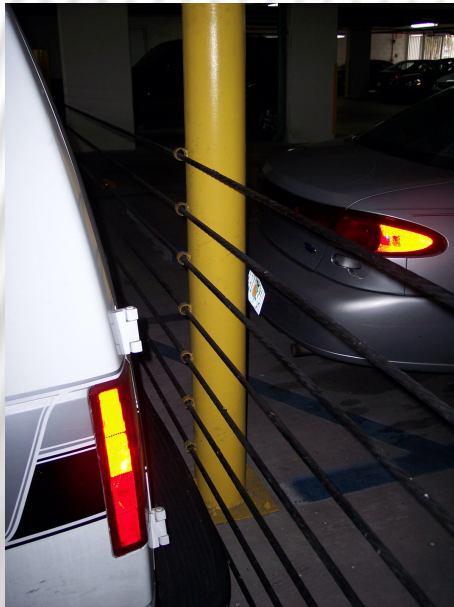
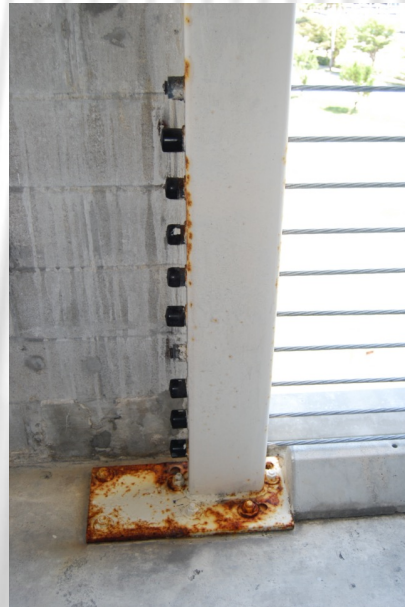
Corrosion or damage to structural steel components used as anchor end terminations or intermediate cable supports can compromise the integrity of the barrier system.

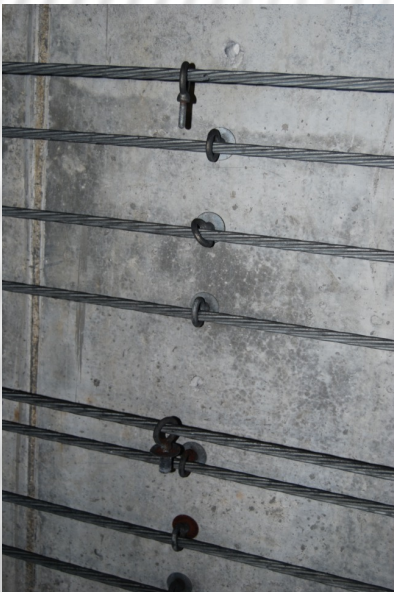
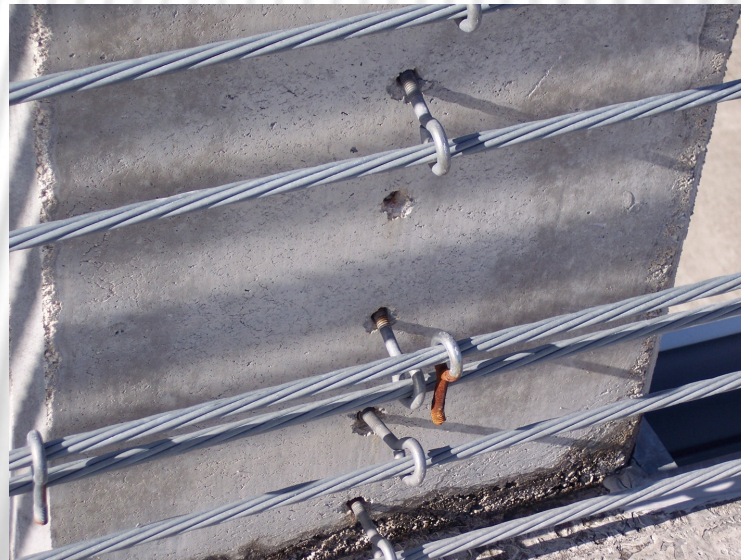
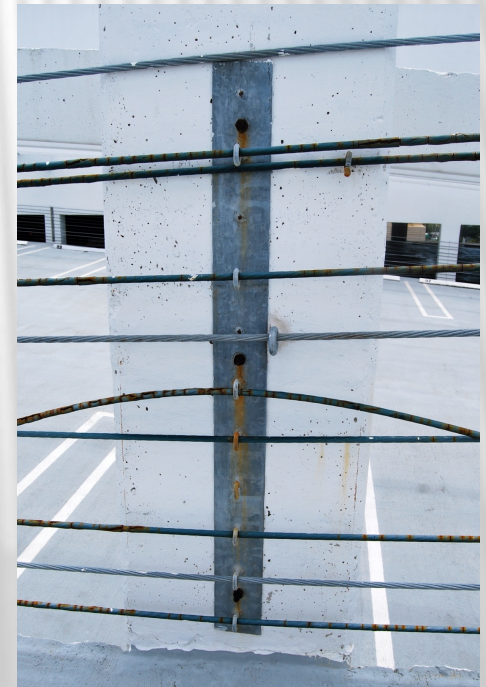
Eyebolts are often used as an intermediate support for the profile of the cable span. Failure of the eyebolts will render the cable spacing non-compliant with the building code.

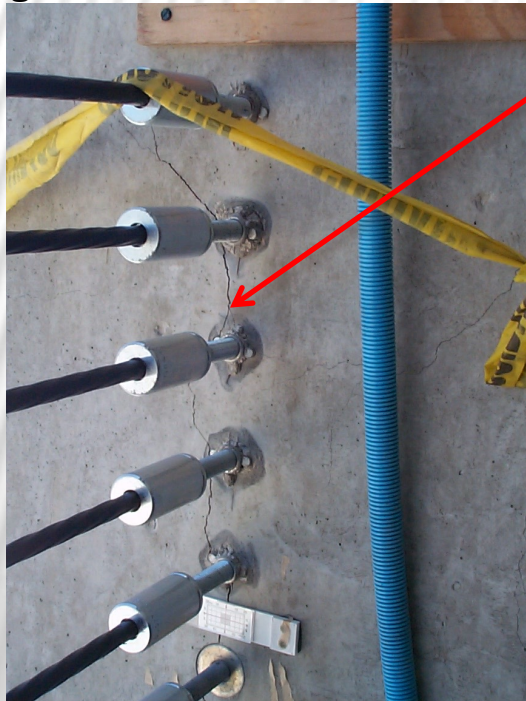
Stress cracks developing in column due to stress load on embedded anchors.

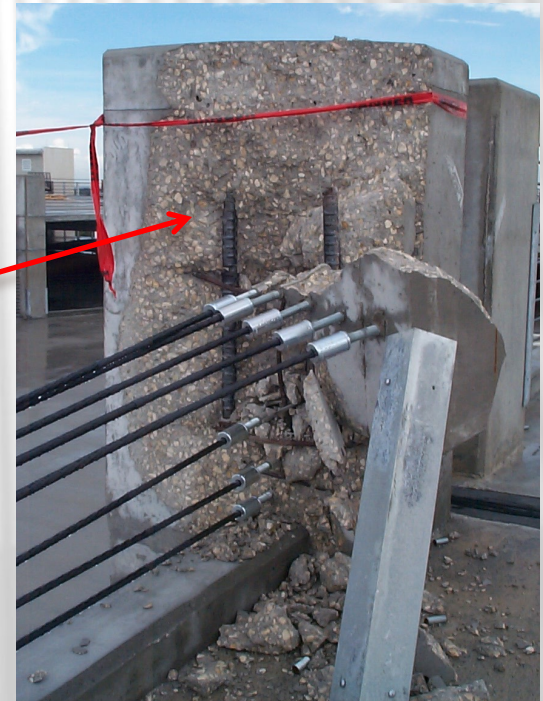
Stress failure due to inadequate column reinforcement.

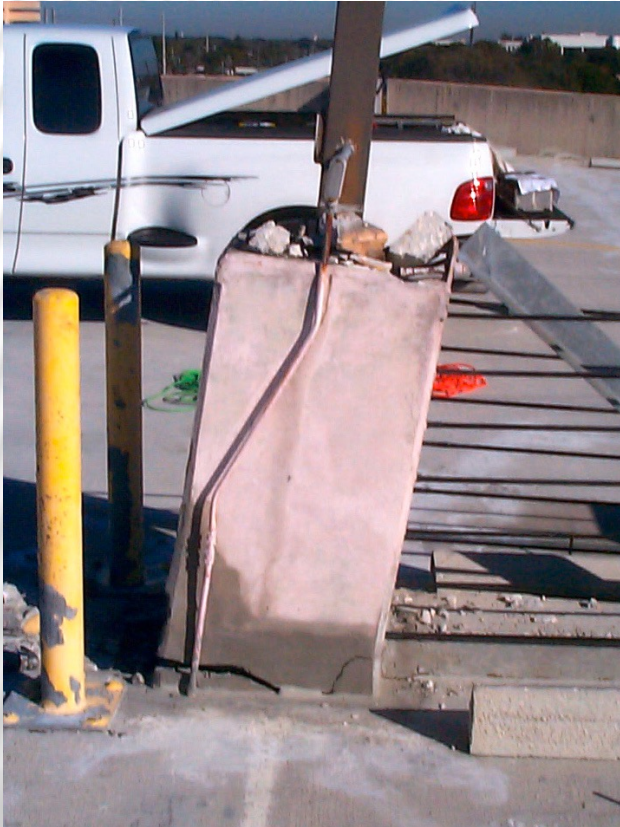
Column rebar from slab was cut during original construction.

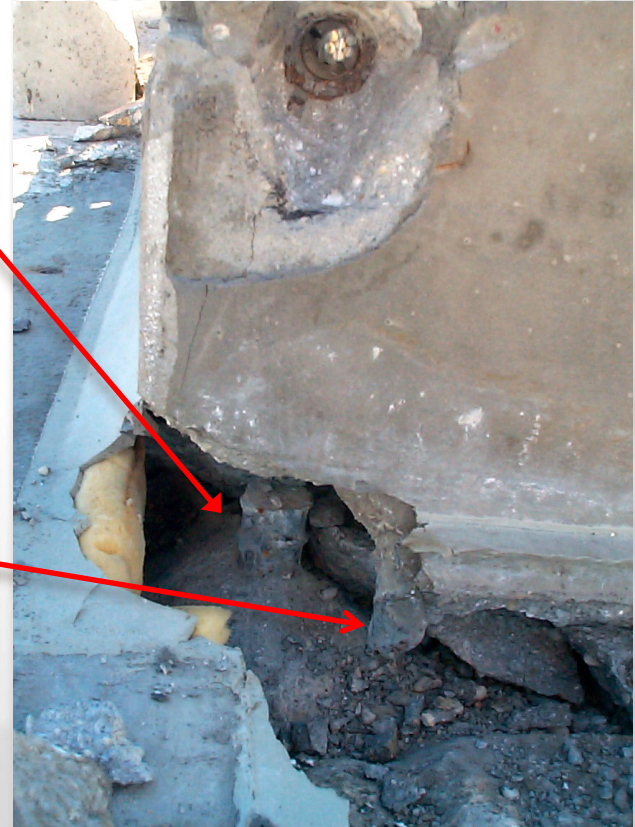
New column rebar was not doweled into slab.

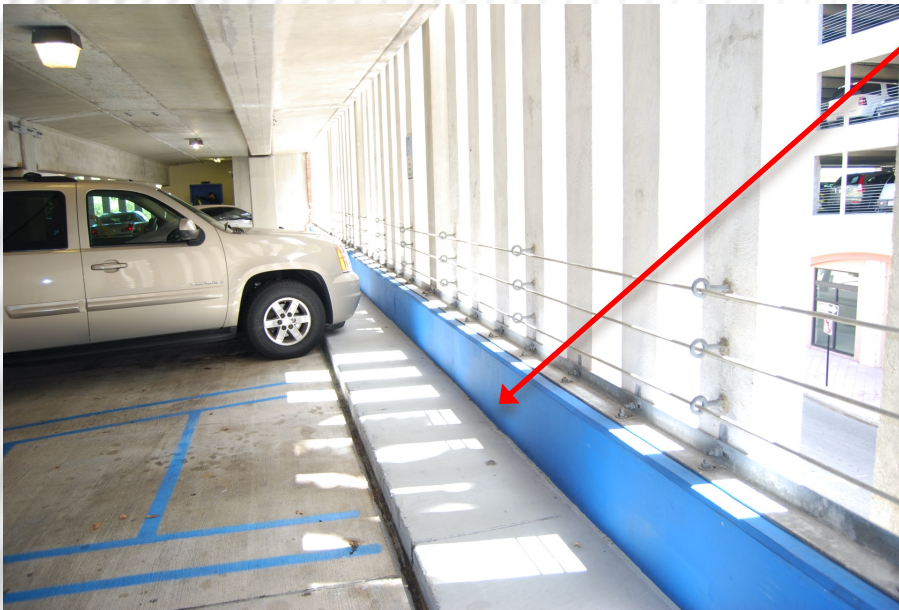
Concrete parapet wall likely meets the vehicular restraint requirements, but the cables fail to satisfy pedestrian code requirements

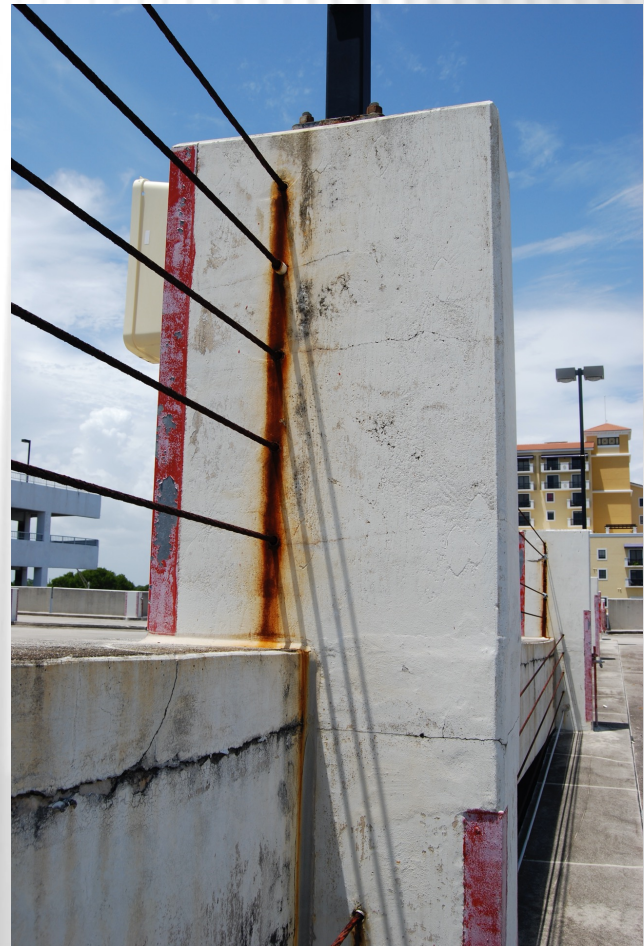
Aside from the corroded condition of the existing cables, the cable spacing is insufficient to meet the vehicular restraint requirements and fails to satisfy pedestrian code requirements.

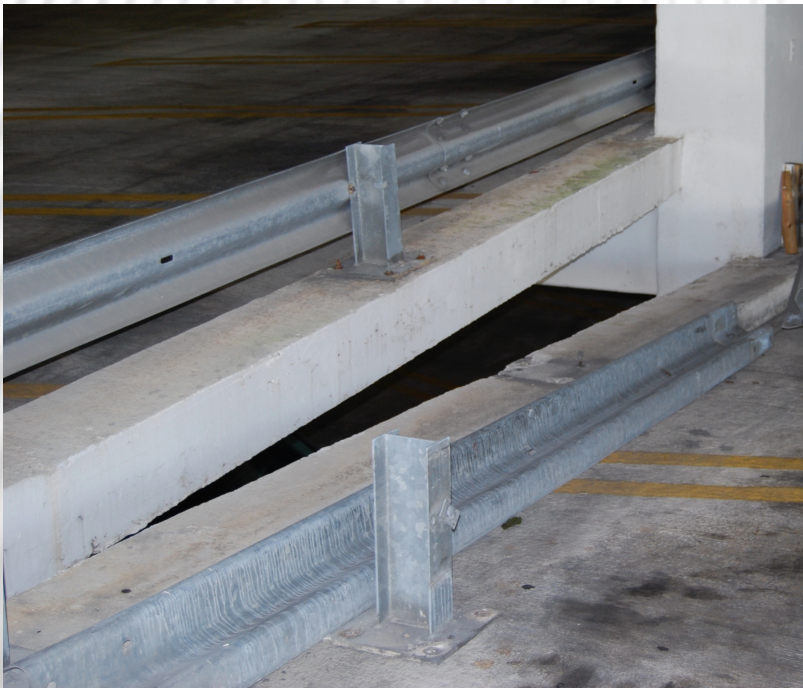
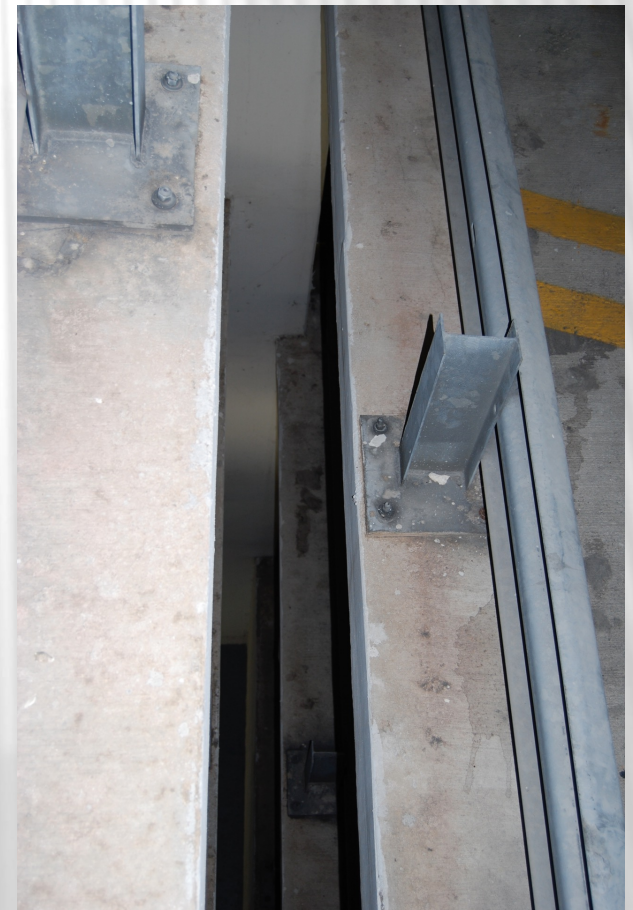
The steel guardrail likely meets the vehicular restraint requirements, but fails to satisfy pedestrian code requirements. As a multi-story structure, this is a significant life safety concern

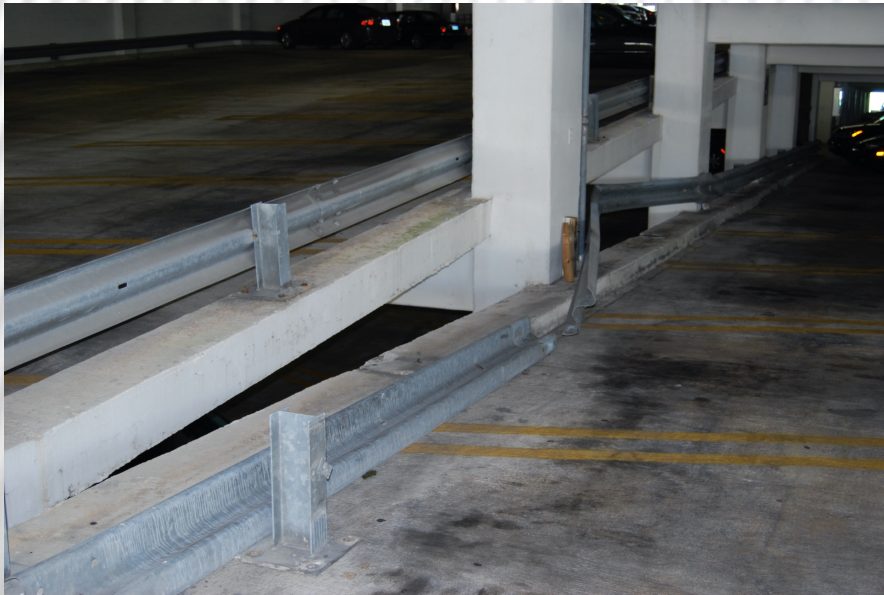
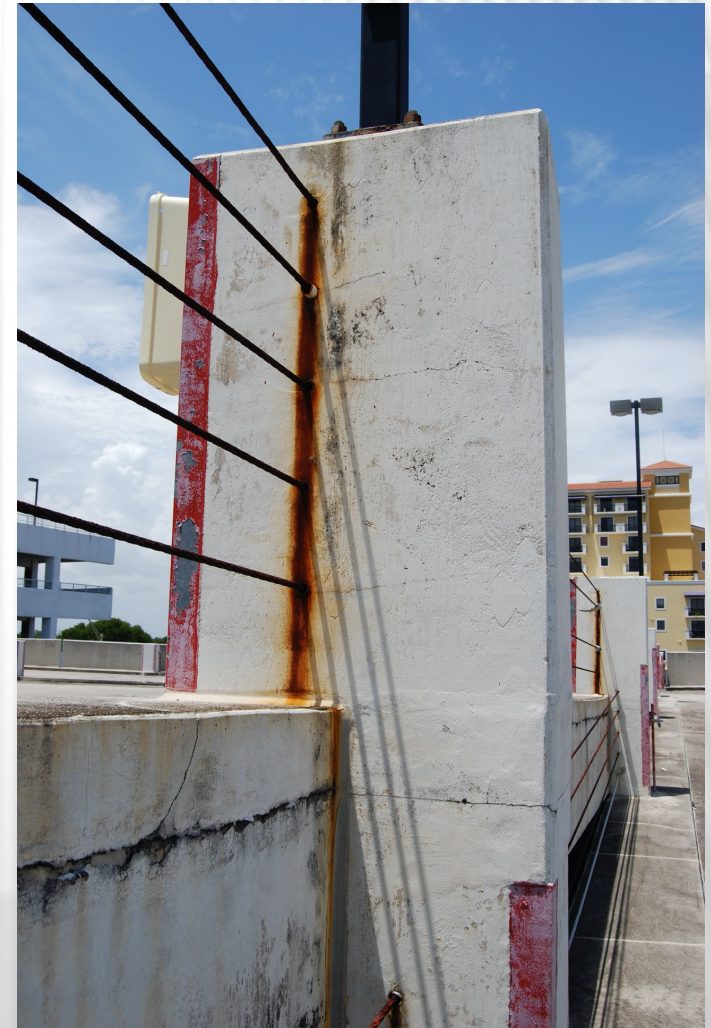
✧ Replacement Alternatives

Replacement of a barrier system is usually required when it has been determined that the existing system has sustained extensive damage (corrosion) or is grossly out of compliance with building codes.

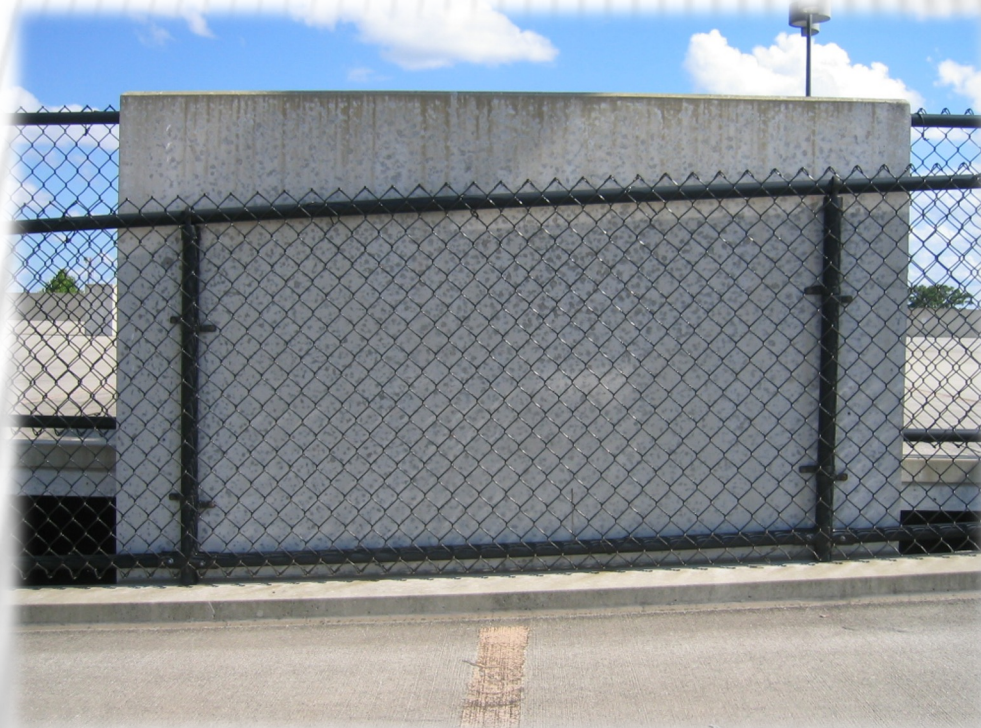
Framed fence systems are utilized exclusively as a pedestrian barrier on those structures that incorporate other means of providing a vehicle barrier.

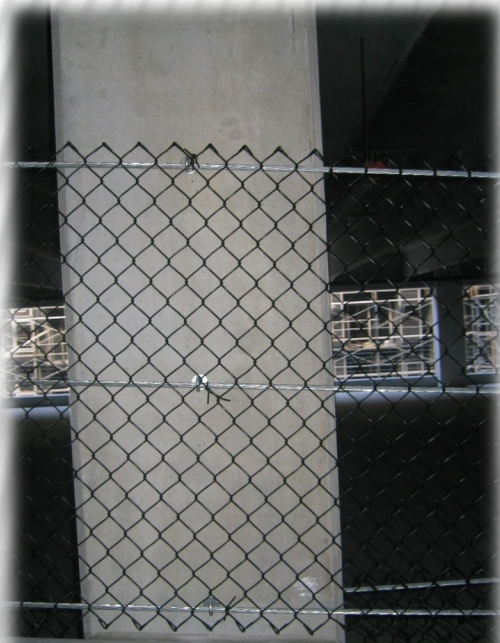
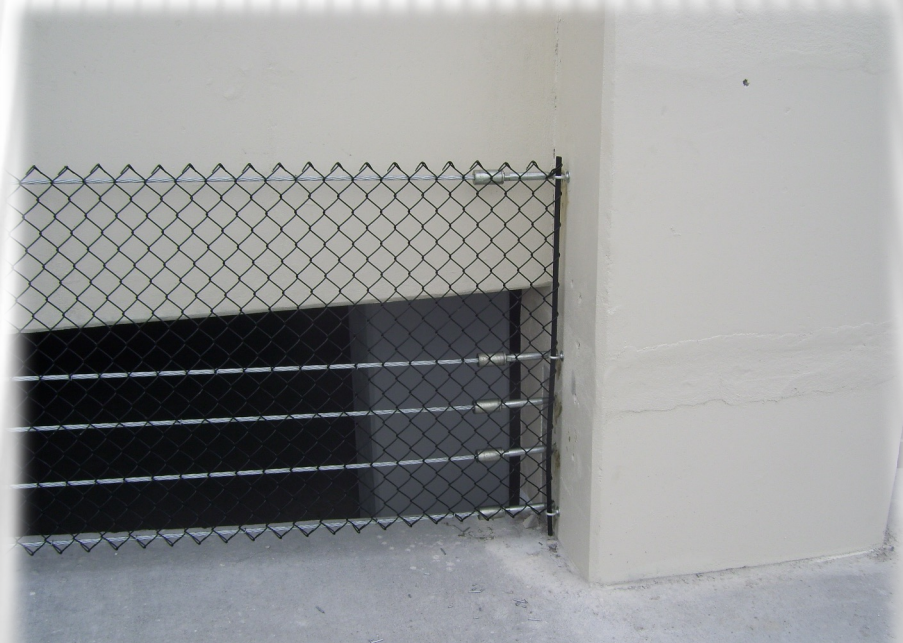
This system utilizes fence for the pedestrian barrier. It is installed without the use of pipe frames, with steel cables providing the fence support. When additional steel cables are incorporated, it can function as a vehicle barrier and pedestrian barrier.

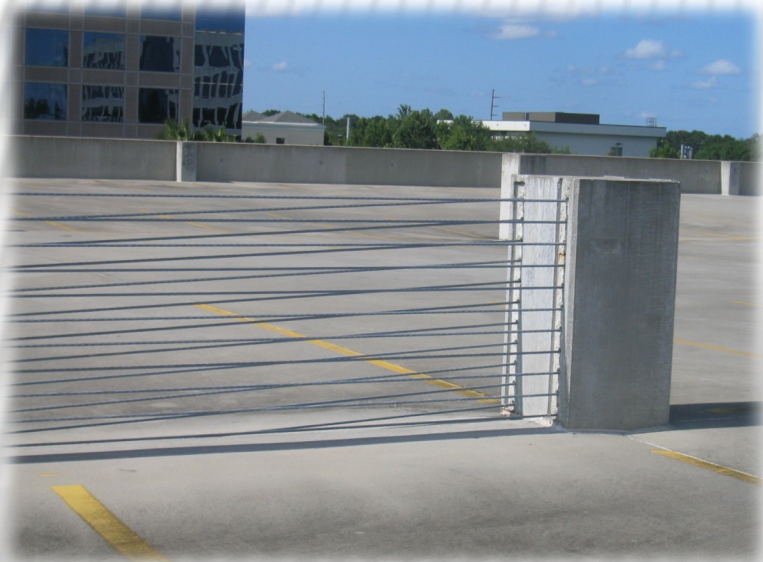
This system utilizes either 3/8" or 1/2" 230k to 270k seven wire galvanized strand. The cable spacing, anchoring hardware, and cable supports must be designed to comply with applicable pedestrian and vehicular restraint codes.

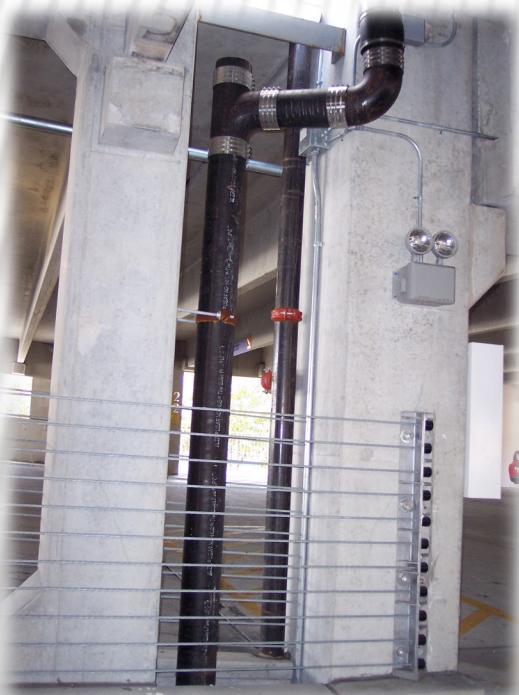
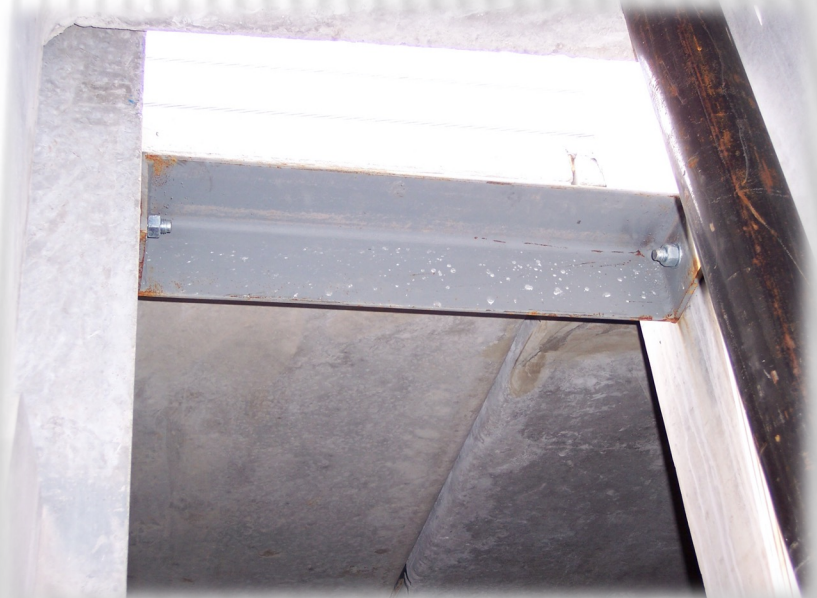
Column stress loads – The columns at the end of each cable run can typically expect a total combined stressing force load of between 33k and as high 75/80k for an 11 cable system. Insufficient design of the column can result in deflection, cracking, or catastrophic failure of the column.

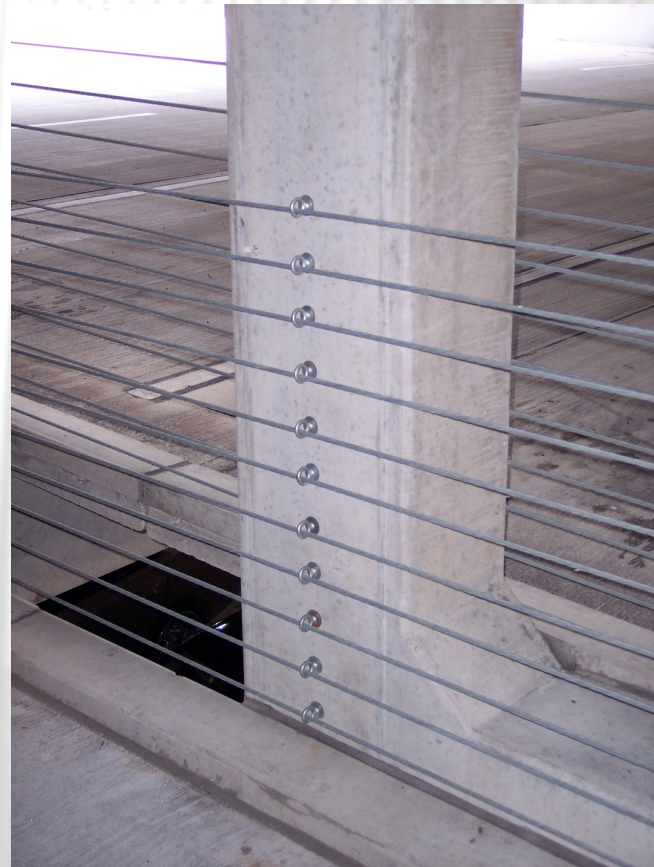
In those cases where the cables do not run through intermediate concrete or steel columns, eyebolts or brackets can be used to maintain the required 4" spacing between the cables.

Otherwise, the stressing load needed to maintain cable separation and performance on long spans may result in excessively high cable tensioning loads.

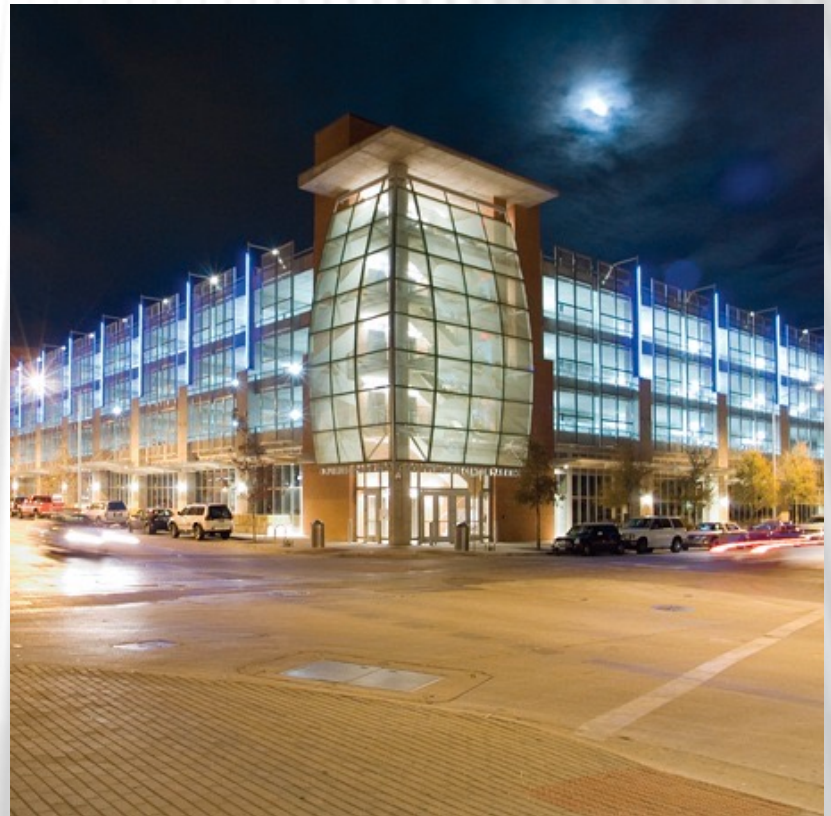
In those instances where the architect has designed the structure with exterior covering (i.e.: aluminum screens, brick facade, precast panels, etc.), the covering must not be within the 18" zone of maximum horizontal deflection of the cables allowed by code.

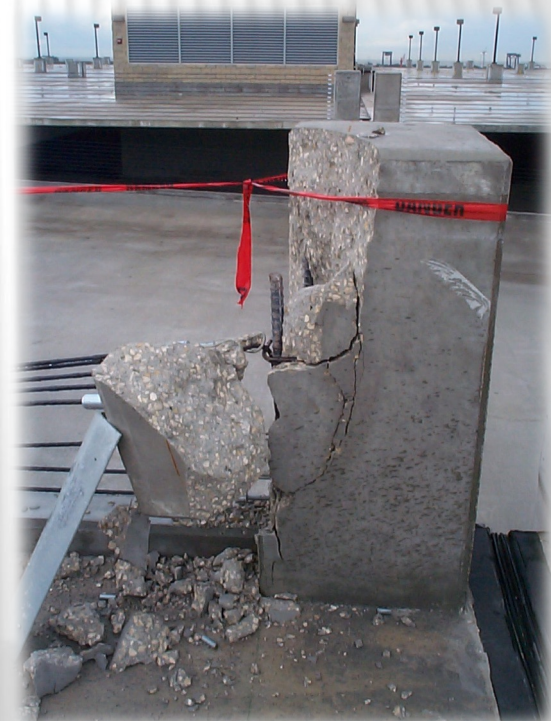
The contractor and structural engineer must ensure that the columns are adequately designed and constructed in order to handle the development of the cable loads into anchor systems embedded into the columns.

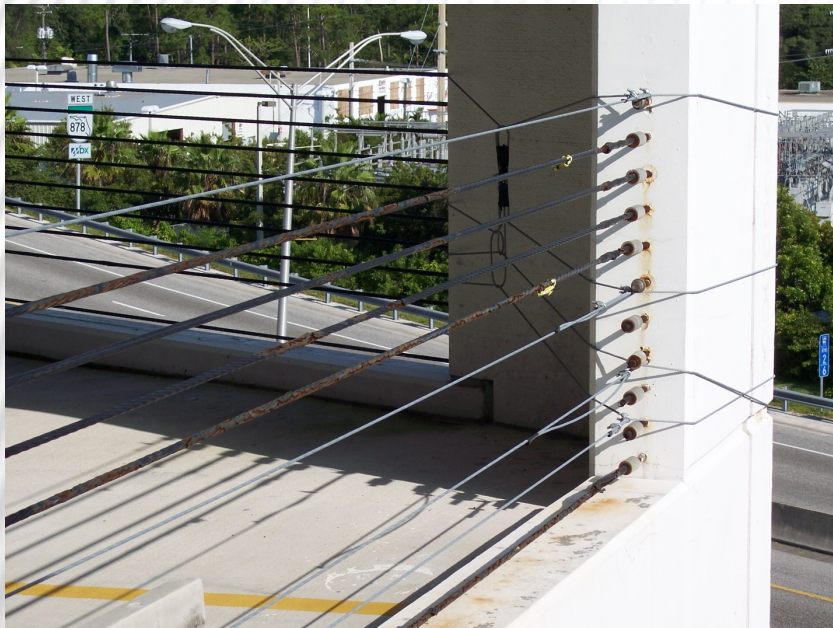
BEFORE: Badly corroded and missing cables.

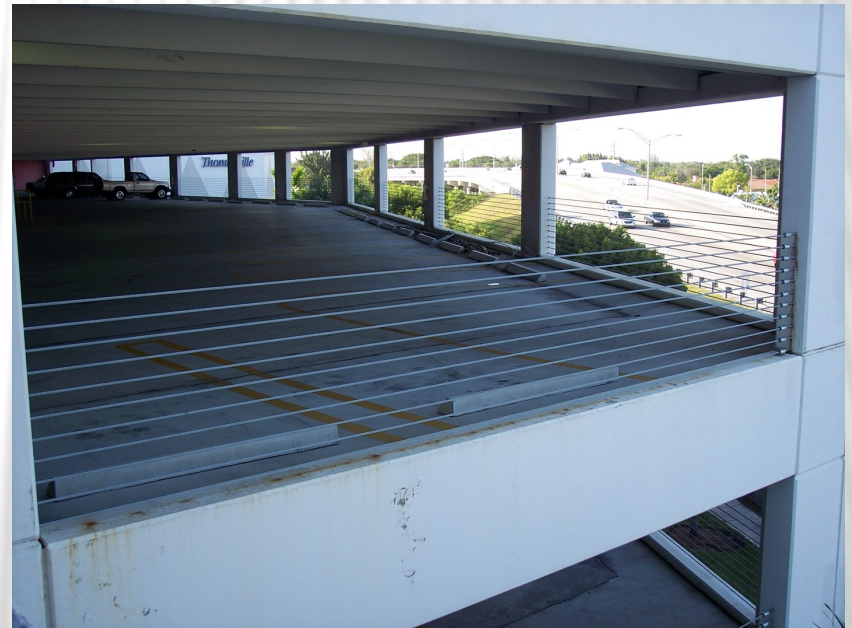
AFTER: New anchors installed and cables replaced.

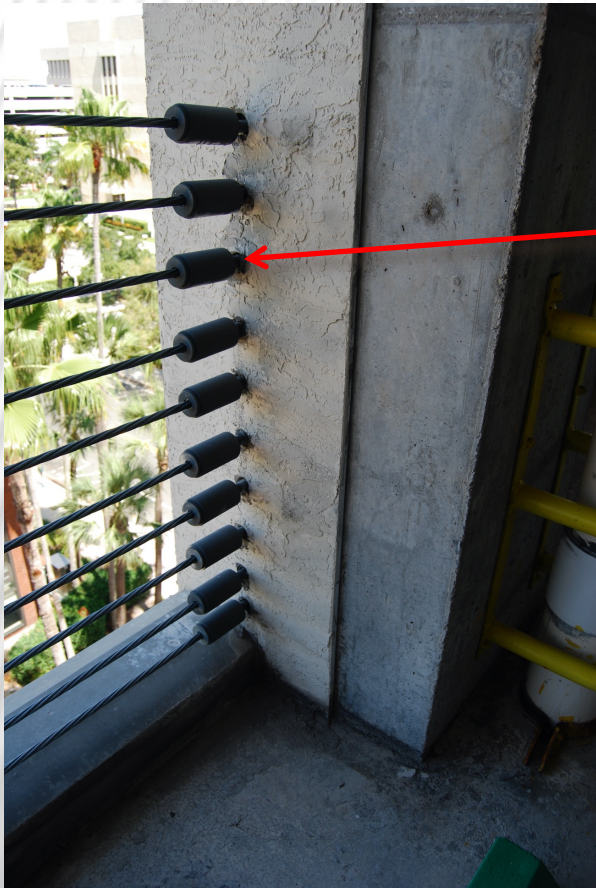
Embedded anchors failing due to inadequate development of threaded rods into the column.

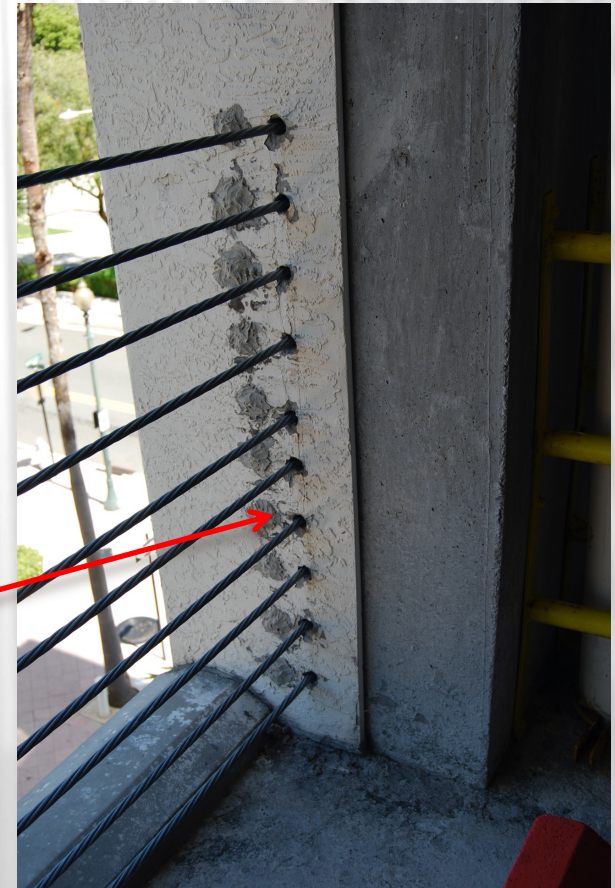
Existing anchors Abandoned. New cables run through holes drilled into the column and fastened to barrel anchors on the back of column.

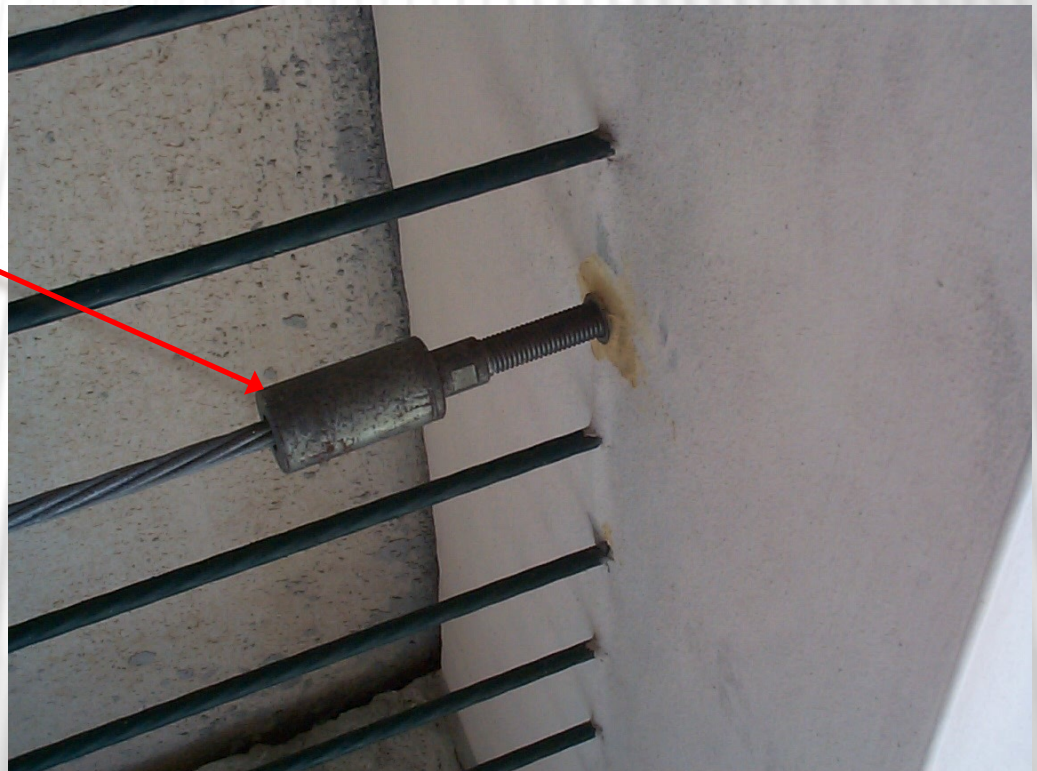
Due to the inability to access the stressing anchor ends, this cable was replaced using a non-adjustable anchor drilled and set with epoxy into the column.
