# Deterioration, Evaluation, and Repair of Post-Tensioned Condominium Structures

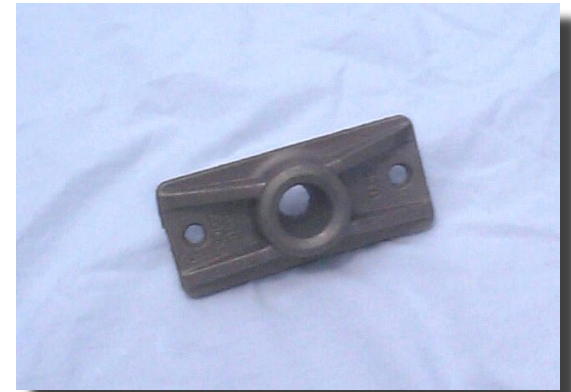
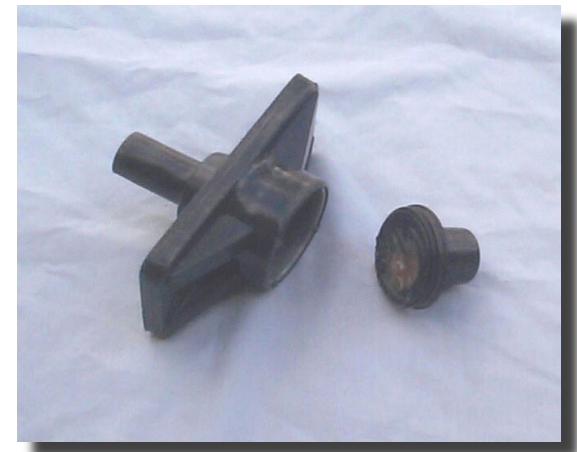
# Terminal Anchors

- Anchors are found at the ends of each cable and transfer force into the concrete.
- **Bare cast iron anchors**
  - ✓ Provides no corrosion protection of the anchor or strand. Highly prone to corrosion.
- **Encapsulated anchors**
  - ✓ Polyethylene encapsulation of the cable, anchor, and end pockets can provide a measure of corrosion protection, but only if properly installed. Improper installation of the stressing anchor pocket seal and grout are a common failure, and will allow moisture to enter tendon and lead to corrosion damage.

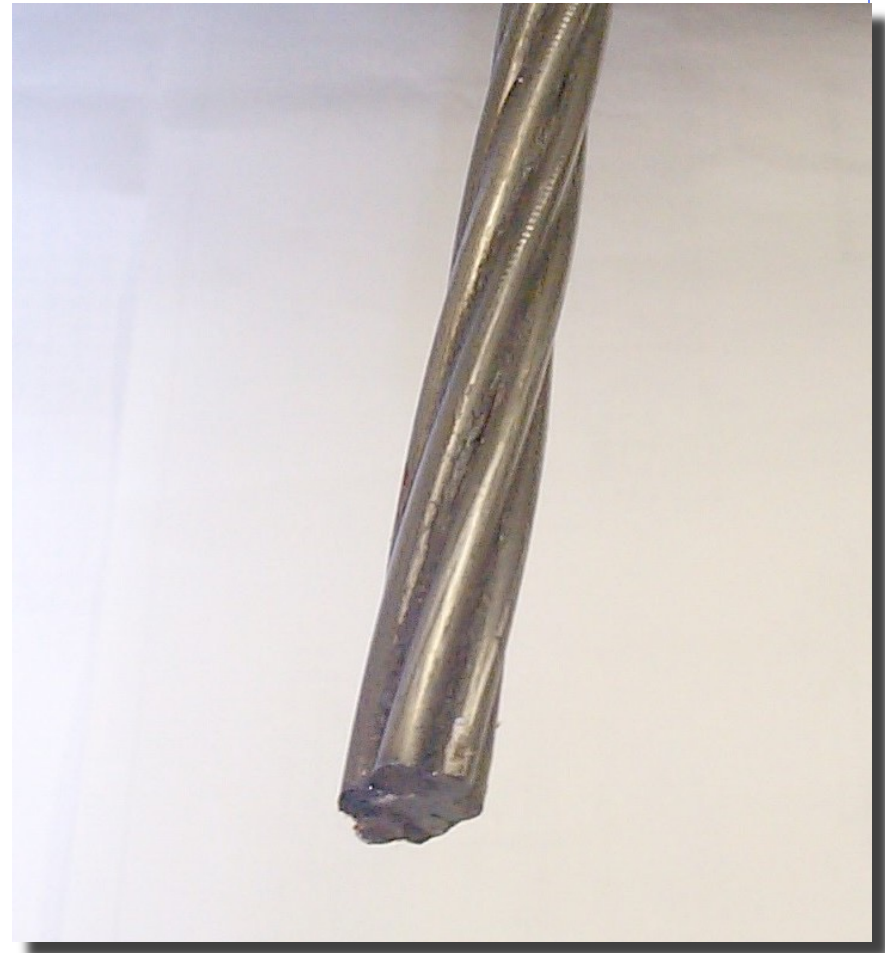
# Post-Tensioned Strand

- Post-tensioned cables are made of high strength steel wires twisted around a center wire.
- 1/2" diameter seven wire post-tensioned cables have been used extensively in residential structures constructed since the 1990's (particularly in coastal areas).
- Cables are stressed to 80% of the specified tensile strength of the strand, which is 33 kips for 1/2" diameter cables.

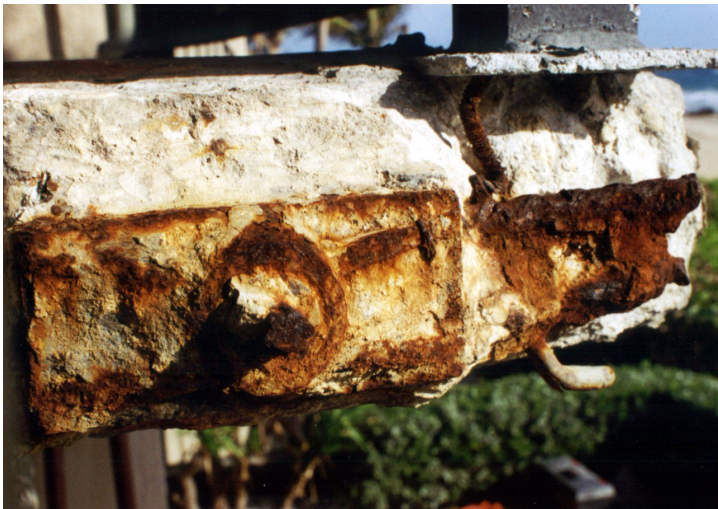
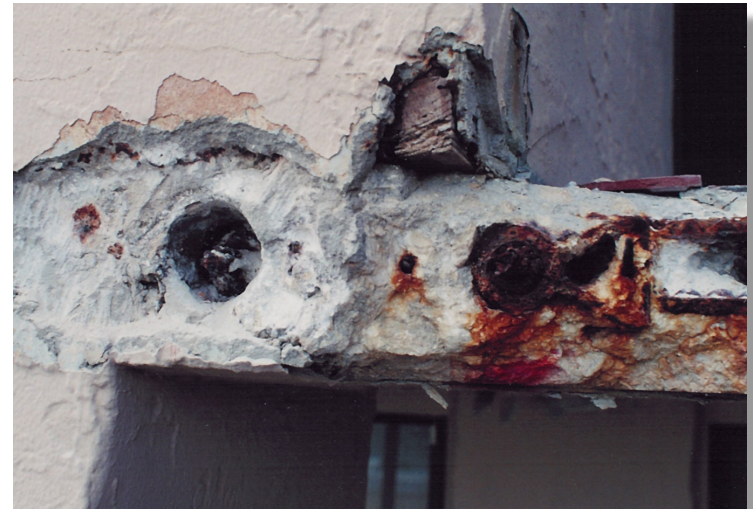
## ➤ Embedded rebar corrosion

- ✓ It is common for residential structures in coastal regions to experience corrosion of the steel reinforcement embedded in the exterior concrete members, typically within the first 20-30 years, and then in decreasing cycles. This is the result of aggressive electrochemical corrosion due to the exposure to salt and moisture in the environment.
- ✓ Post-tension cable anchors are typically found within the structural elements that are most exposed to the corrosive effects of the salt laden environment, and are therefore at a heightened risk of failure resulting from corrosion..
- ✓ Once cracks and spalls develop at the slab edges, this can allow water to enter into the anchor and/or strand, which can lead to corrosion, and ultimately failure of the tendon.

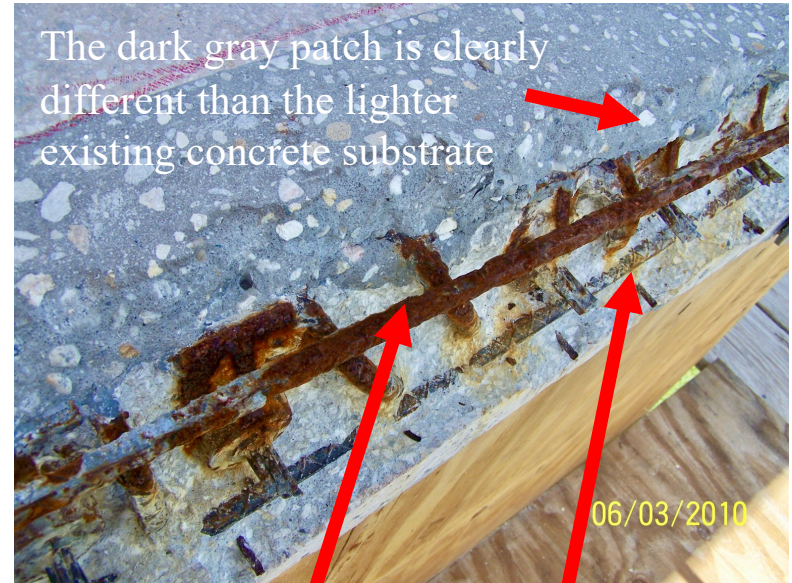
Note advanced state of rebar corrosion where it was sandwiched between old and new concrete.

Note less rebar corrosion where it remained fully embedded in the old concrete.

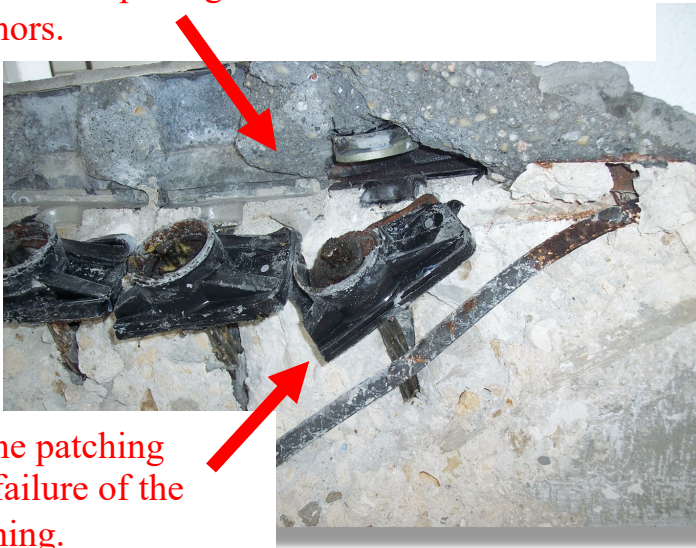
Continued corrosion of rebar after patching resulted in spalling of the concrete around the anchors.

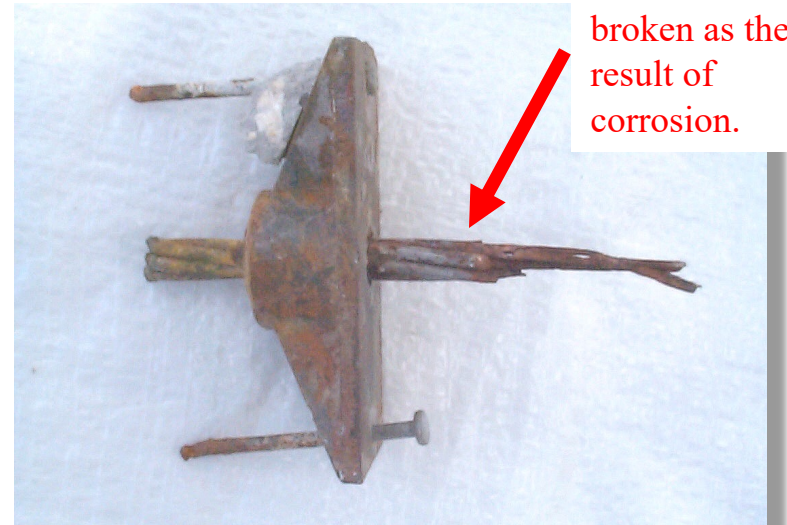
Failure of the patching resulted in failure of the post-tensioning.

Cable has broken as the result of corrosion.

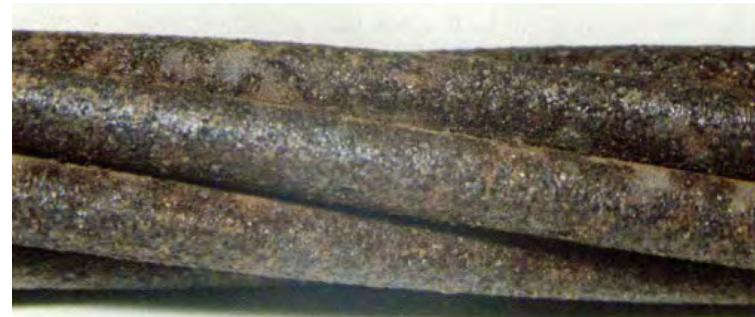
Advanced pitting

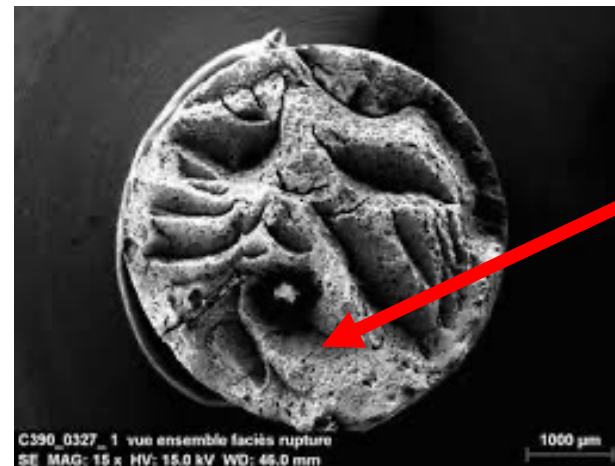
Microscopic image of brittle failure at the end of wire

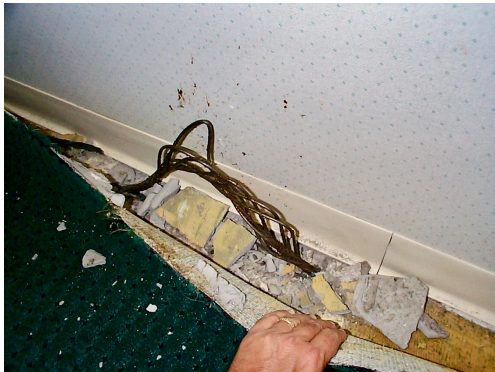
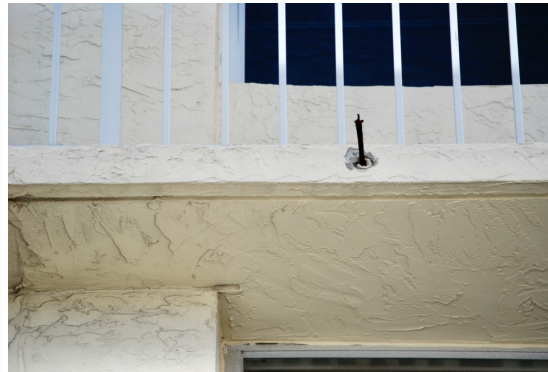
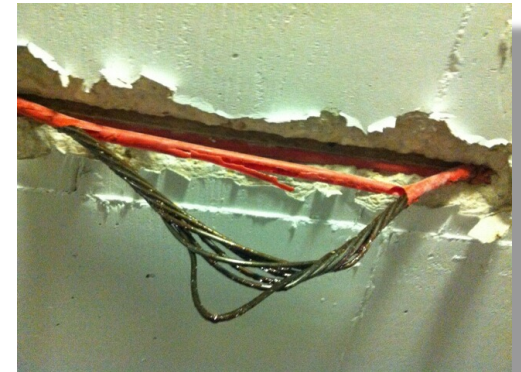
## ➤ Broken cables / warning Signs

- ✓ Experience has shown that few (often less than 1%) of broken tendons will result in a visible sign of failure. Unfortunately, broken cables rarely give visible evidence of their failure because the structure will absorb the release of energy without allowing the cable to rupture.
- ✓ Depending on its design, a high number of cables may break before the structure shows outward signs of distress.
- ✓ This requires monitoring of the building for signs of structural distress, such as shear or flexural cracking, which can be evidence of a localized loss of multiple post-tensioned cables that has placed the structure at risk.
- ✓ Depending on the building design and other factors, the accumulated loss of a post-tensioned reinforcement in a localized area may result in sudden structural failure with little warning.

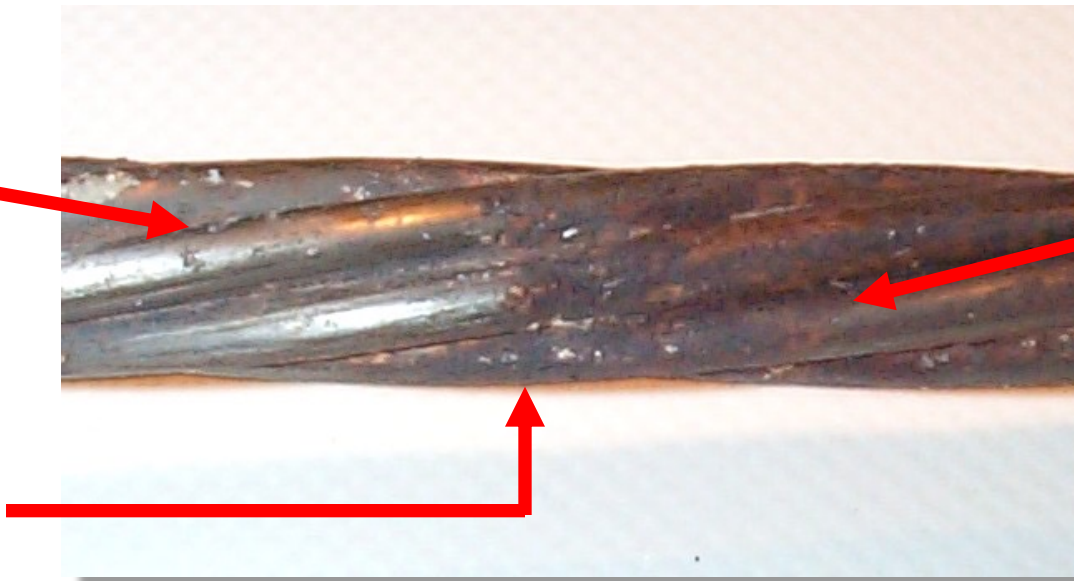
This part of the cable was encased in sheathing and was protected from exposure to corrosion.

Termination point of cable sheathing. Anticipate this to be where the cable will break.

This part of the cable was stripped of sheathing and fully embedded in the concrete, resulting in corrosion.

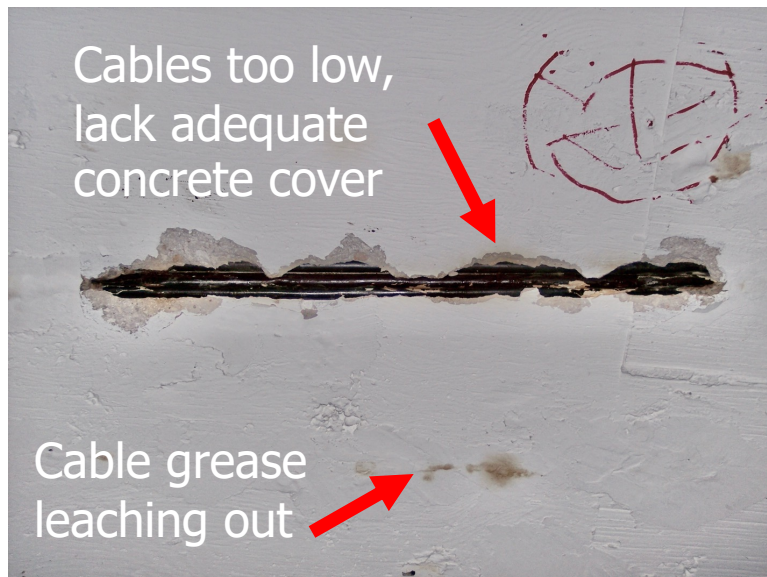
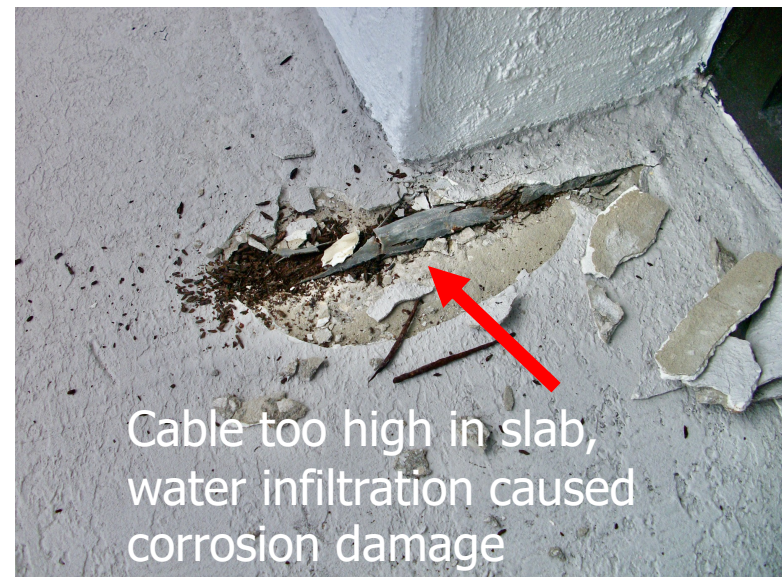
## ➤ Inadequate concrete coverage

- ✓ During concrete placement, cables can be knocked off their chair supports, or pushed to the surface if not tied to support reinforcement. This leaves the cables without adequate concrete cover, making them more susceptible to water infiltration and corrosion damage.

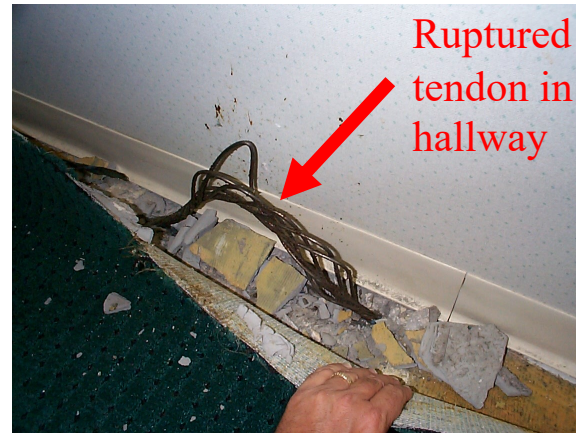
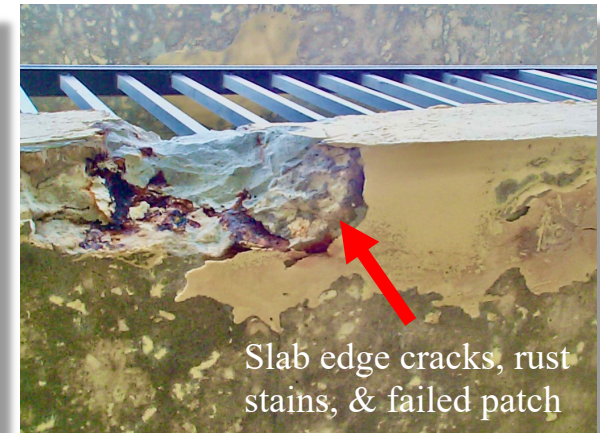
## ➤ Visual inspection

- ✓ In most cases, an investigation can focus on three issues simultaneously. Look for obvious evidence of damaged post-tensioning (ruptured cables), look for signs of corrosion damaged concrete (cracks, spalls, or rusty stains), and any signs of structural distress that could be signs of a loss of post-tensioning (flexural or shear cracks).
- ✓ Be mindful that it's nearly impossible to determine the precise condition of a tendon with only a visual inspection, and conditions may warrant the use of additional evaluation methods.

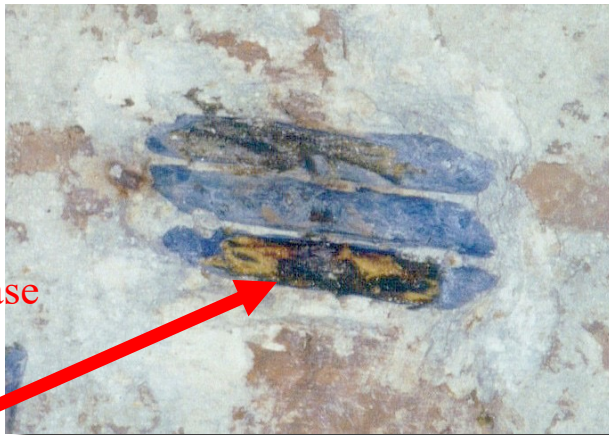
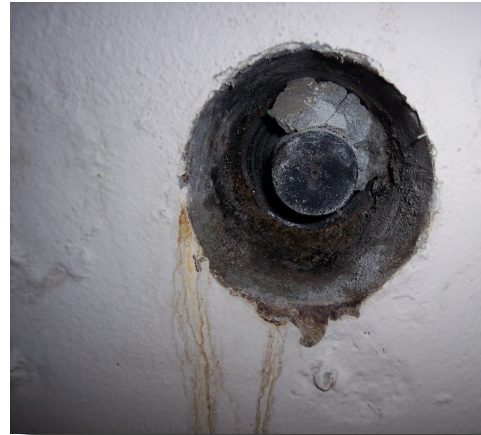
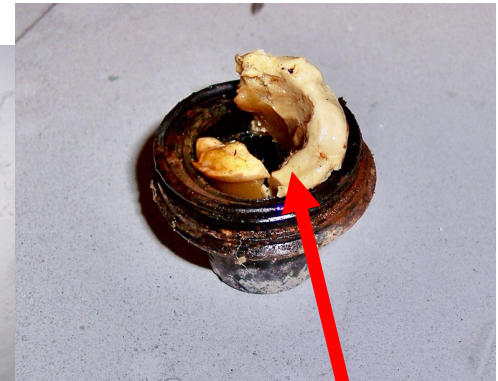
Opaque grease is a sign of water intrusion

- ✓ If water intrusion is suspected, it may be useful to examine the low points of a tendon for evidence of water and/or corrosion. Opaque grease can be a sign of water intrusion. May be more useful on older PT systems with heat sealed or push through sheathing, because modern extruded sheathing will impede water infiltration.
- ✓ Some engineers have determined it useful to remove the stucco and grout in order to inspect the anchor pockets for evidence of corrosion. However, it is impossible to accurately correlate the condition of the strand tail in the pocket to the tensioned portion of the cable.

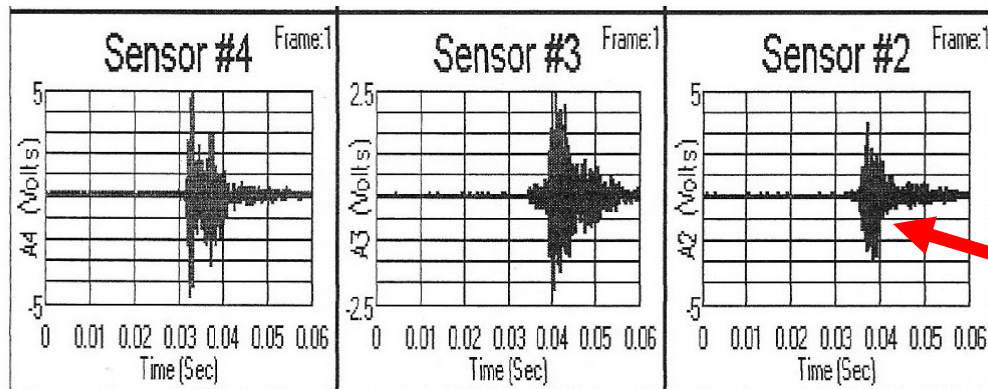
Files showing  
acoustic events  
recorded during  
monitoring

- ✓ Utilizes accelerometers bonded to the post-tensioned structure on 1,000 SF centers to monitor the acoustic footprint of the shear wave energy generated by wire or strand failures.
- ✓ Acoustic events are recorded by on site computer and then analyzed by a trained structural engineer.
- ✓ Requires a significant capital investment in the equipment and installation.
- ✓ Requires the continued investment in long term monitoring and evaluation services.

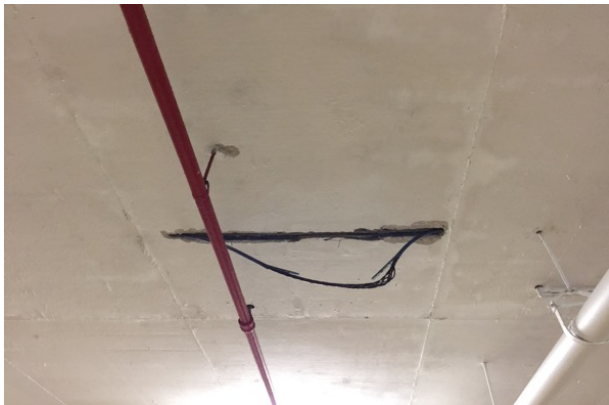
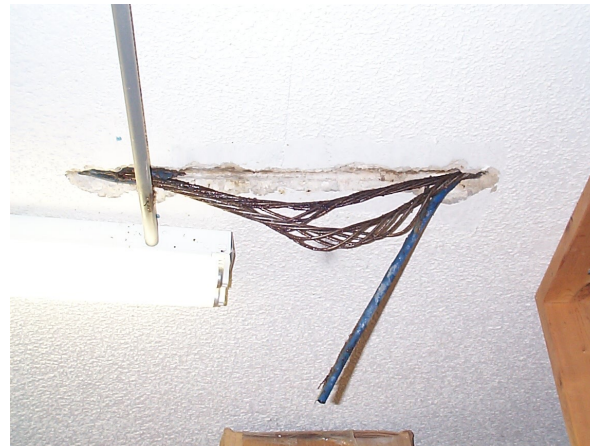
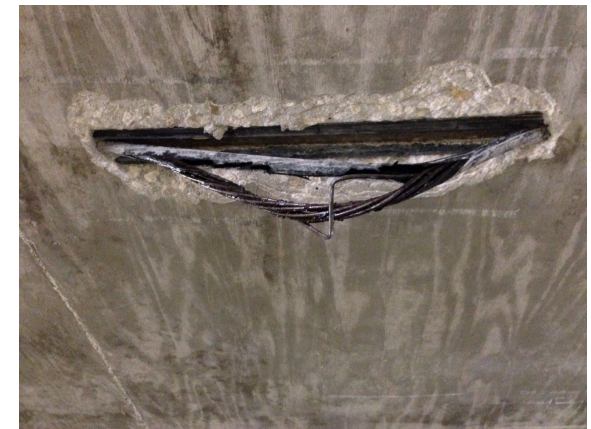
## ➤ Cable Replacement

- ✓ When it is not possible, practical, or cost effective to repair damaged or broken tendons using a splice repair, then replacement of the tendon may be necessary.
- ✓ Is often done when the cables are damaged or broken within the building interior, making demolition of the concrete to expose and repair the damaged cable difficult.
- ✓ These repairs can be complicated due to field conditions, such as corrosion of cable, sheathing damage, or other obstructions.

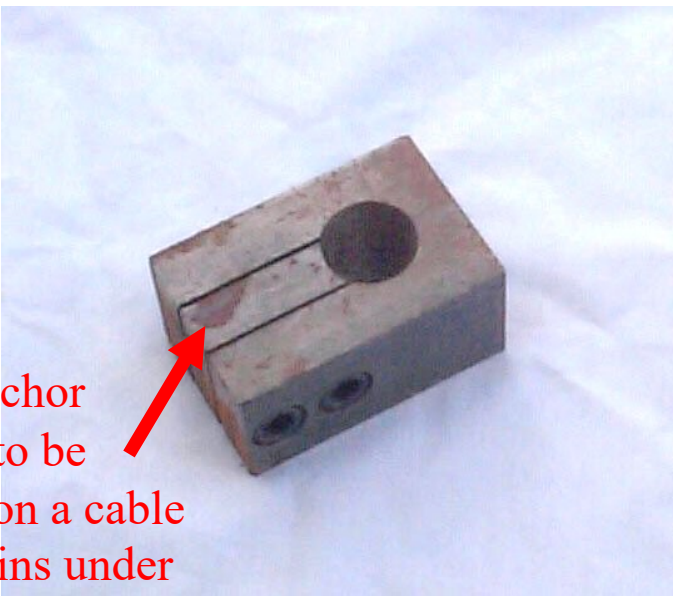
## ➤ Single cable lock-off anchors

- ✓ The troubleshooting anchor is used to provide a temporarily anchor at a new location on an existing tendon.
- ✓ Allows the post-tensioned forces to be temporarily removed from a limited portion of a tendon span, usually for repairs.

Slot in anchor allows it to be installed on a cable that remains under tension.

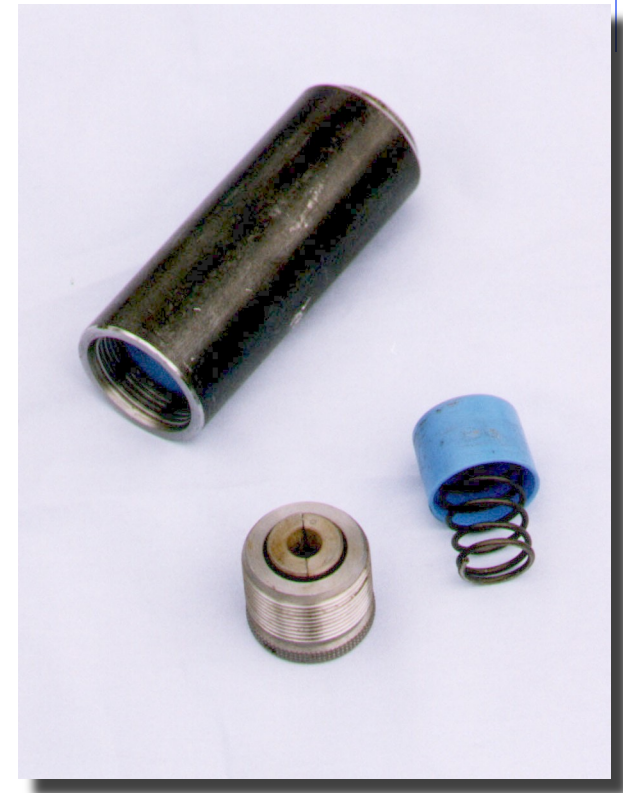
## ➤ One time use splice couplers

- ✓ Used for joining a section of new strand to an existing cable at some point along the tendon span.
- ✓ Requires access to a terminal end anchor in order to re-establish tension.

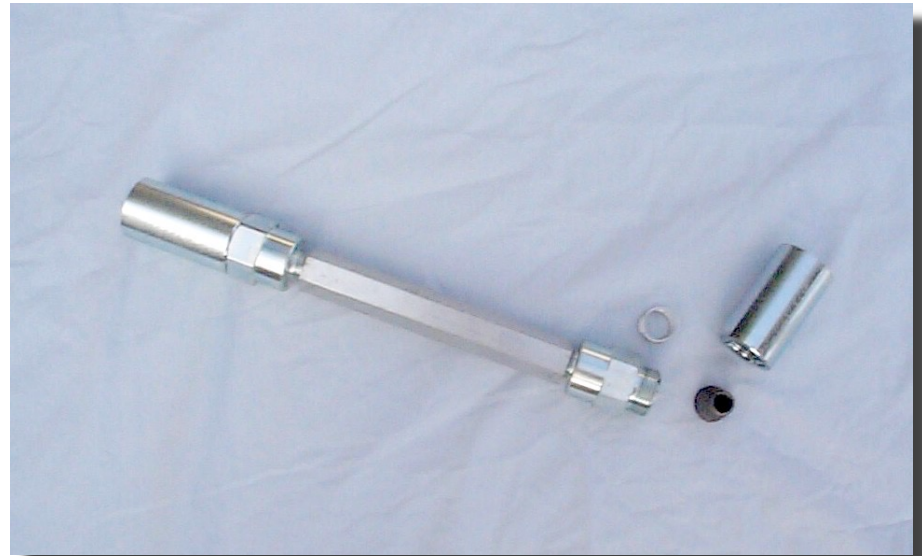
- Cable tensioning with a stressing splice
  - ✓ Typically used for splicing damaged cables along their length.
  - ✓ Trade names such as LokCouplers / Grabits.
  - ✓ Does not require access to the stressing end anchors for reestablishing tension of the repaired cable.
