EZ PLACE CABLE RAIL STRENGTH ANALYSIS - REV 1 (Includes Test Results)

CRVH-001
EZPLACE CABLE RAIL - HIGH IMPACT
90 DEGREE

WG Fabricators LLC
QCM Job No. 24GM-404

RE: WFG Rail Pull Test P/N AC1318-19.
Test Performed 07/02/24

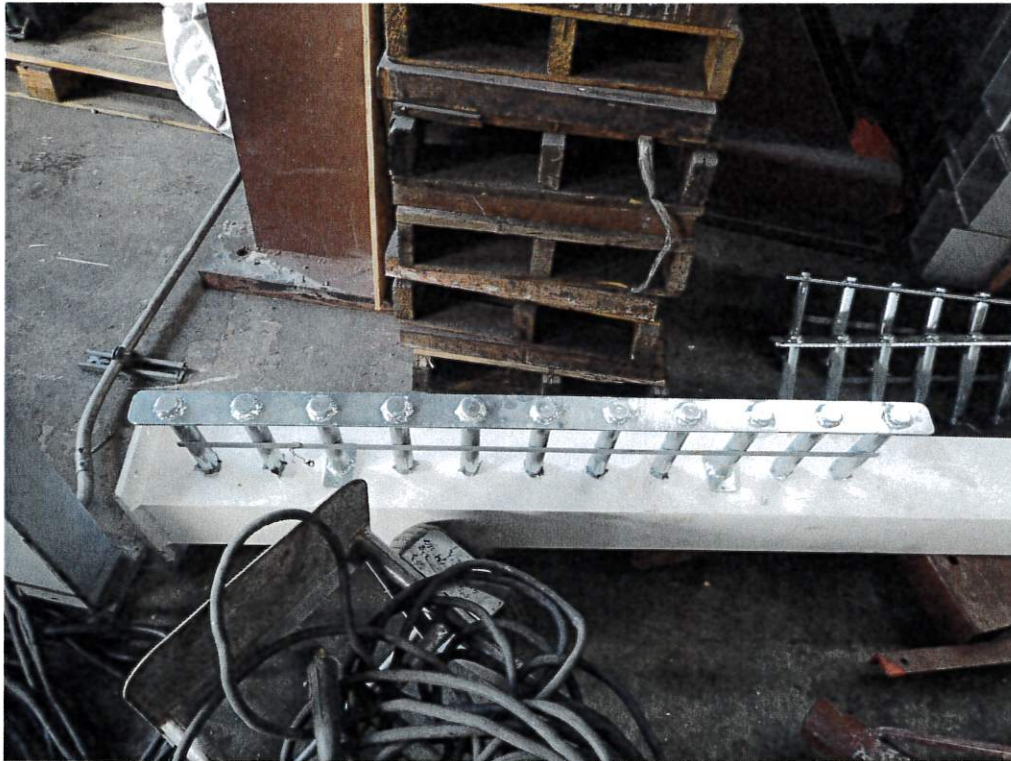
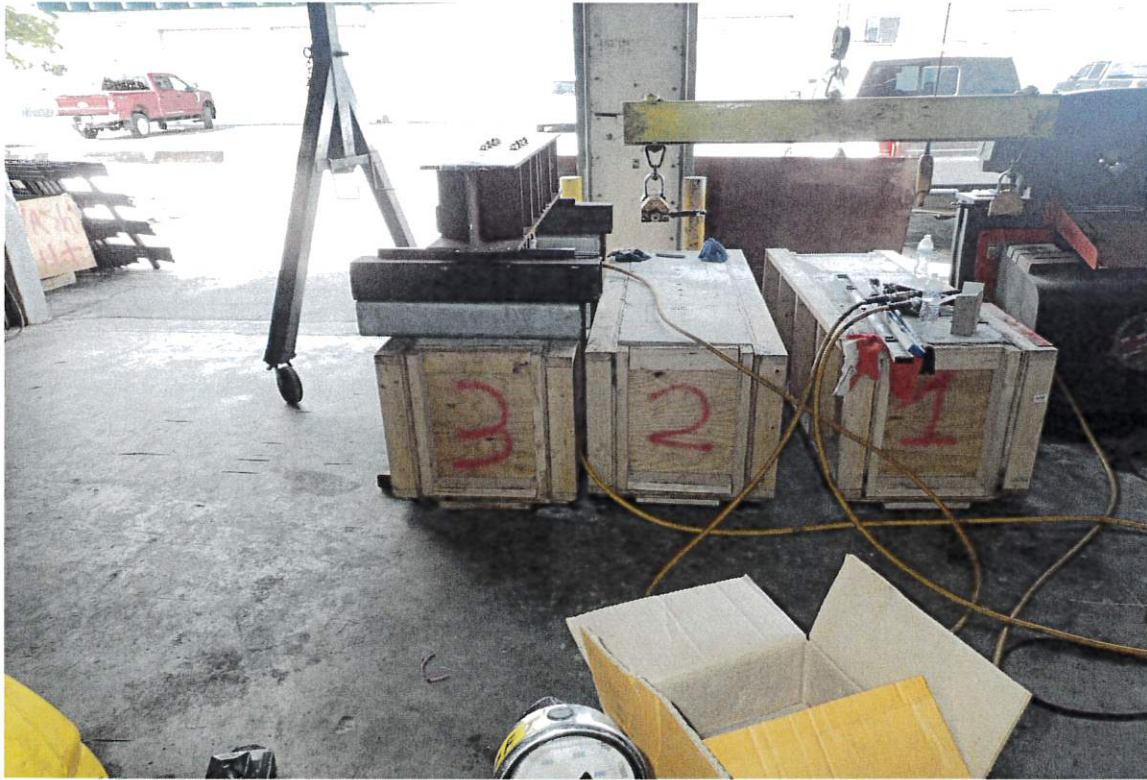
This summary is for load testing to failure of WFG Rail P/N AC1318-19. Three concrete enclosures were fabricated to encase WFG Rail Assembly, 24" x 24" x 60" with 6,500 PSI cement mix and cured for six days prior to testing. See Figures 1-3. A fabricated steel I-Beam for a cross-head was used; connecting eight threaded $\frac{3}{4}$ "-B7 rods to $\frac{1}{2}$ " steel plate with three Grade 8, $\frac{3}{4}$ " bolts torqued to 104 ft/lbs. inserted to WFG Rail Assembly. See Figures 4-10. Two hydraulic 30 ton jacks were used under cross-head to produce a tension load on the WFG rail assembly. Power was applied to Enerpac Pump/Gauge and Jacks to give an indicated 1,000 PSI on pressure gauge producing a PSI stress load of approximately 22,000 on all samples. See Figures 11-16.

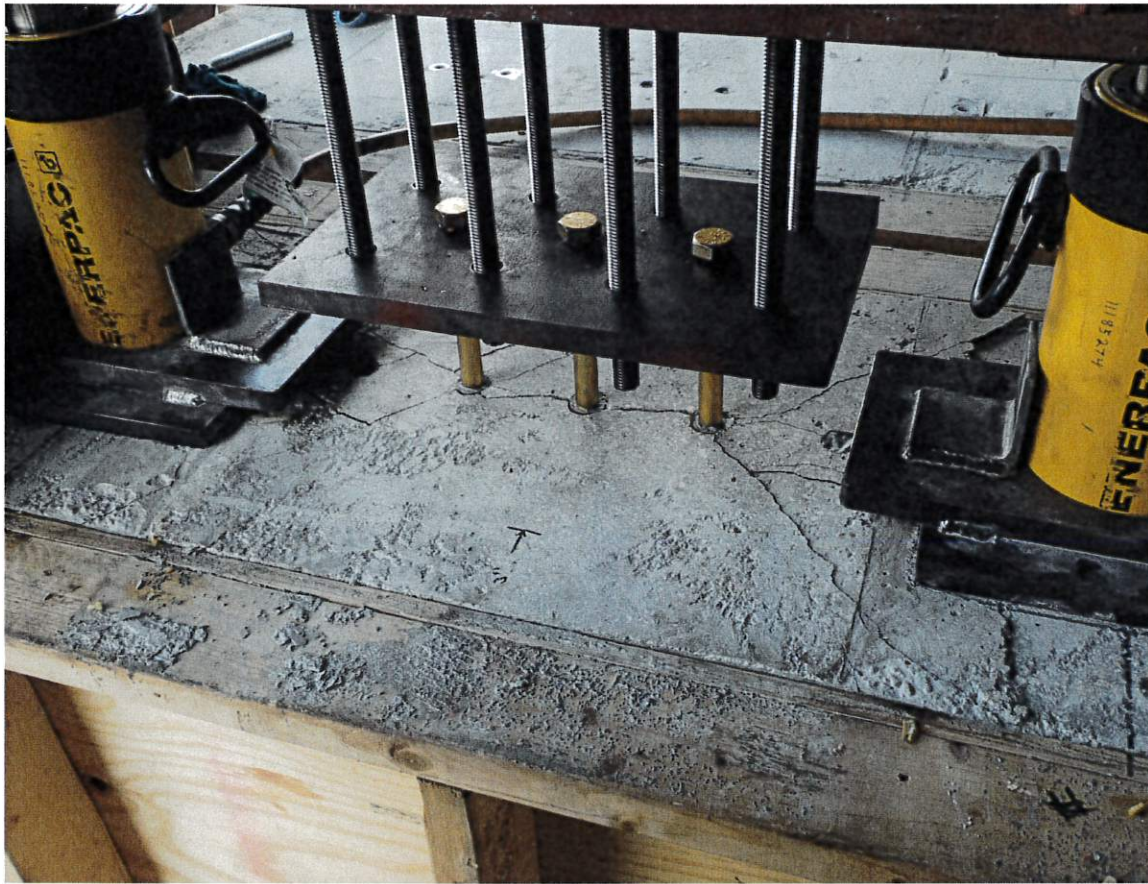
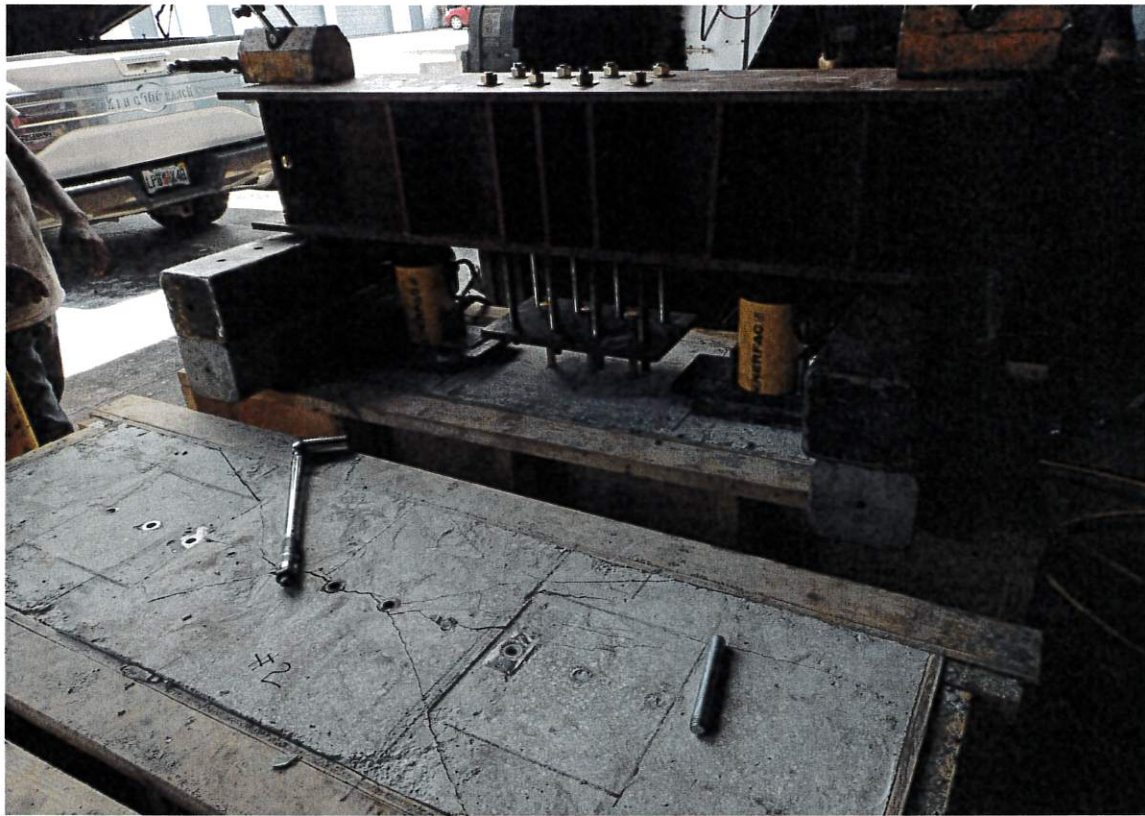
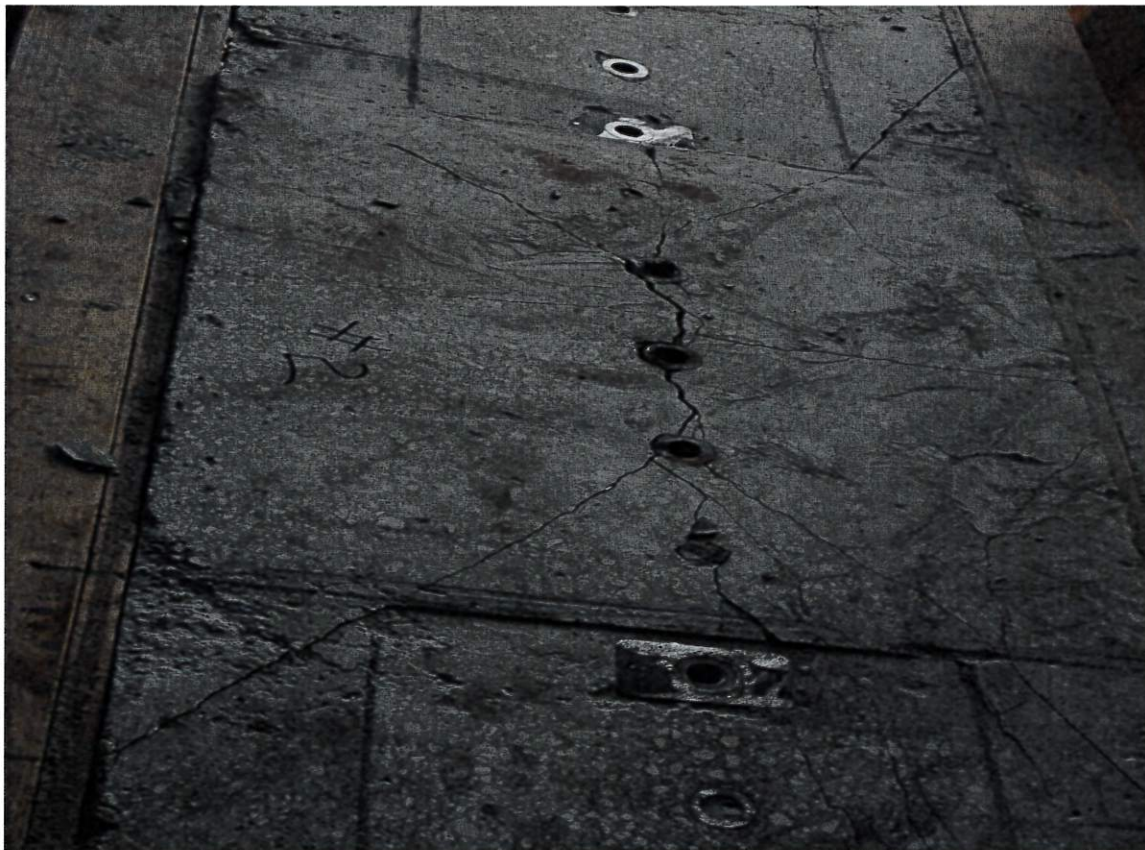
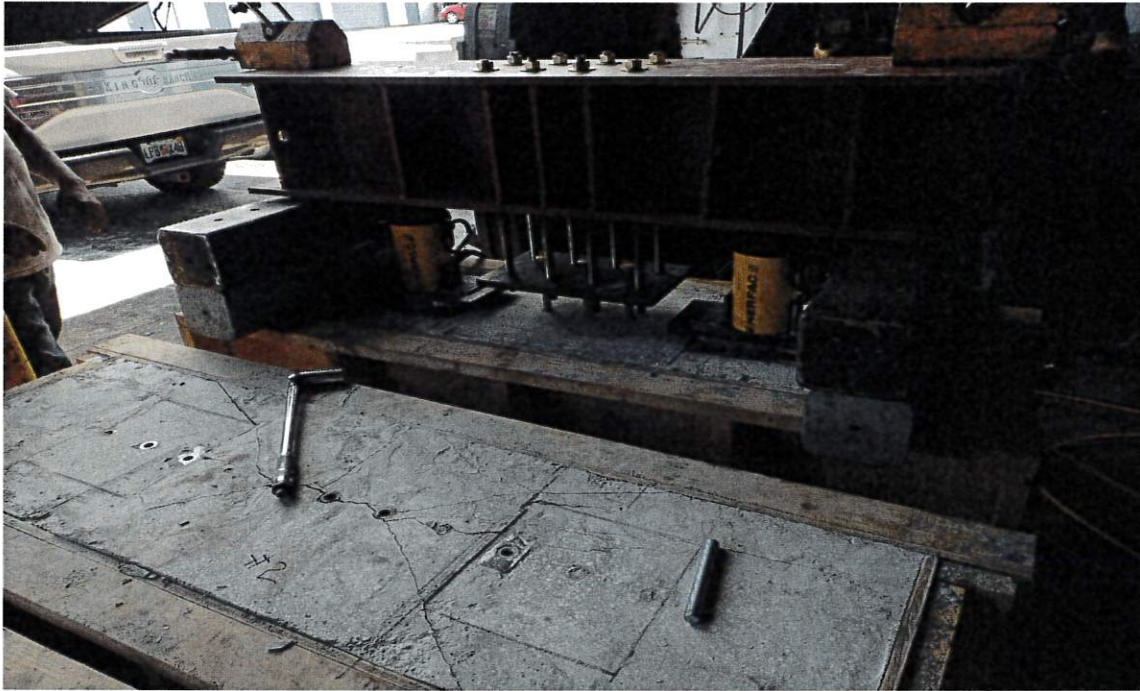
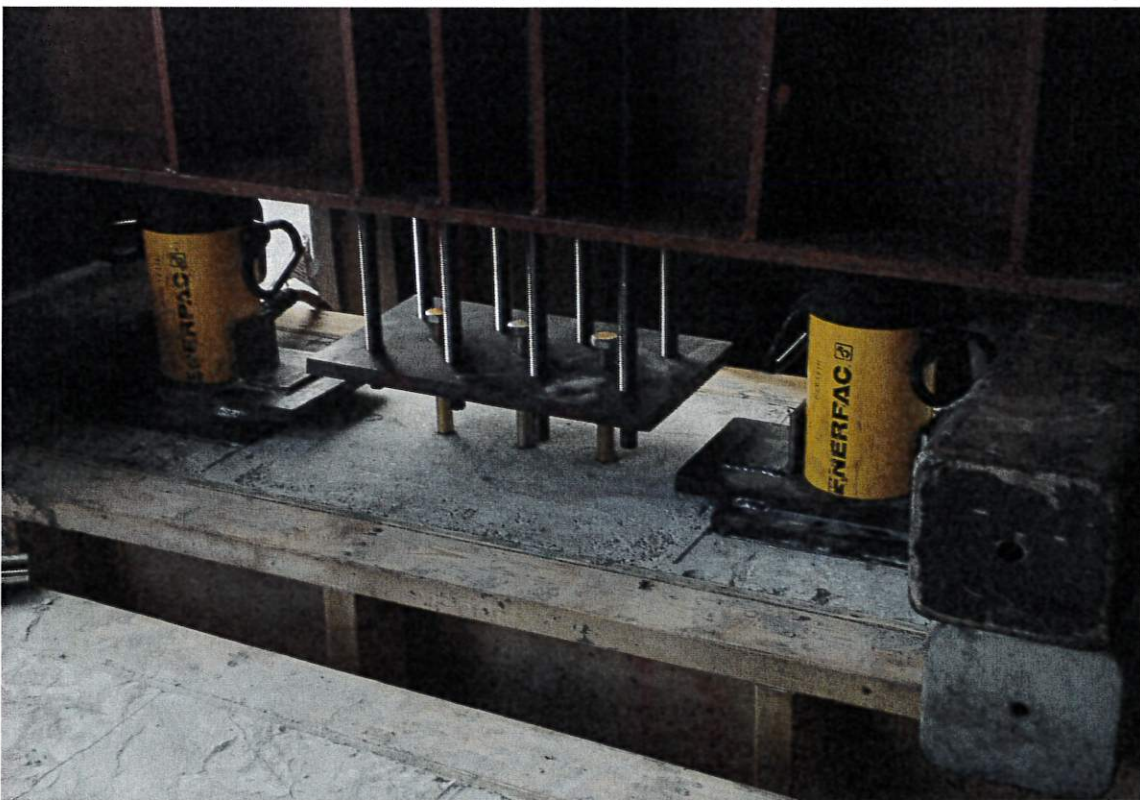
Power was applied to an estimated rate of .5 in/min C/H speed until maximum value achieved on pressure gauge when pressure drops indicating failure load. Procedure was performed on all three samples showing failure mode. See Figures 17-22.

The exact classification (shear / bending / pull out) of the beam failures is difficult to determine from the cracking patterns. In one case, there was a transverse crack across the center of the beam (mid-span). This would indicate the beam acting like a “long beam” and failing as a classic bending failure as opposed to a beam failing in shear. However, there was only a single instance of this.

The rail assembly itself was bent (See pictures). This is because the rail assembly was being held down on its ends by the test fixture.

It was also noted that the rail assembly was bent just outboard of the three center inserts when the testing was done. The raw test results indicate that the rail assembly sustained a test load of 131.0 Kips before failure. However, this load also included some “overage” due to the fact that we were holding the rail assembly down at it’s ends at the same time. We therefore attempted to adjust for this “overload” by estimating how much load it took to bend the rail assembly as was observed in the
