#### Deterioration, Evaluation, and Repair of Post-Tensioned Condominium Structures

## Index

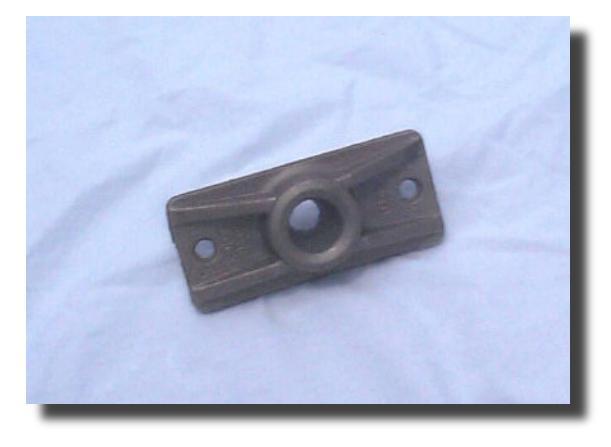
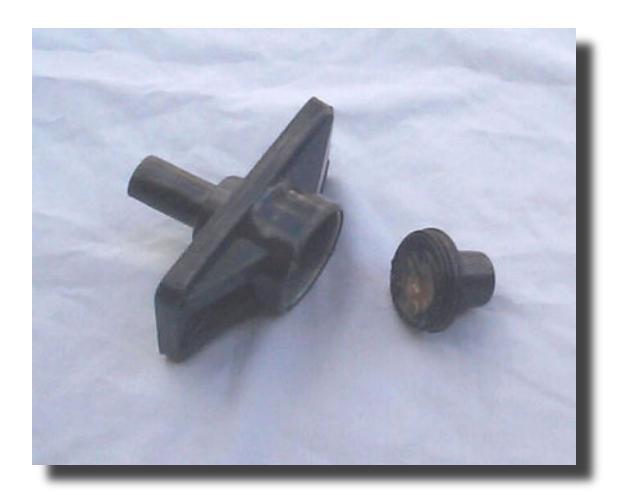
## **Terminal Anchors**

Anchors are found at the ends of each cable and transfer force into the concrete.

#### Bare cast iron anchors

Provides no corrosion protection of the anchor or strand. Highly prone to corrosion.

#### Encapsulated anchors

Polyethylene encapsulation of the cable, anchor, and end pockets can provide a measure of corrosion protection, but only if properly installed. Improper installation of the stressing anchor pocket seal and grout are a common failure, and will allow moisture to enter tendon and lead to corrosion damage.

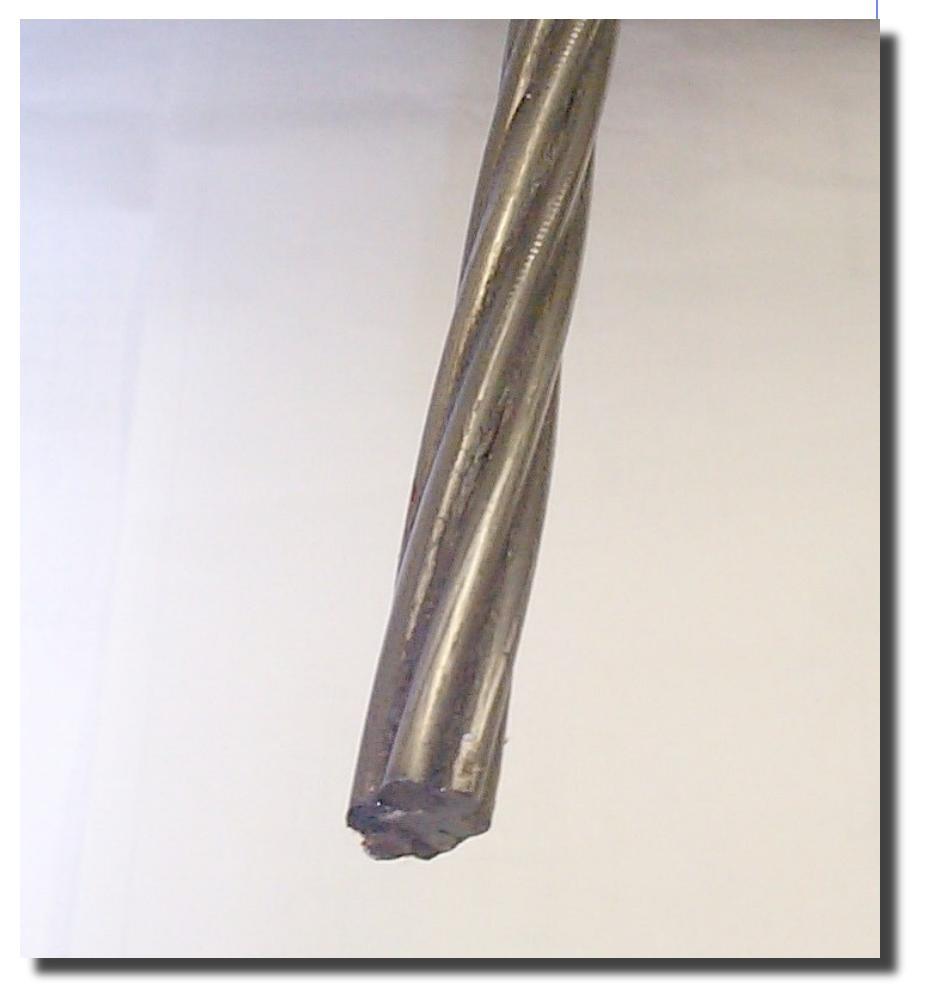
## **Post-Tensioned Strand**

- Post-tensioned cables are made of high strength steel wires twisted around a center wire.
- 1/2" diameter seven wire post-tensioned cables have been used extensively in residential structures constructed since the 1990's (particularly in coastal areas).
- Cables are stressed to 80% of the specified tensile strength of the strand, which is 33 kips for ½" diameter cables.

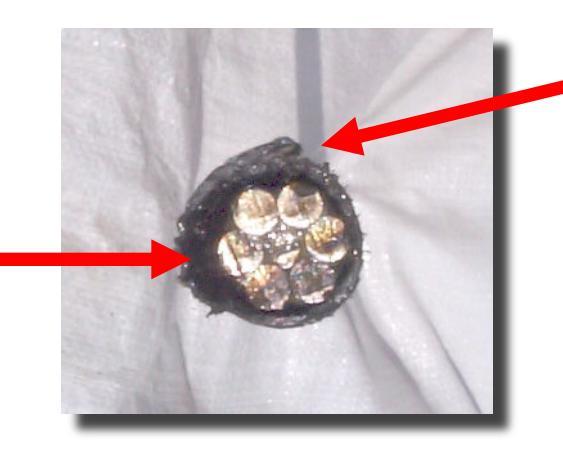
- ✓ Found in older structures (pre-1980's).
- ✓ Uses a flat plastic strip and a heat-sealed seam to create a round cable sheathing.
- It is common for the seam to fail and allow water to enter the cable.
- ✓ Sheathing is larger in diameter and a void exists along cable length. Will retain water.
- $\checkmark$  Structures with this type of sheathing should be examined closely for cable corrosion.
- Corrosion can affect the cables anywhere along their length, and far from any concrete spalling at the terminal anchors.

Larger diameter of sheathing leaves a void that can hold moisture

Overlapping heatsealed seam can fail and permit moisture to infiltrate the cable

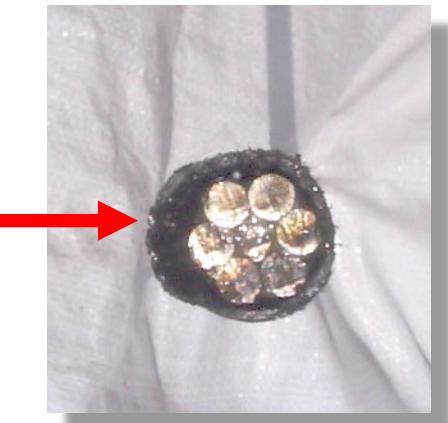
#### > Push through plastic

- Found in older structures (pre-1980's).
- ✓ Uses extruded plastic to create the cable sheathing.
- This sheathing is larger in diameter and a void exists along cable length. Will retain water.
- Structures with this type of sheathing should be examined closely for cable corrosion.
- Corrosion can affect the cables anywhere along their length, and far from any concrete cracking or spalling.
  - Larger diameter of sheathing leaves a void that can hold moisture

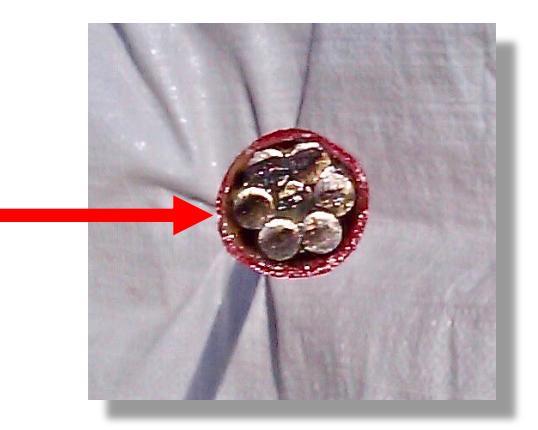
#### Extruded plastic

- The PTI currently certifies the use of this type of sheathing.
- Method of assembly leaves minimal void between cable and sheathing, which is filled with corrosion inhibiting grease (effectively eliminating any voids).
- ✓ Can be watertight when used with an encapsulated anchor system.
- Cables are still susceptible to localized damage conditions, but less to systemic problems.
  - Improved sheathing will protect the cables from moisture

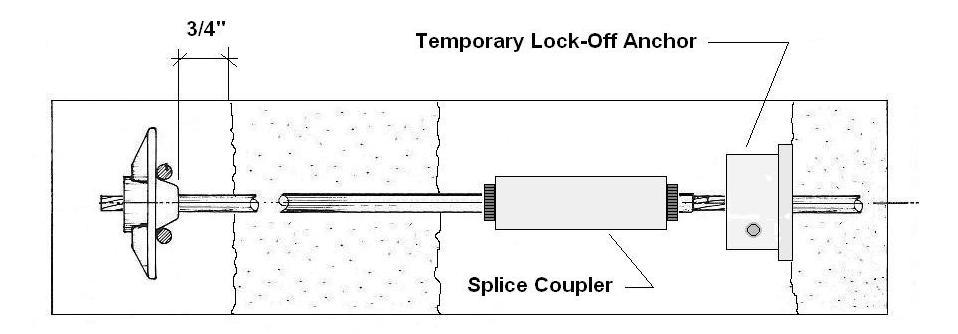
#### Correct repair geometry

- When performing concrete structural repairs, the ICRI Guideline No. 03730 "Guide for Surface Preparation for the Repair of Deteriorated Concrete Resulting from Reinforcing Steel Corrosion" requires a "minimum ¾ inch (19mm) clearance between exposed rebars and surrounding concrete or ¼ inch (6mm) larger than the largest aggregate in the repair material, whichever is greater."
- However, the concrete excavation recommended by the ICRI will occur behind the posttensioned tendon anchors, and within the anchorage high-stress zone. In order to perform this work safely, the tension load on existing anchors must be temporarily relocated to a new temporary anchor.

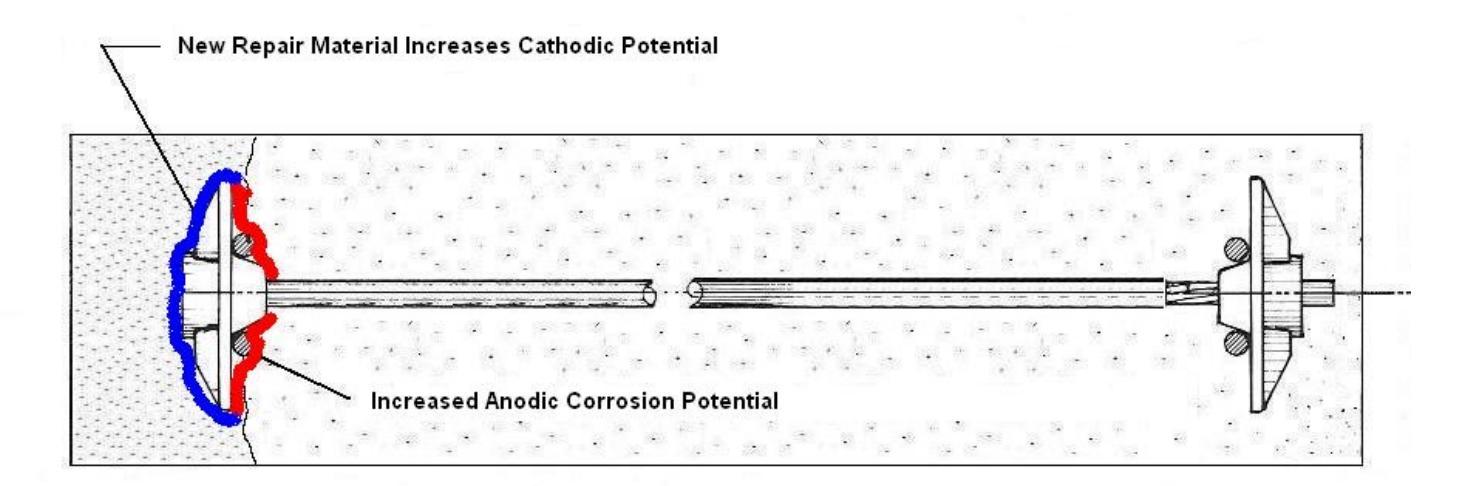
#### Incorrect repair geometry

- ✓ When cracked and spalled concrete is removed only from the face of the anchors and/or rebar, this causes the embedded steel elements to become "sandwiched" between the existing concrete and new concrete.
- ✓ This creates a macroscopic corrosion cell with increased corrosion potential and causes the embedded steel to corrode at a rapid rate.

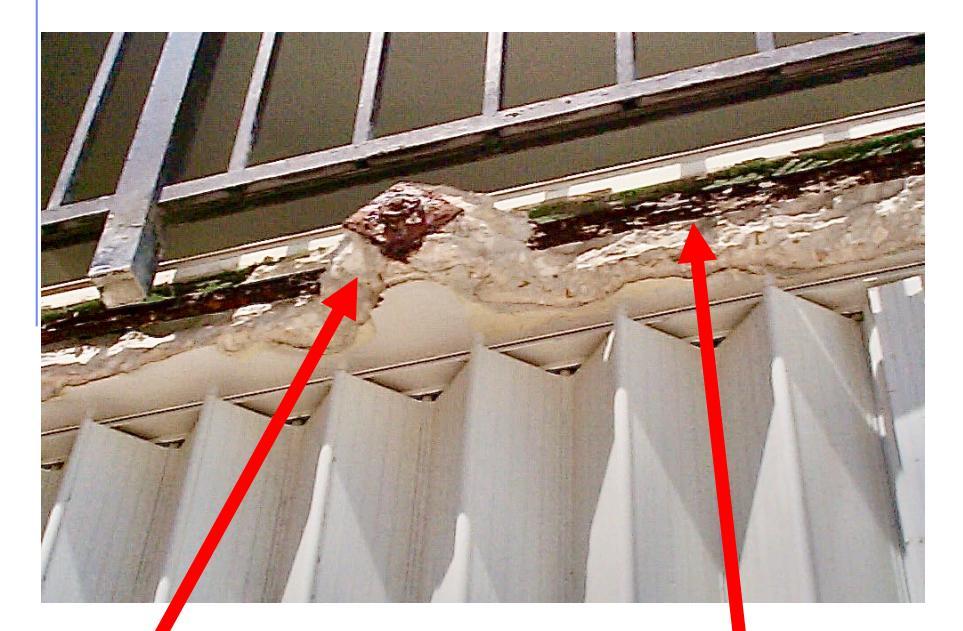
Rebar continues through existing concrete behind the PT anchor, which creates an electrochemical corrosion hot spot. Rebar has not been fully excavated, which will sandwich it between the existing concrete and new concrete on the face.

Note advanced state of rebar corrosion where it was sandwiched between old and new concrete.

The dark gray patch is clearly

different than the lighter

existing concrete substrate

Note less rebar corrosion where it remained fully embedded in the old concrete.

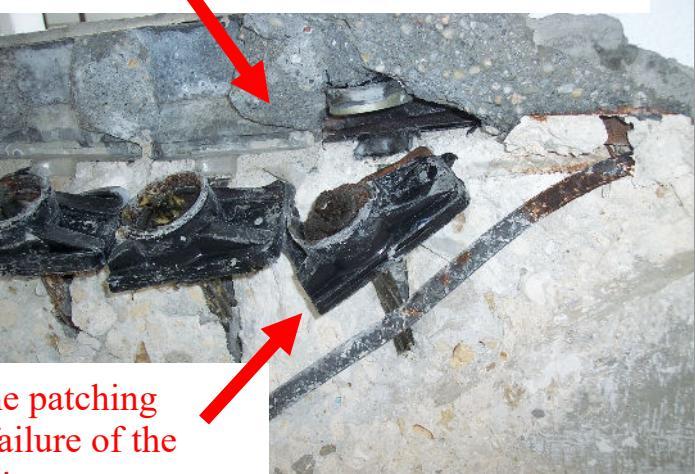
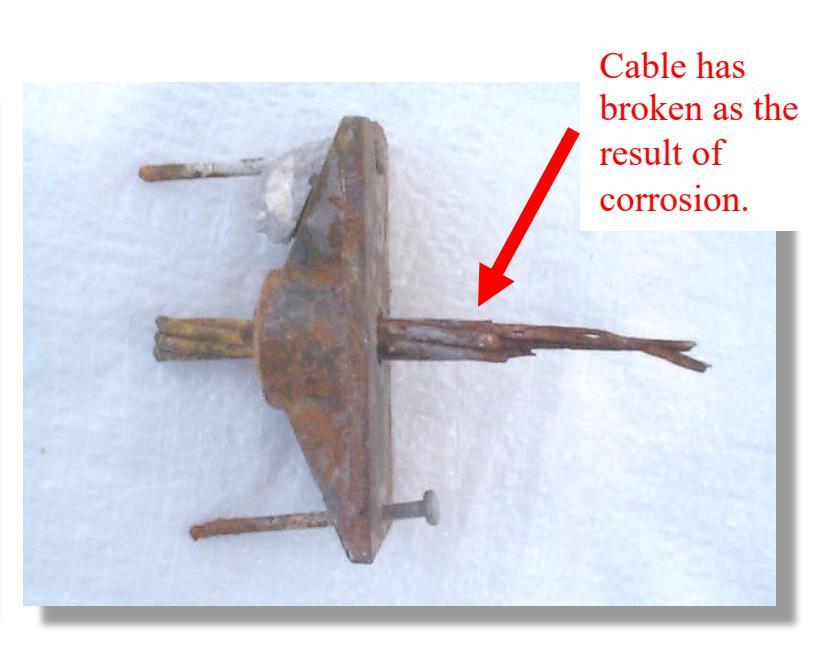
Continued corrosion of rebar after patching resulted in spalling of the concrete around the anchors.

Failure of the patching resulted in failure of the post-tensioning.

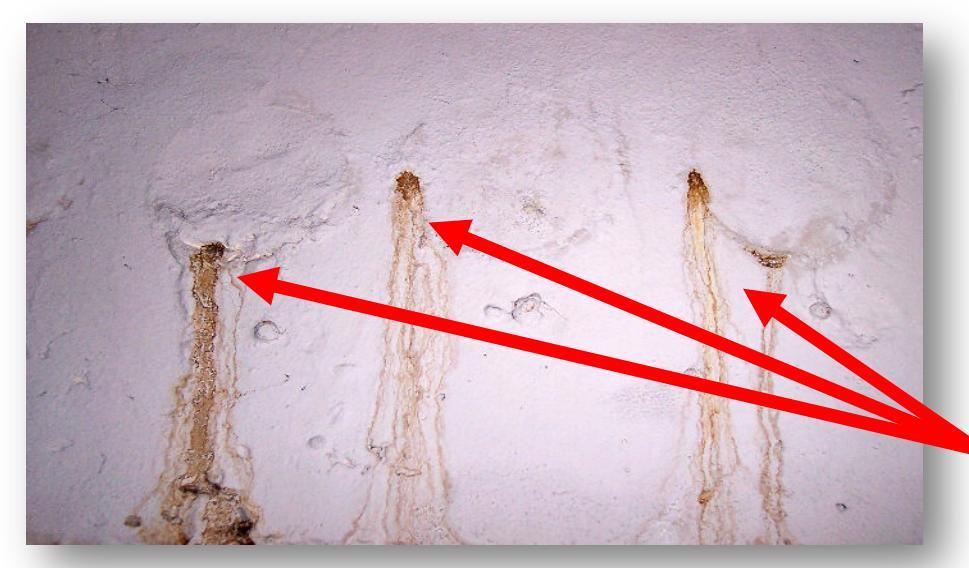
Water leaking from the anchor pockets is a serious concern.

- The introduction of water into any part of a post-tensioned tendon (either the cable, anchors, and wedges) will ultimately result in a failure of the cable from corrosion.
- ✓ Cable failures result in a complete loss of post-tensioned reinforcement across the entire span of the affected tendon and resulting structural member..
- ✓ Water can enter through cracks, spalls, and other inclusions anywhere along the length of the tendon span, and at the stressing pockets.
- As buildings age, they are increasingly at risk of strand corrosion.

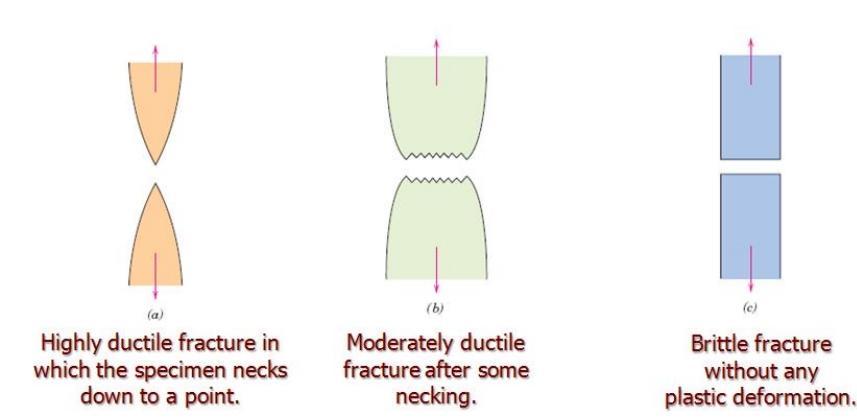
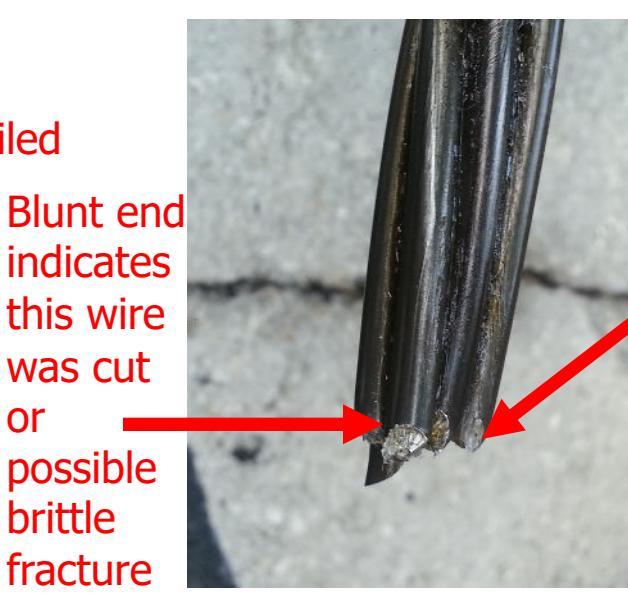
#### **Ductile Fracture**

The ends of cable wires can show how they failed

Necking is evidence of a ductile failure of wire

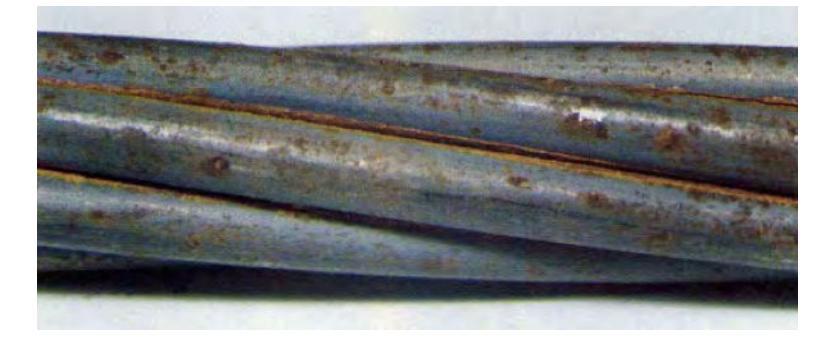
#### Minor pitting

- This is a localized form of corrosion that is visible on the strand surface. Moisture within the tendon sheathing will lead to the development of corrosion of the strand.

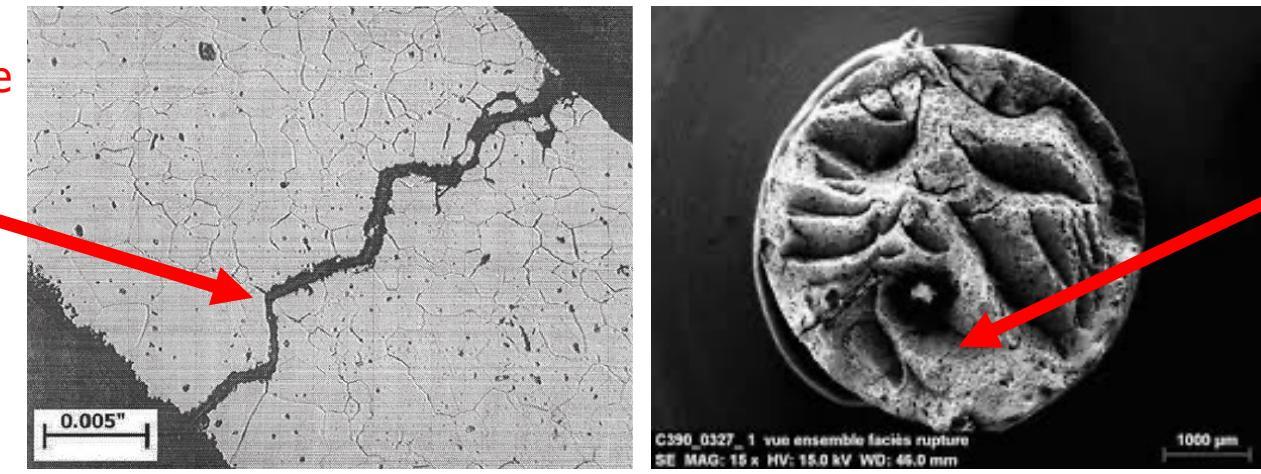
Microscopic image of brittle failure crack in wire

Microscopic image of brittle failure at the end of wire

- This is a somewhat rare form of damage, and it is often associated with impressed current cathodic protection of prestressed concrete structures. It's not likely to be encountered on post-tensioned structures, unless an impressed current cathodic protection system has been installed on the building.
- Occurs when atomic hydrogen finds its way between the grains of the steel and forms molecular hydrogen, which has a much greater volume and causes cracking.
- / It reduces ductility of steel & results in sudden brittle failure.

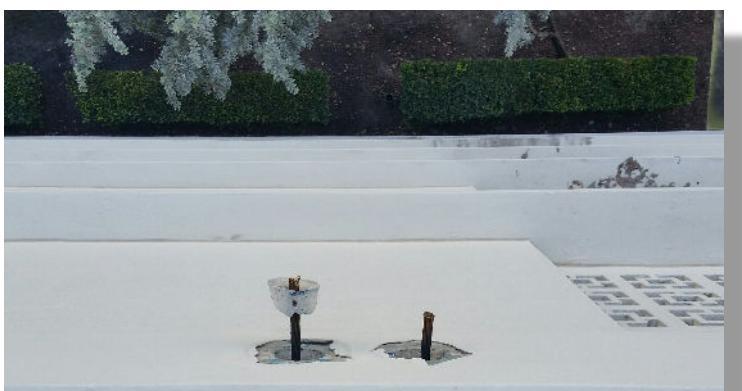
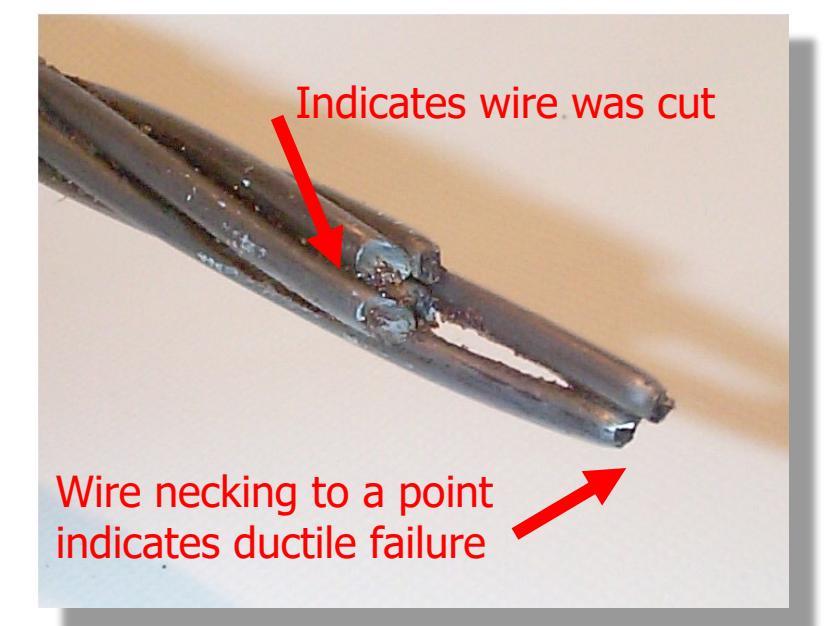
Broken cables extending from anchor pockets is evidence that cables are broken.

- Given that post-tensioned cables are stressed to 80% of their ultimate tensile strength, they can fail if only 1 out of the 7 wires are cut.
- Strands are often damaged by trades that cut or drill into the structure (plumbers, shutter installers, electricians, etc.)
- ✓ Unfortunately, broken cables rarely give visible evidence of their failure because the structure will usually absorb the release of energy without damage.

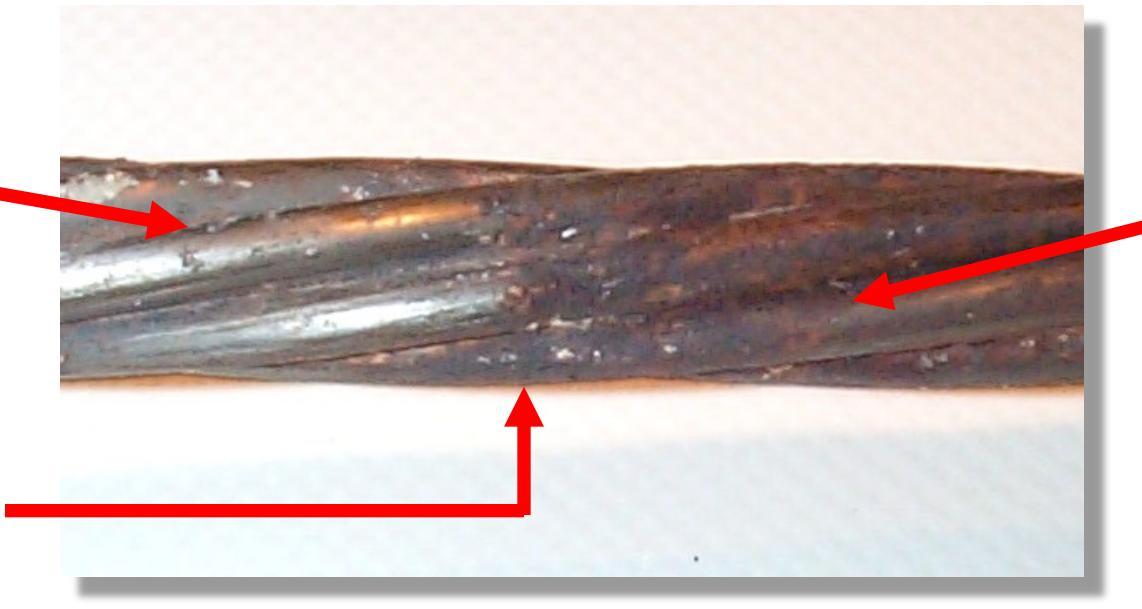
This part of the cable was encased in sheathing and was protected from exposure to corrosion.

Termination point of cable sheathing. Anticipate this to be where the cable will break.

This part the of cable was stripped of sheathing and fully embedded in the concrete, resulting in corrosion.

- Any part of the strand that is in direct contact with concrete (without sheathing) is subject to the same electrochemical corrosion that affects mild steel embedded in concrete.
- Prior to the adoption of encapsulated PT tendon hardware, it was common for PT contractors to remove sheathing at dead-end anchors in order to create a short length of bonded cable to help hold the cable at the dead-end anchor during cable stressing.
  - Corrosion of the portion of the cable embedded in concrete can cause it to break.

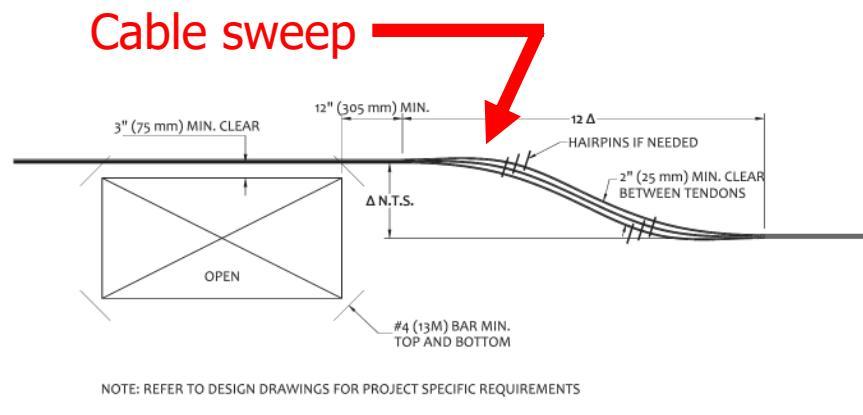
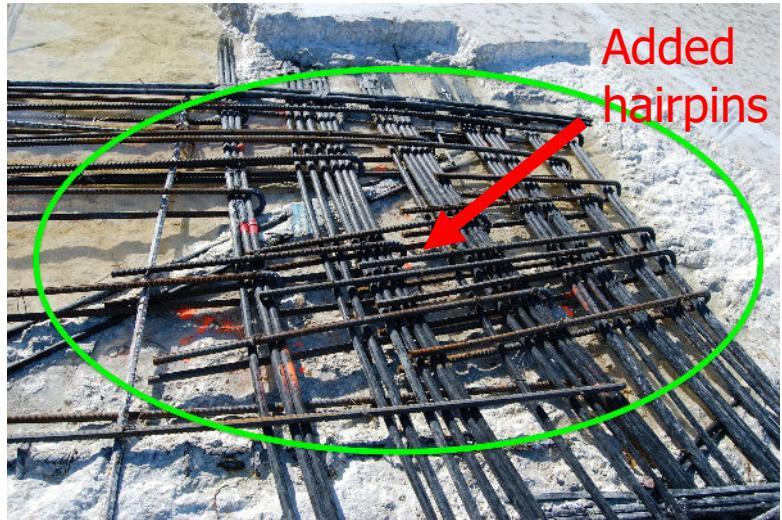
- The PTI requires the use of hairpin reinforcement to control shear forces that develop within the concrete due to a lateral sweep of the cables off centerline.
- ✓ This type of failure usually dates back to the buildings' original construction, and occurs when the post-tension cables are placed without sufficient hairpin reinforcement. Repair will require the installation of additional reinforcement to remediate this condition.

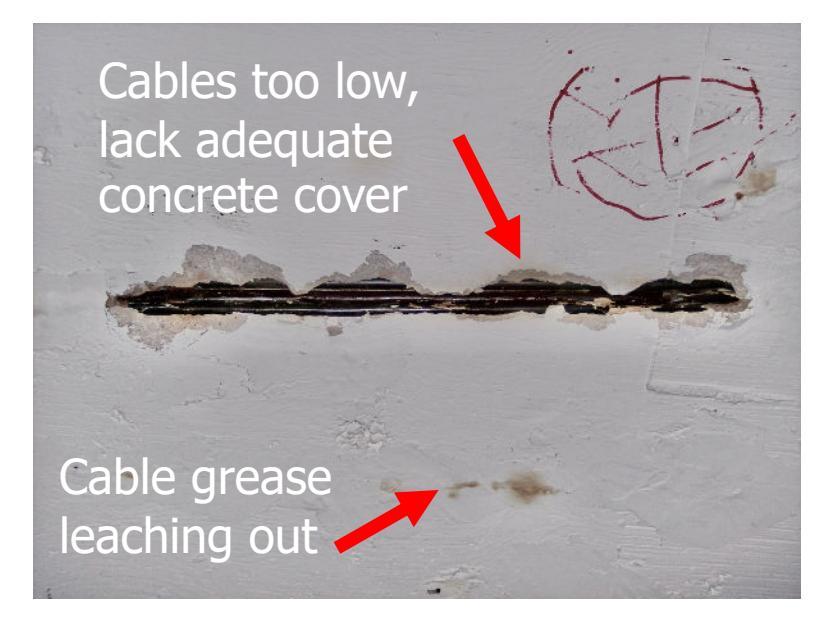
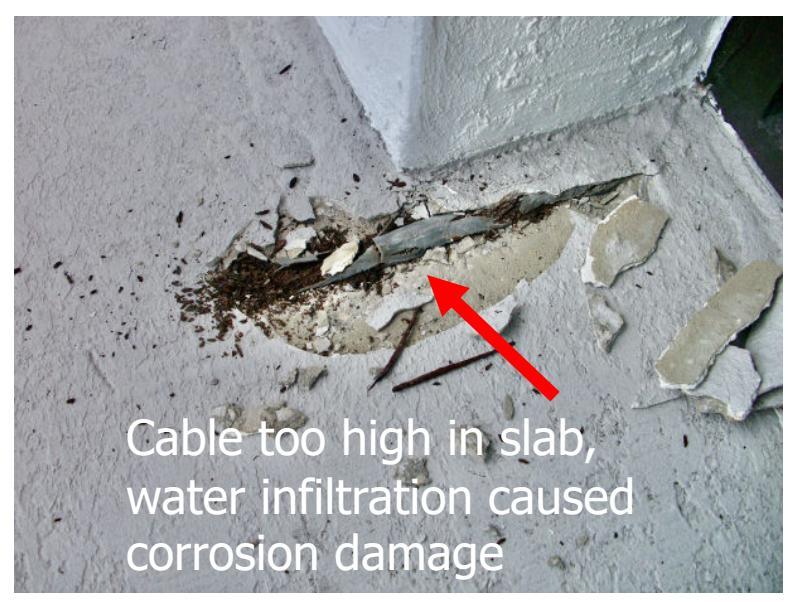
During concrete placement, cables can be knocked off their chair supports, or pushed to the surface if not tied to support reinforcement. This leaves the cables without adequate concrete cover, making them more susceptible to water infiltration and corrosion damage.

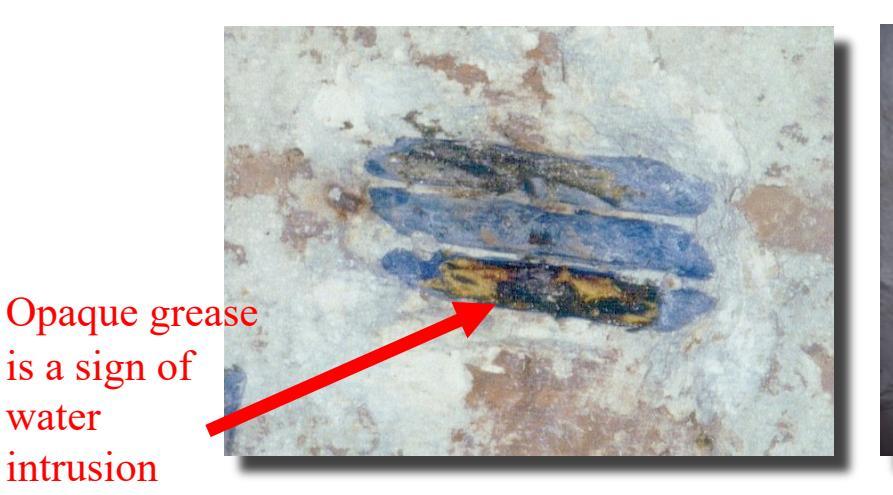
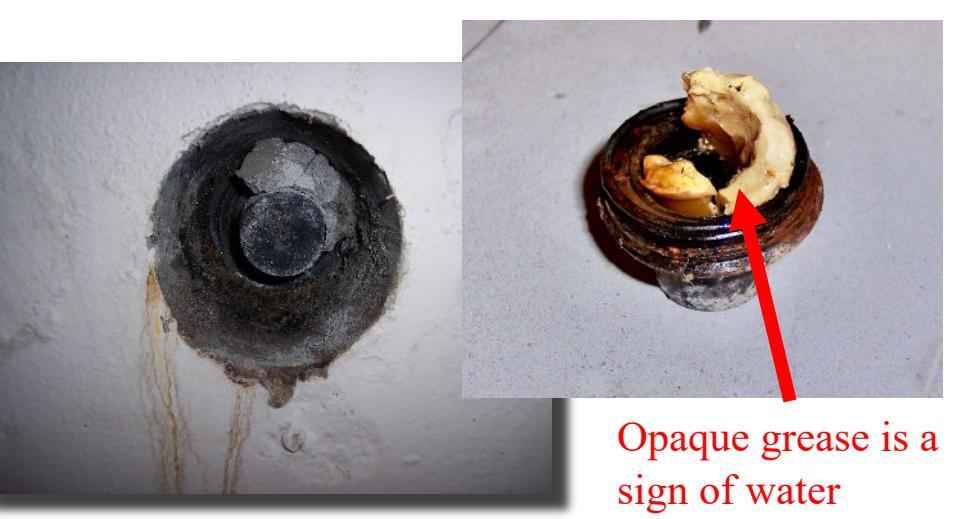
- If water intrusion is suspected, it may be useful to examine the low points of a tendon for evidence of water and/or corrosion. Opaque grease can be a sign of water intrusion. May be more useful on older PT systems with heat sealed or push through sheathing, because modern extruded sheathing will impede water infiltration.
- Some engineers have determined it useful to remove the stucco and grout in order to inspect the anchor pockets for evidence of corrosion. However, it is impossible to accurately correlate the condition of the strand tail in the pocket to the tensioned portion of the cable.

water

intrusion

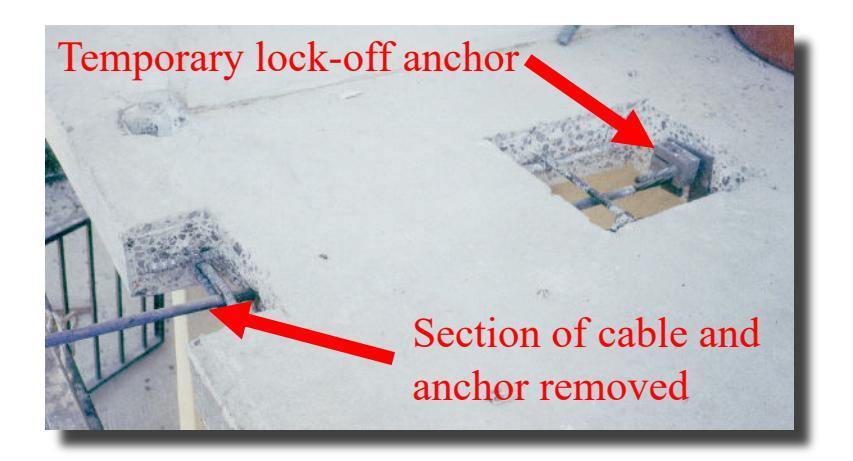
Relative absence of corrosion on cable tail in pocket.....

Removal of sample shows failure of tendon due to corrosion

- In some cases, it may be determined necessary to remove and examine samples of the tendons on a limited basis.
- Removal of a length of strand allows for examination for evidence of corrosion and / or failure

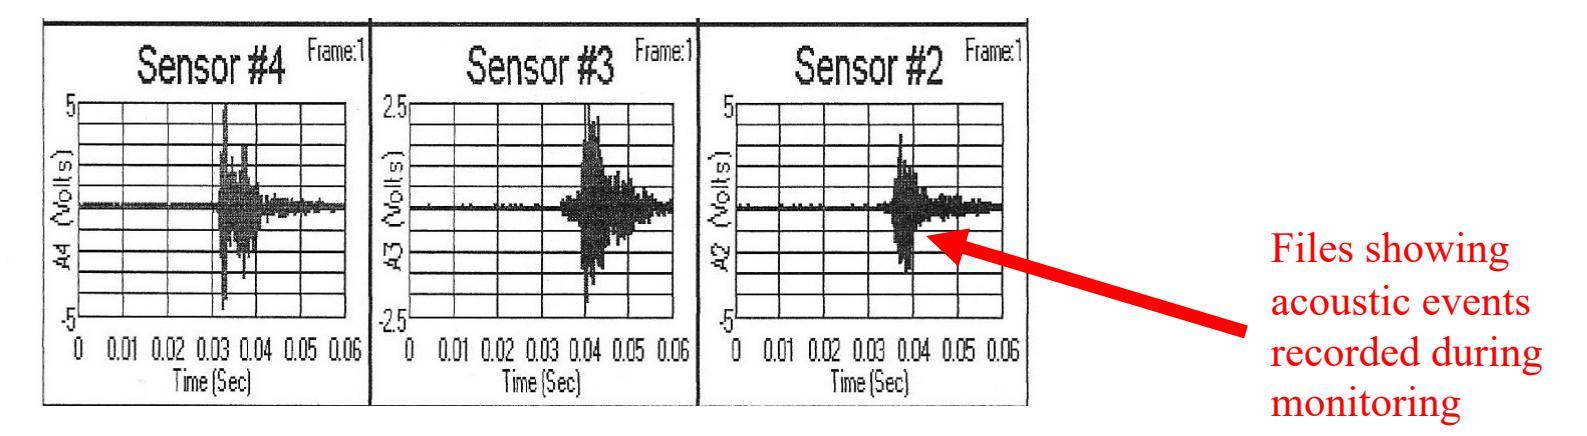
- ✓ Utilizes accelerometers bonded to the post-tensioned structure on 1,000 SF centers to monitor the acoustic footprint of the shear wave energy generated by wire or strand failures.
- ✓ Acoustic events are recorded by on site computer and then analyzed by a trained structural engineer.
- Requires a significant capital investment in the equipment and installation.

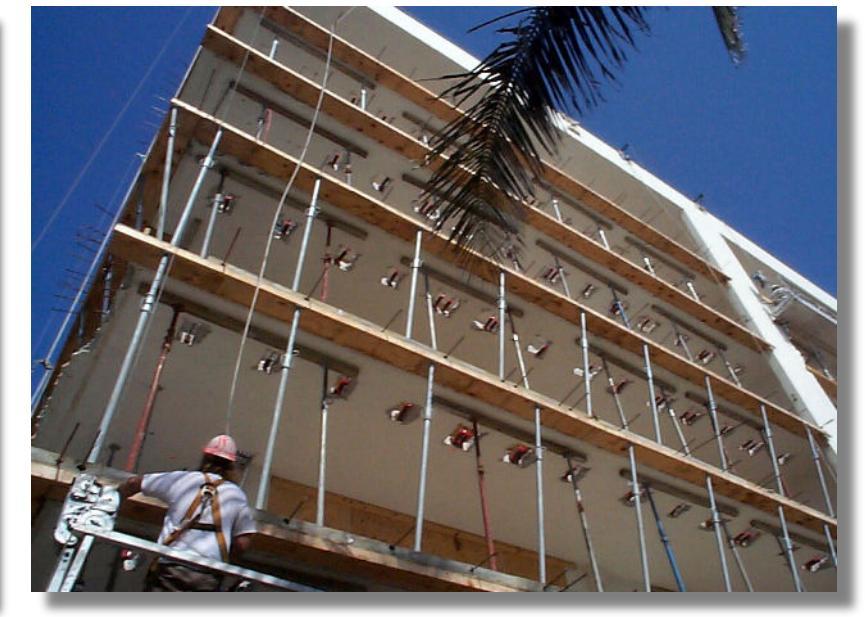
- The troubleshooting anchor is used to provide a temporarily anchor at a new location on an existing tendon.
- ✓ Allows the post-tensioned forces to be temporarily removed from a limited portion of a tendon span, usually for repairs.

Slot in anchor allows it to be installed on a cable that remains under tension.

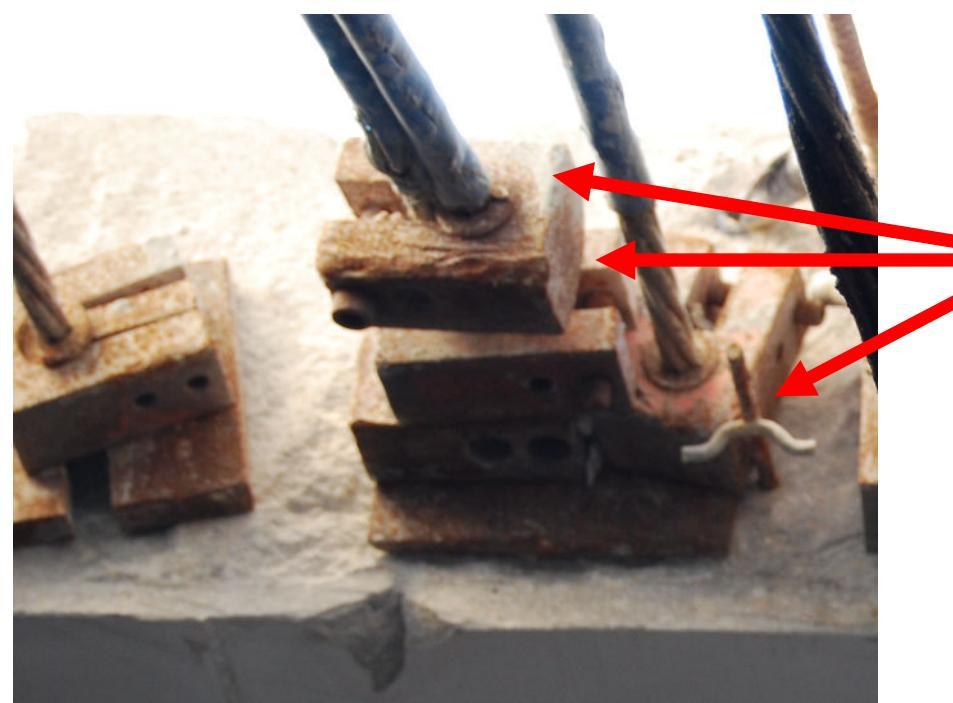
The installation of temporary anchors on bundles of multiple cables using single cable anchors can be extremely difficult and dangerous. A failure can result in injury, damage, and a significant loss of post-tensioning in a localized area, which is structurally significant.

Stacked lock-offs are highly unstable and should be avoided

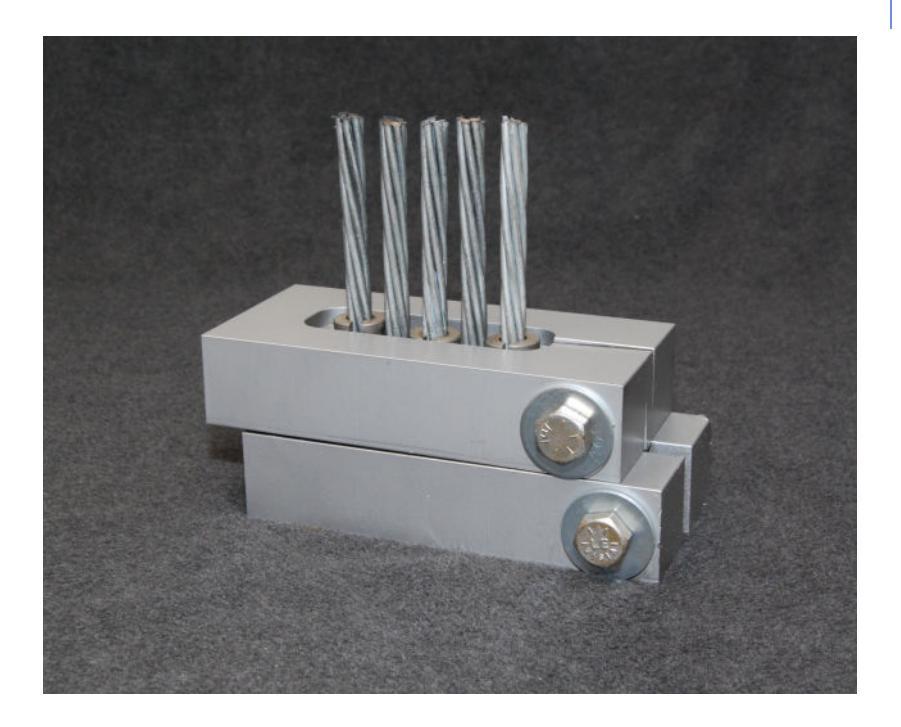
#### Patented Multi-Cable Anchor

- Locking off multiple cables with single cable anchors can be extremely difficult and dangerous.
- Any failure during the repair process can result in injury, damage, and a significant loss of posttensioning in a localized area.
- ✓ This device is used to lock-off multiple cables and is safer than stacking up multiple single cable anchors.

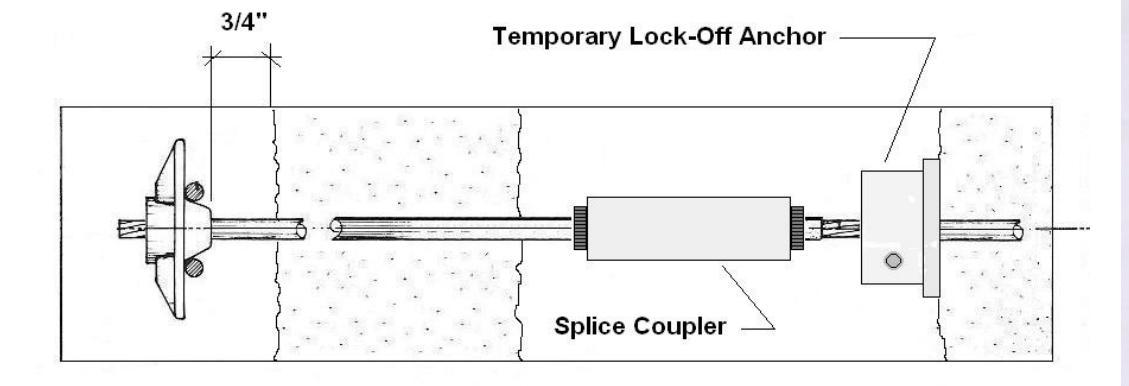
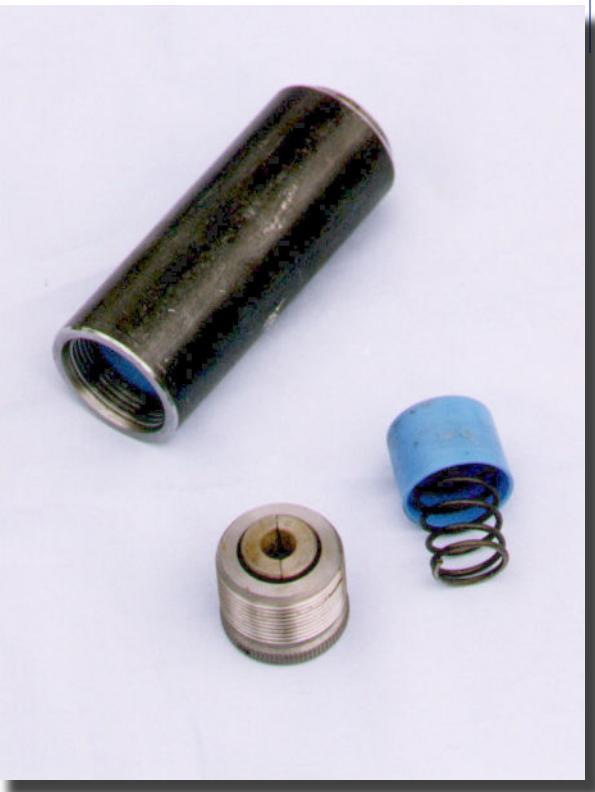
#### One time use splice couplers

- Used for joining a section of new strand to an existing cable at some point along the tendon span.
- Requires access to a terminal end anchor in order to re-establish tension.

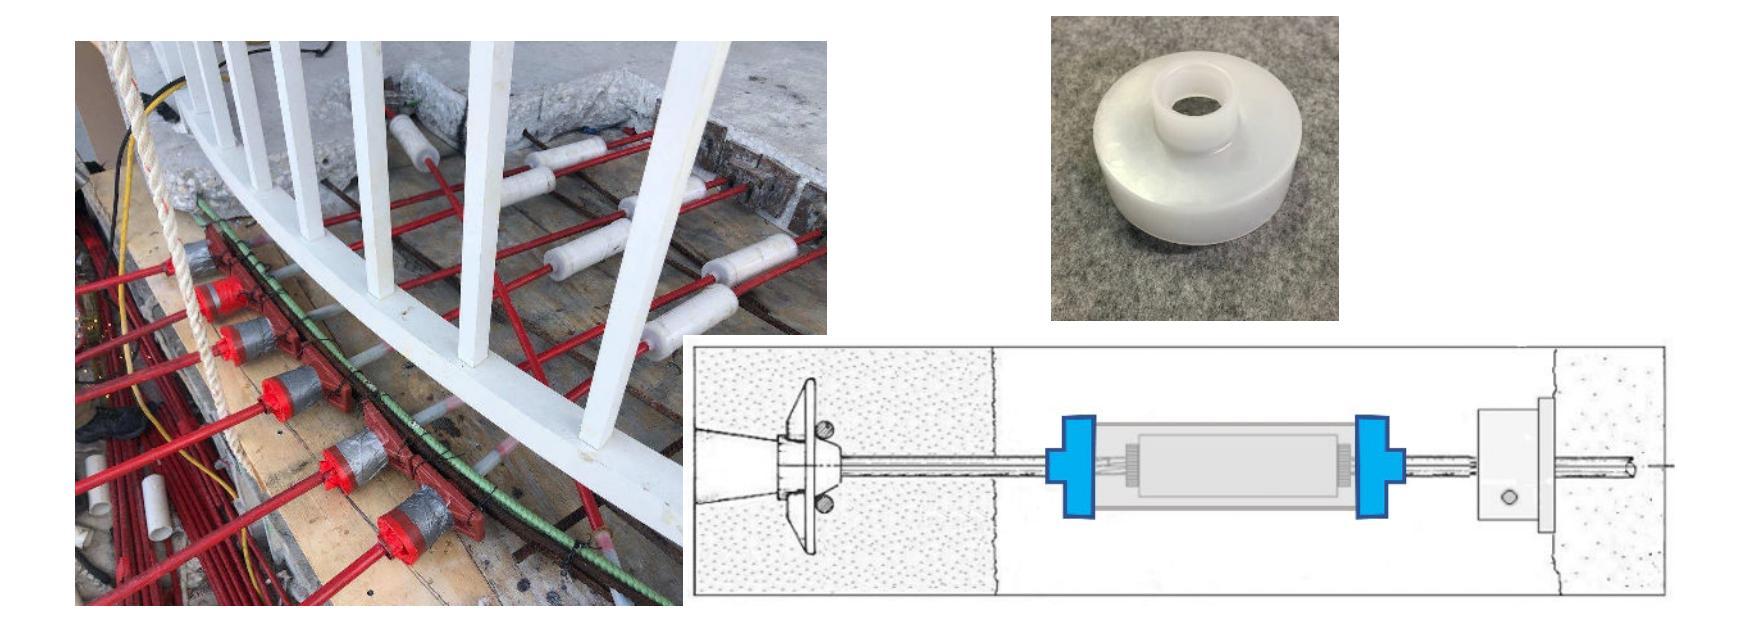
## Splice coupler encapsulation

Cable splices should be encapsulated using PVC or HDPE pipe and sealed with Splice Caps (Post-tensionProducts.com).

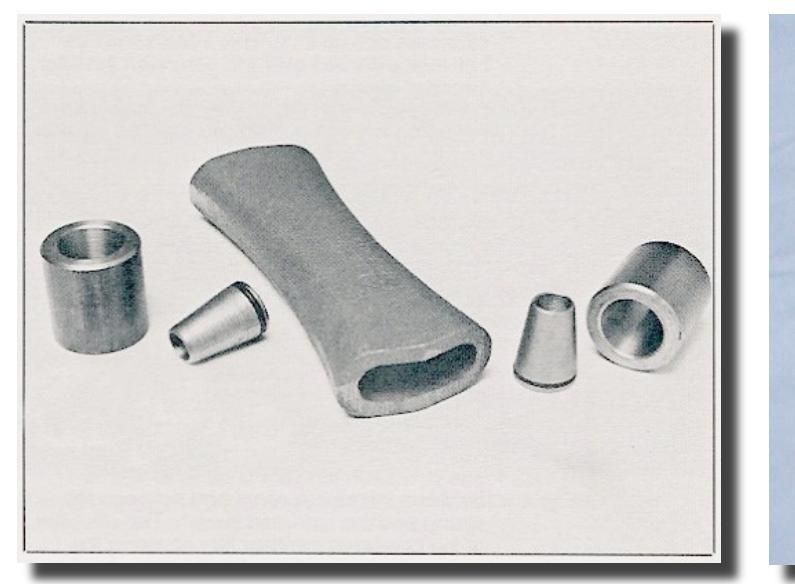
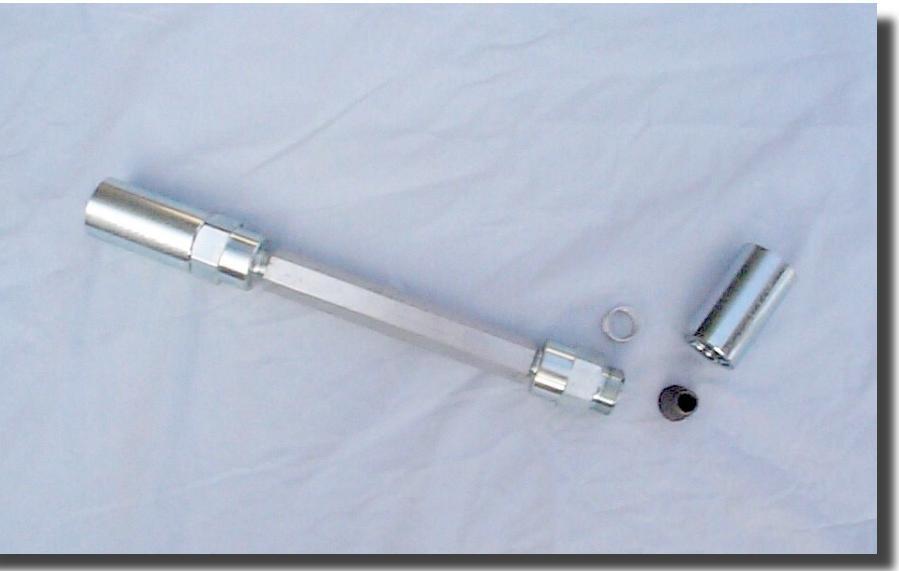
- Cable tensioning with a stressing splice
- Typically used for splicing damaged cables along their length.
- Trade names such as LokCouplers / Grabits.
- Does not require access to the stressing end anchors for reestablishing tension of the repaired cable.
